295 Commonwealth Ave #5c  
Floor Plan  
1/8" = 1'-0"

## 295 Commonwealth Ave #5c Window Elevations

295 Commonwealth Ave #5c  
**Window Details**

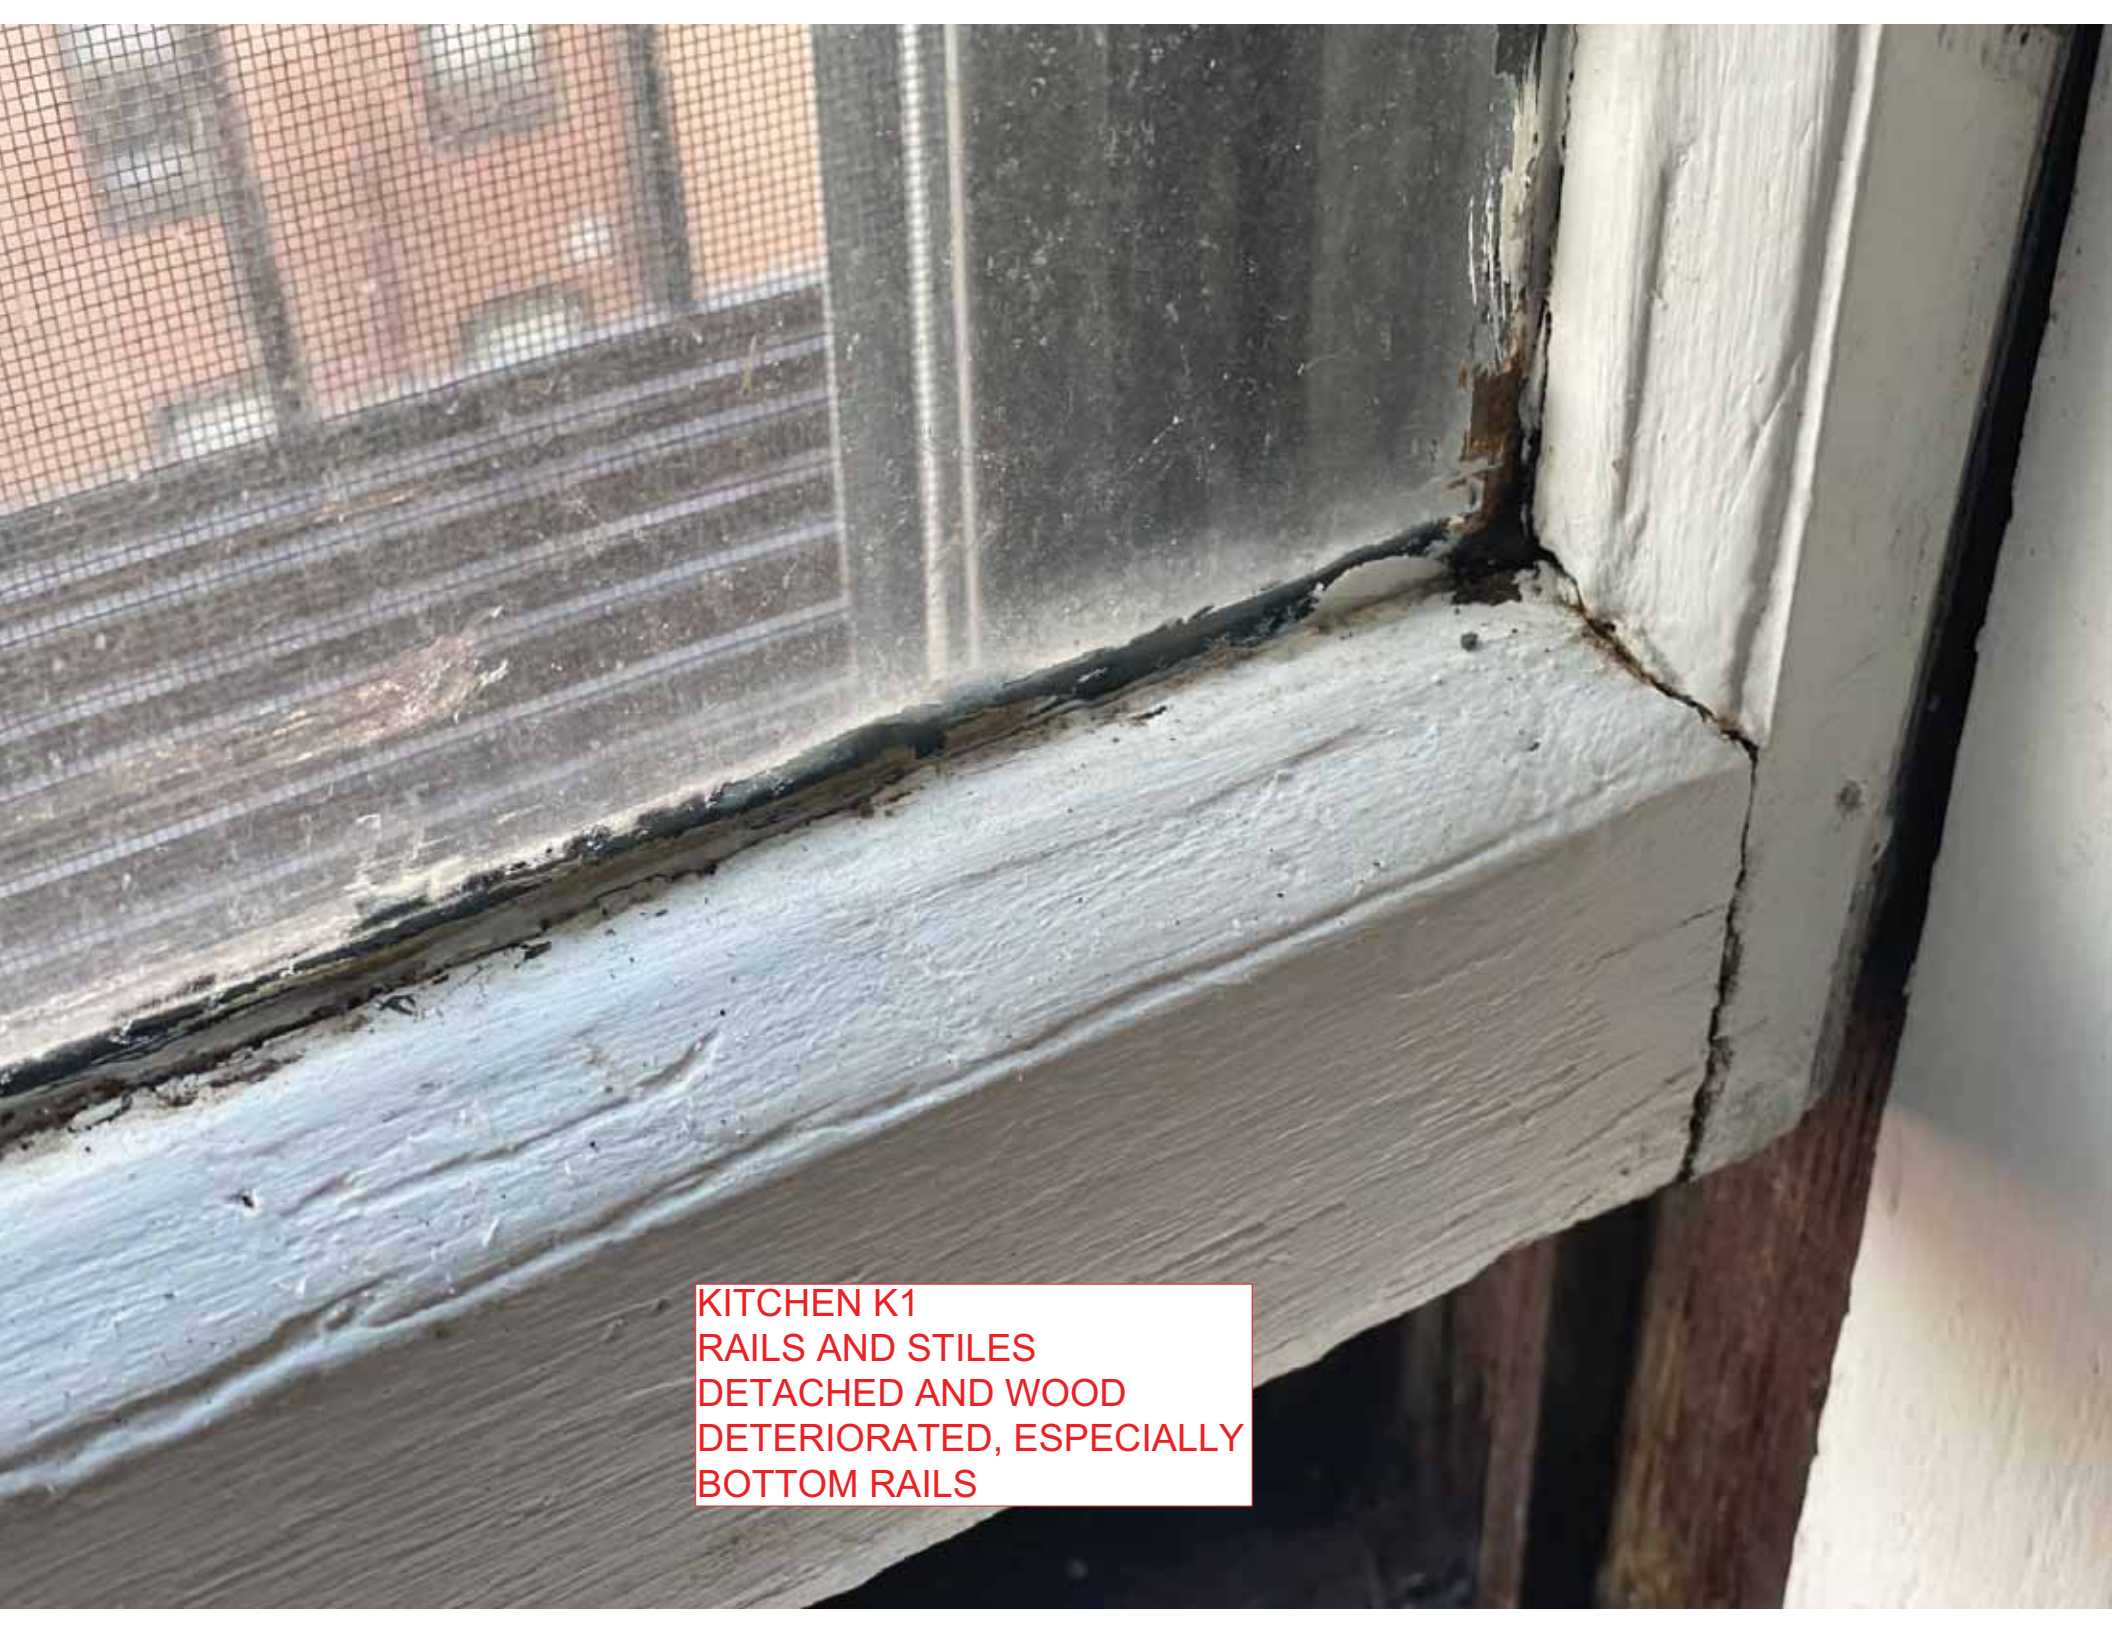
KITCHEN K1  
RAILS AND STILES  
DETACHED AND WOOD  
DETERIORATED, ESPECIALLY  
BOTTOM RAILS

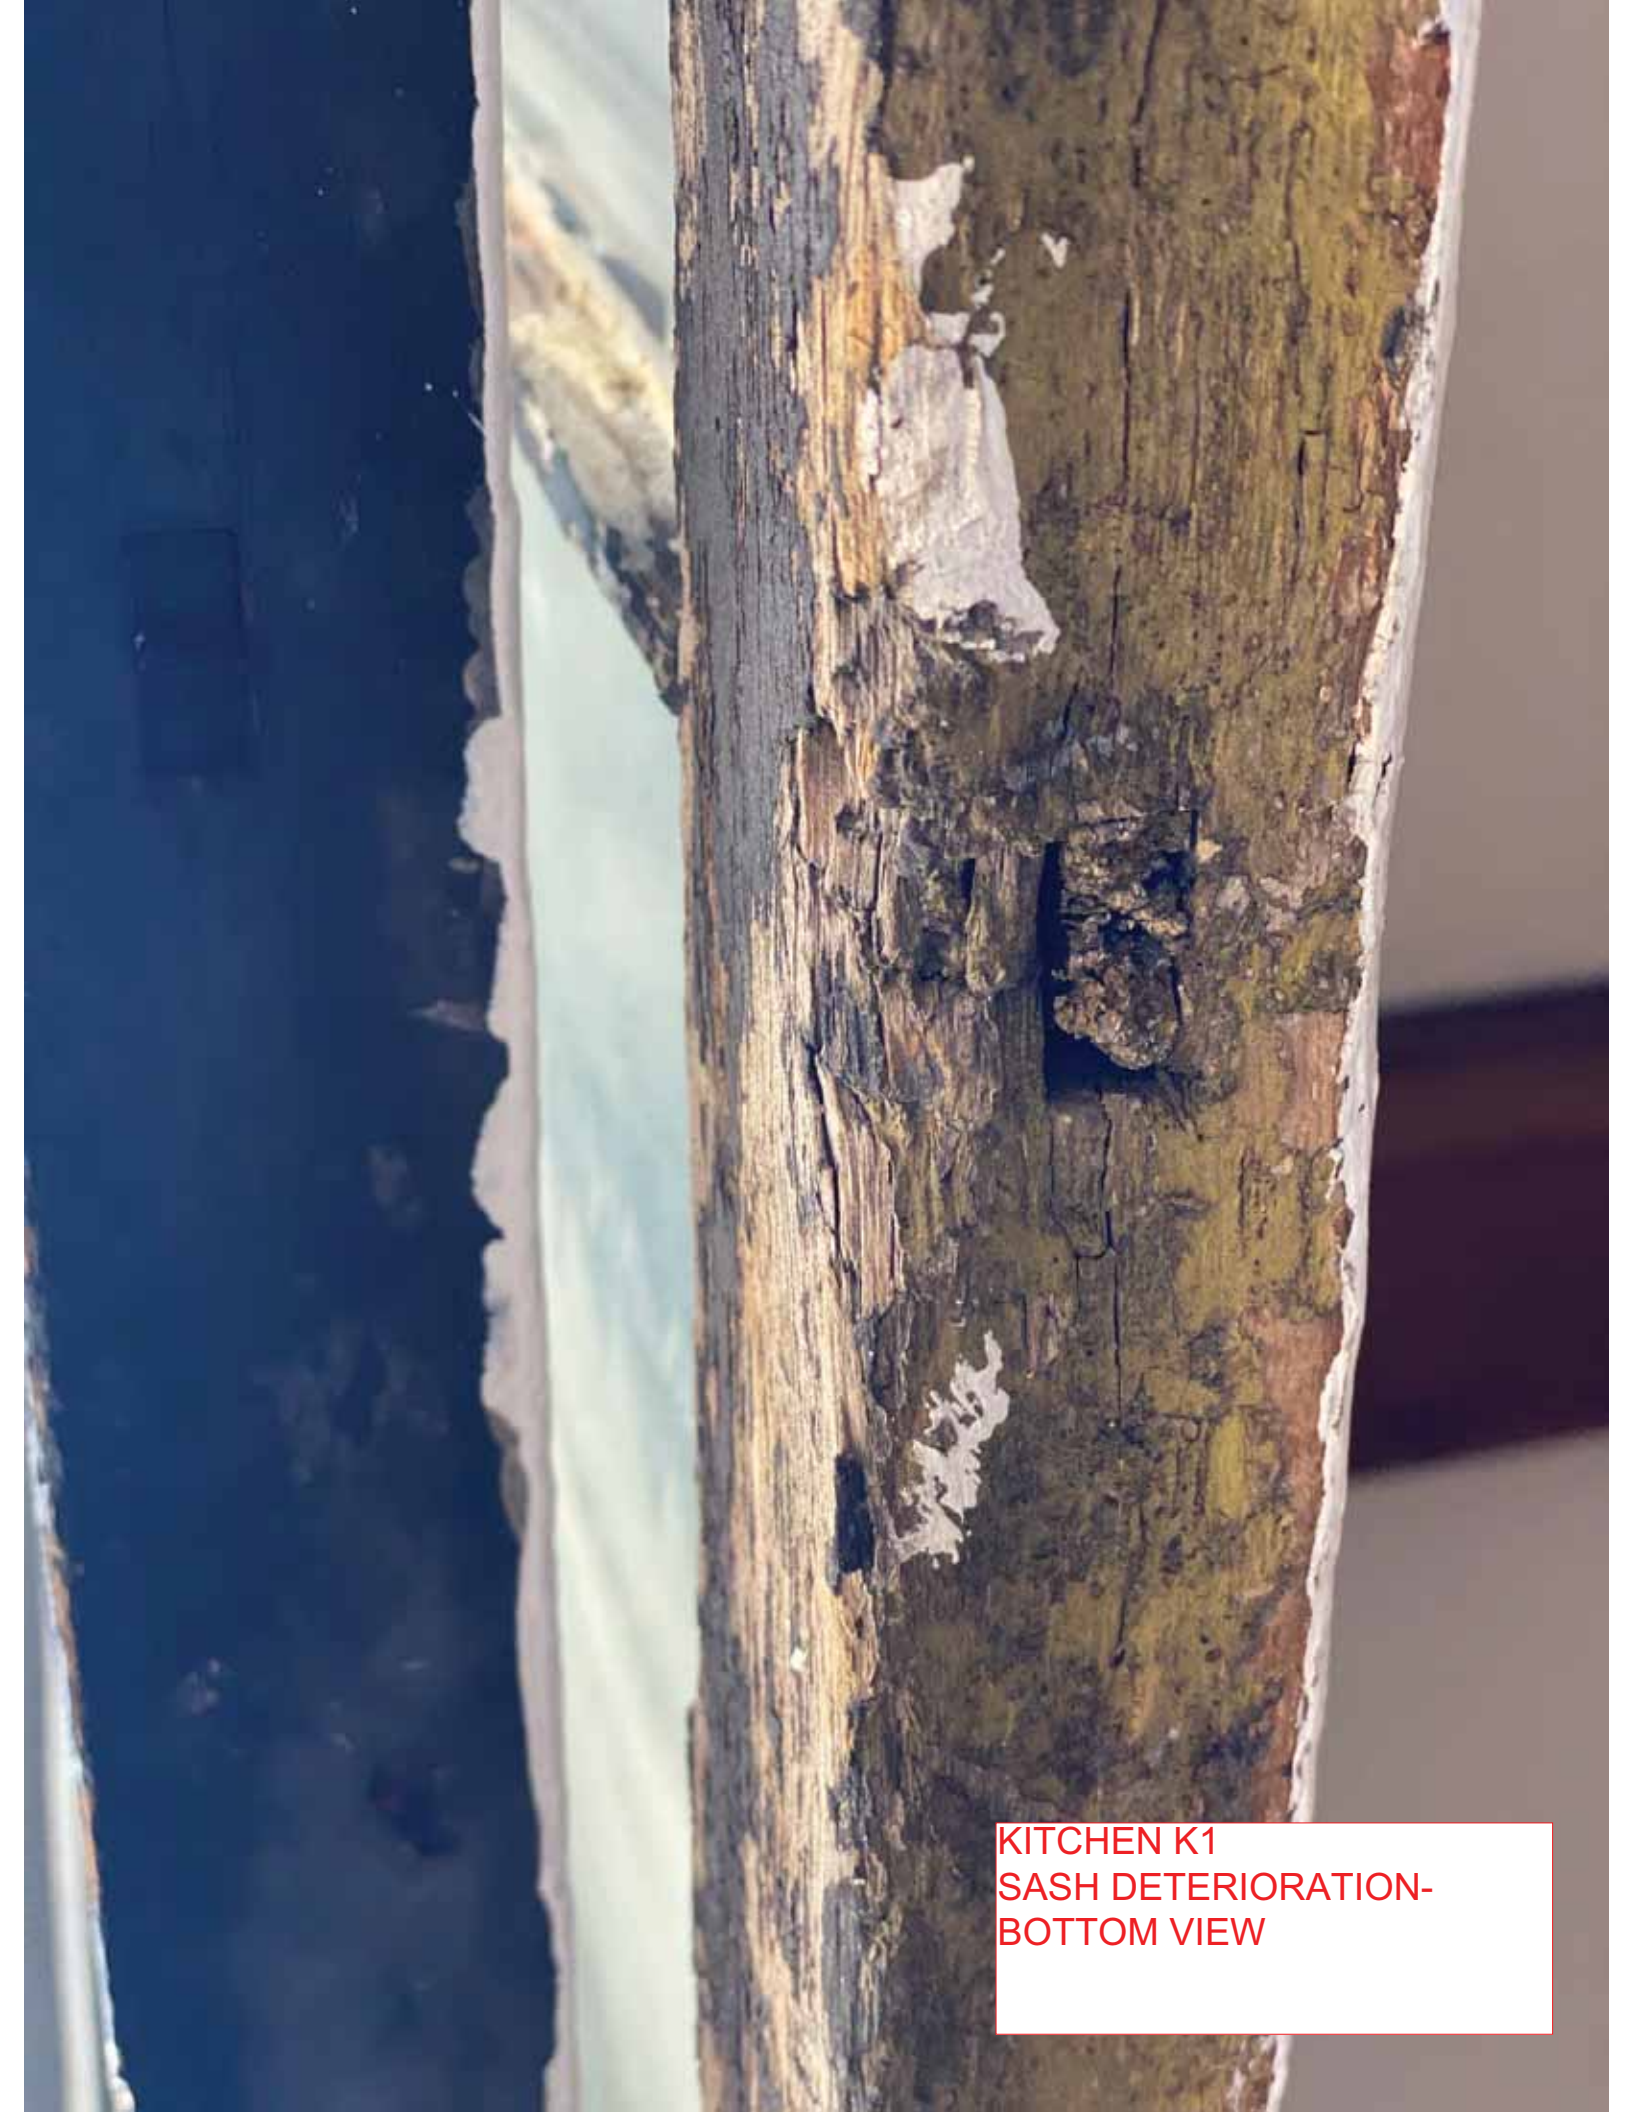
KITCHEN K1  
SASH DETERIORATION-  
BOTTOM VIEW

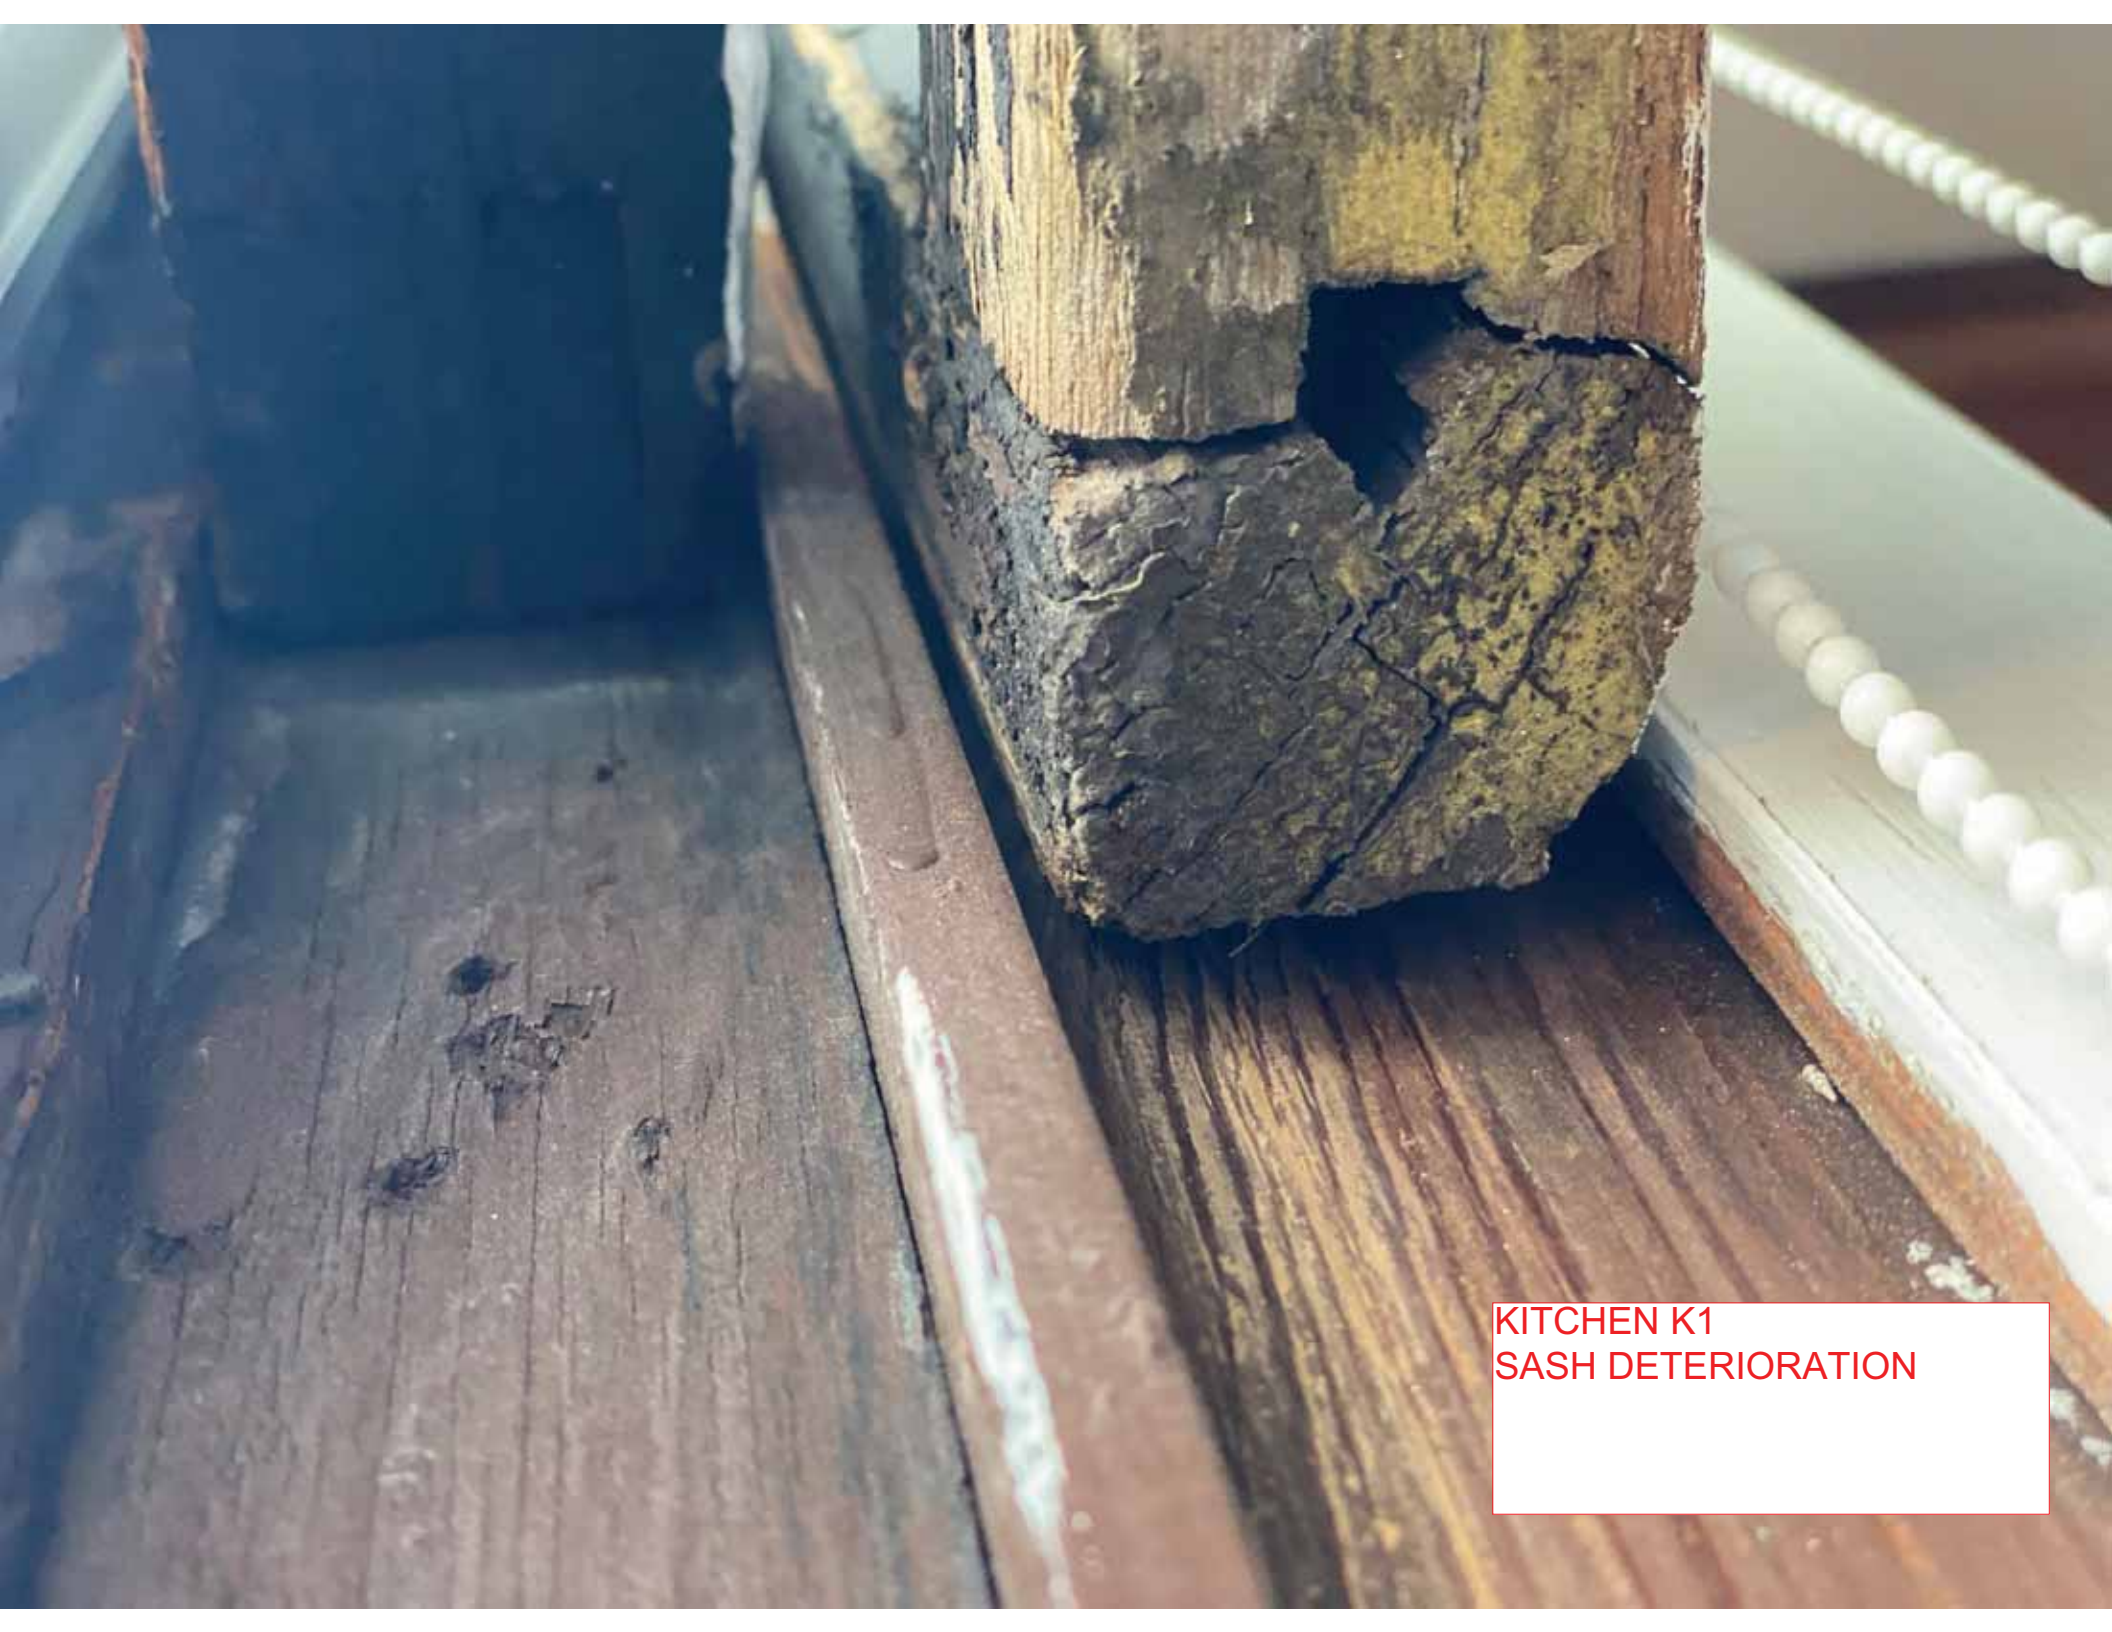
KITCHEN K1  
SASH DETERIORATION

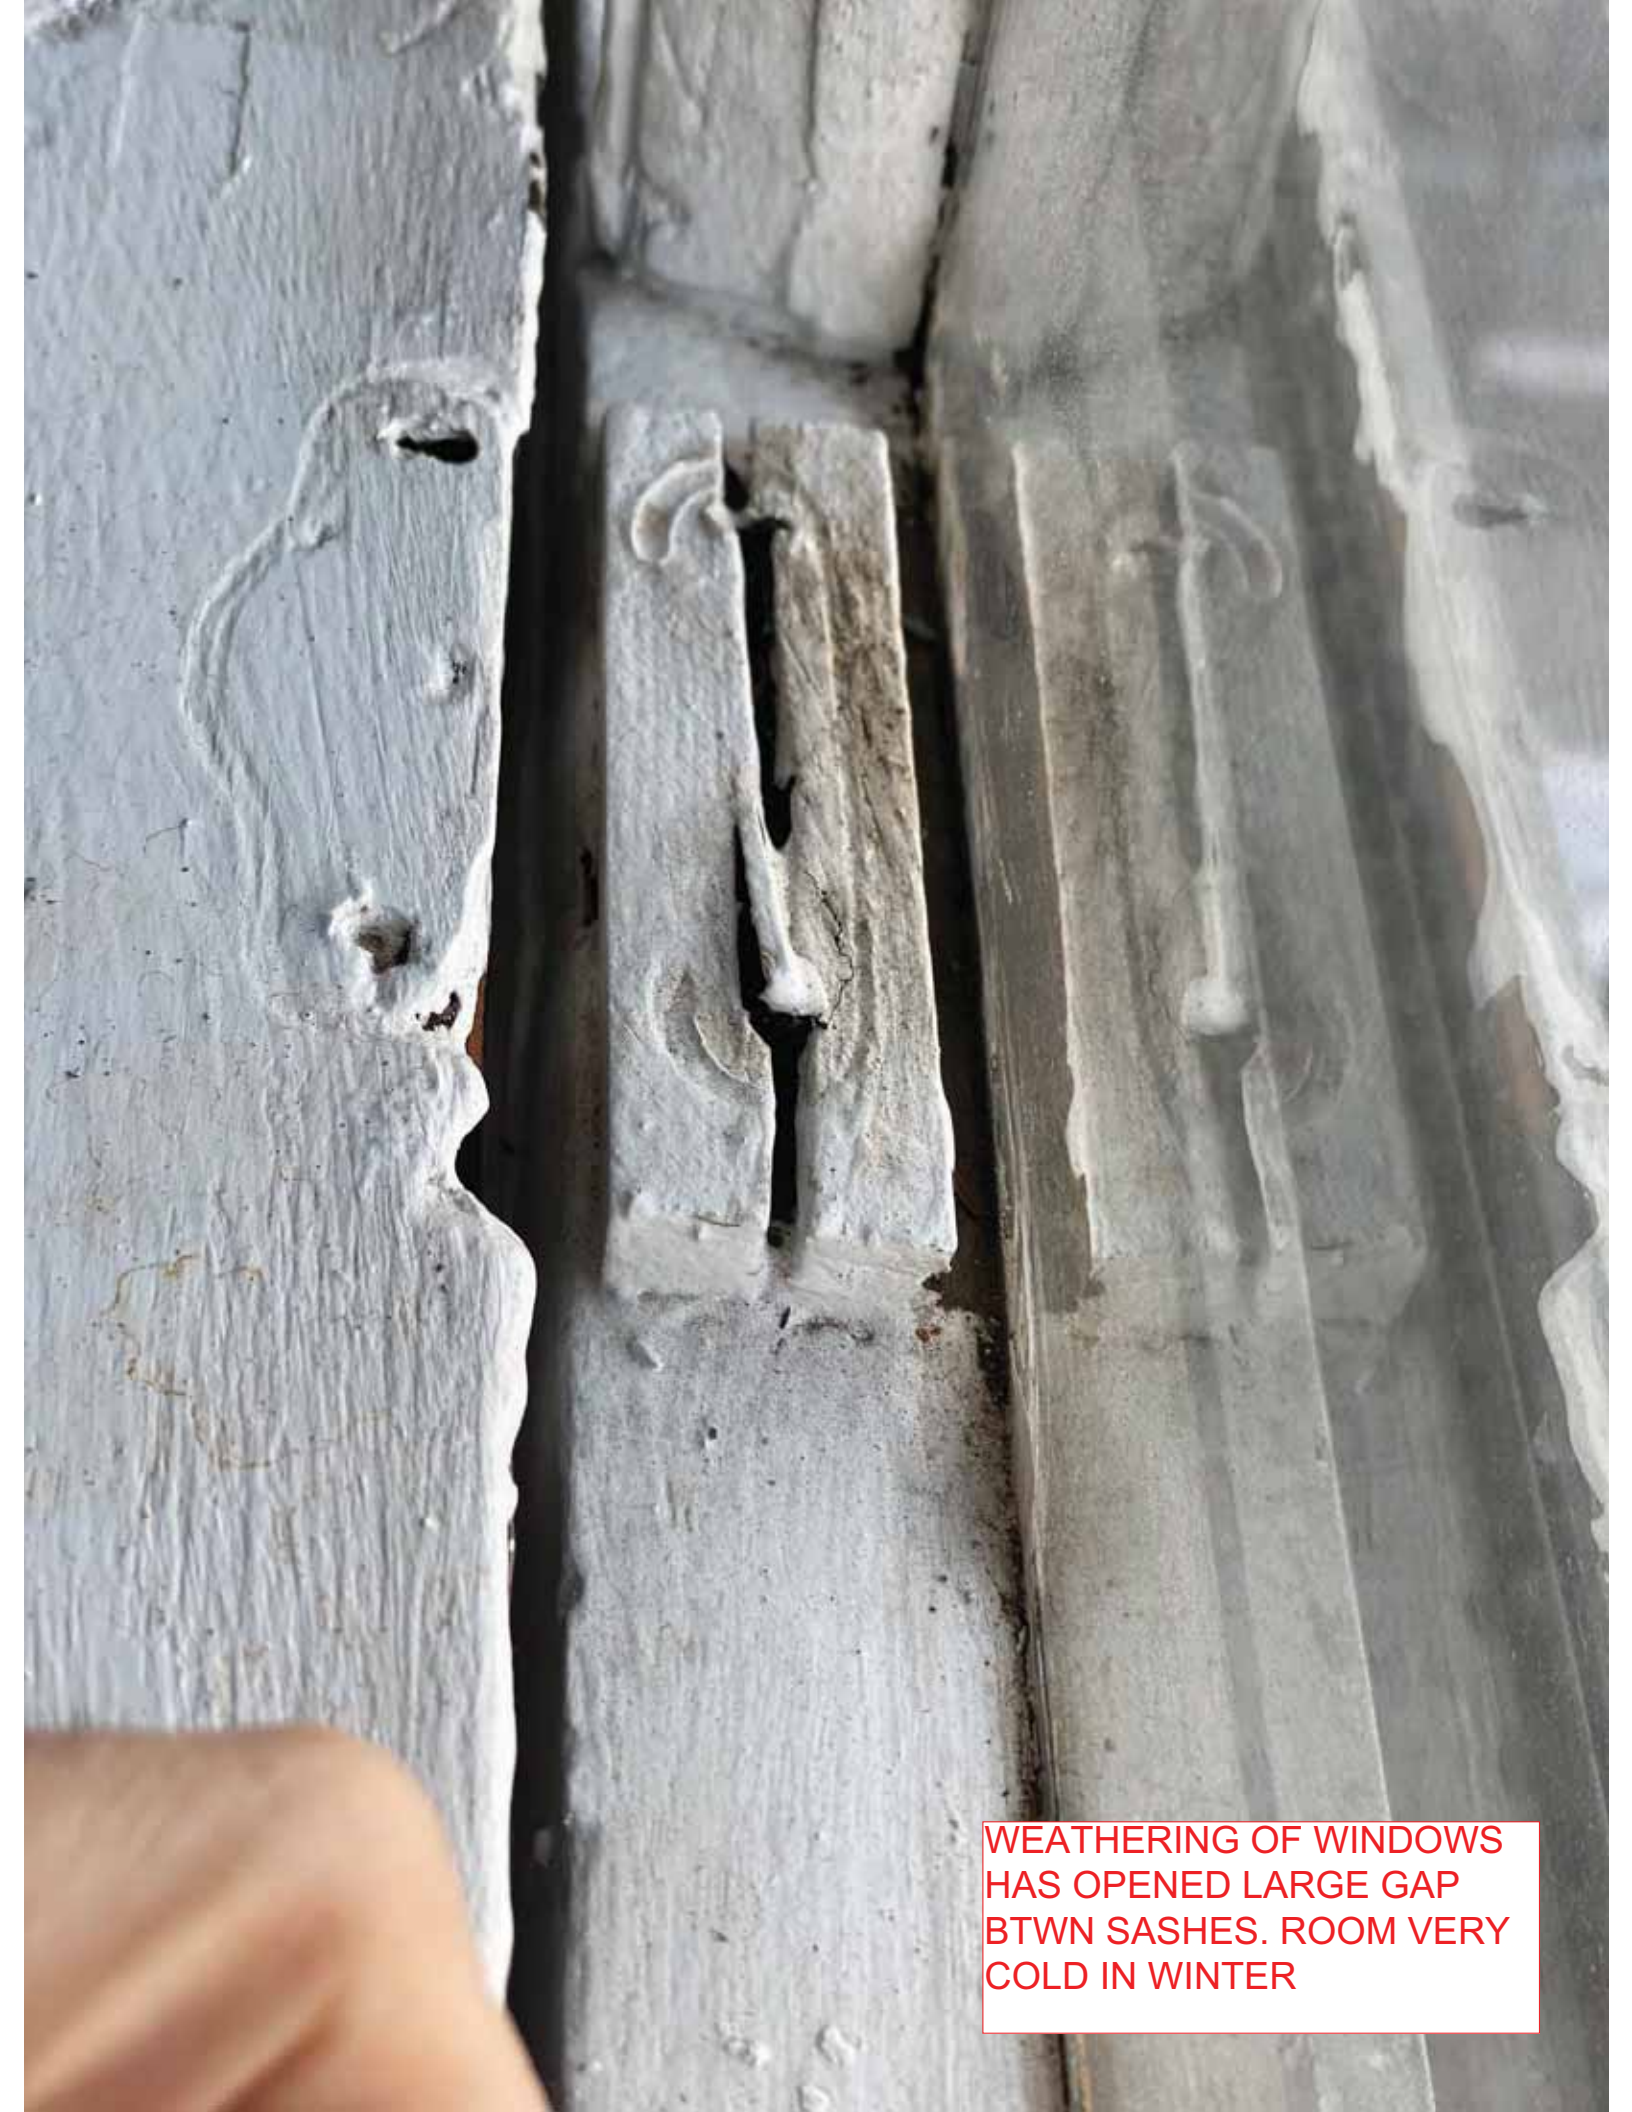
WEATHERING OF WINDOWS HAS OPENED LARGE GAP BTWN SASHES. ROOM VERY COLD IN WINTER

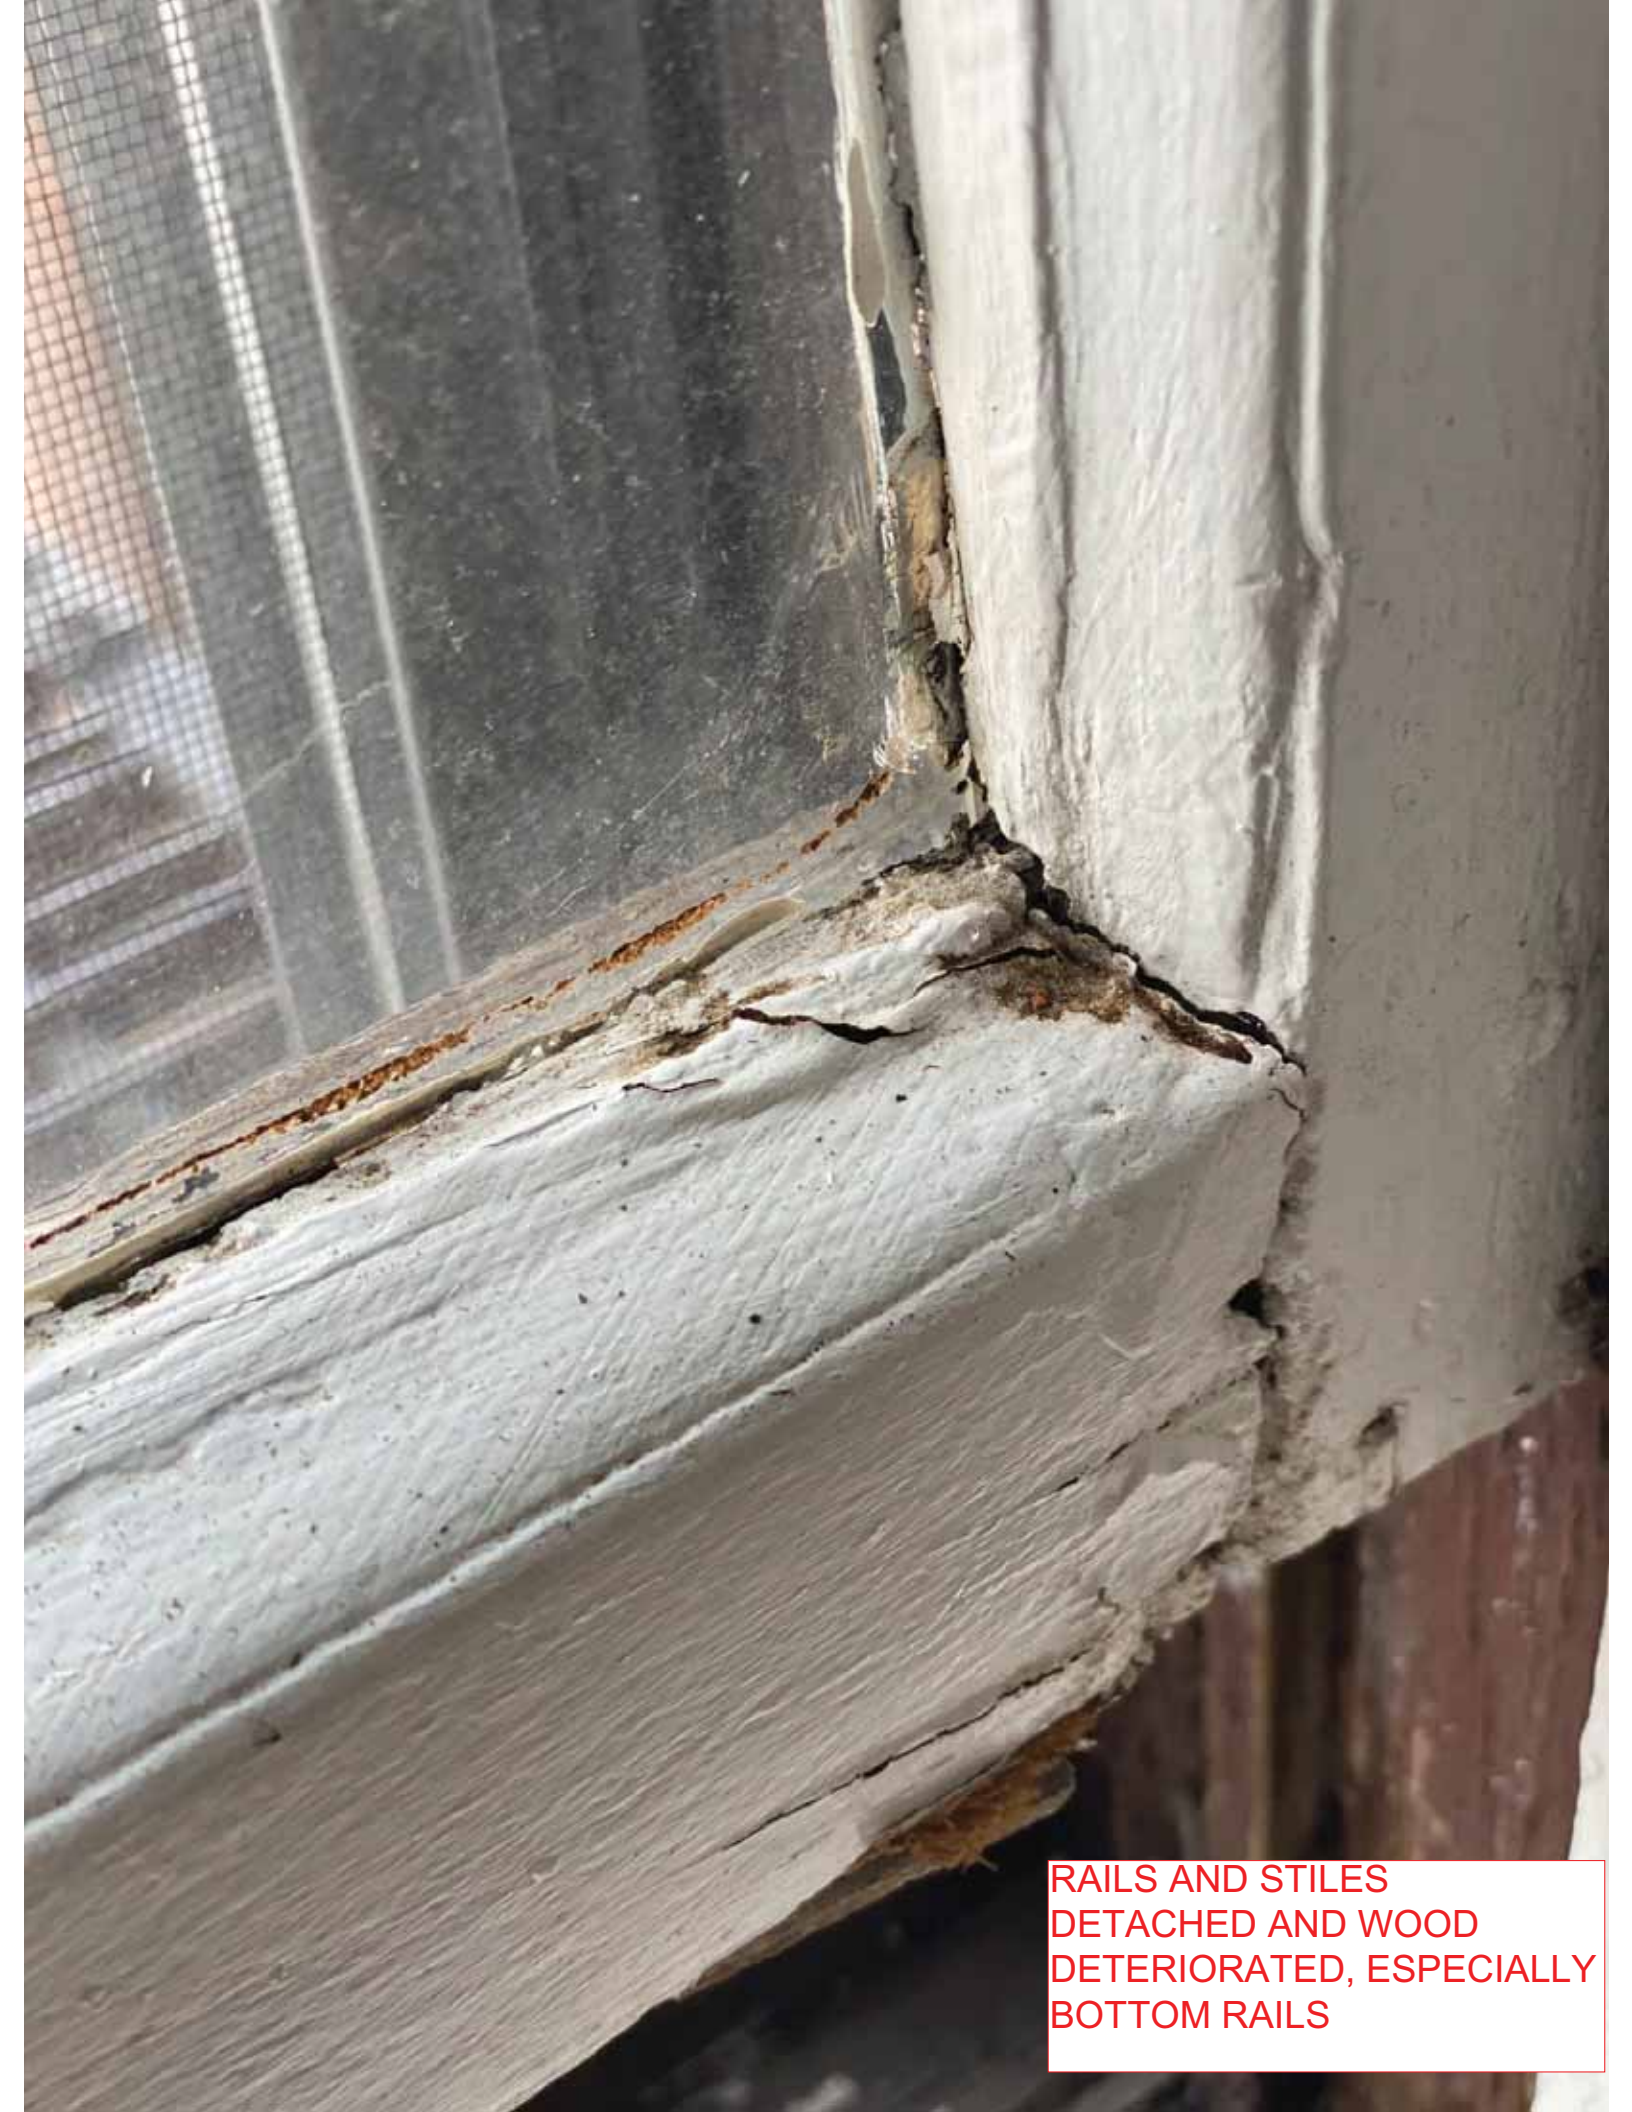
RAILS AND STILES  
DETACHED AND WOOD  
DETERIORATED, ESPECIALLY  
BOTTOM RAILS

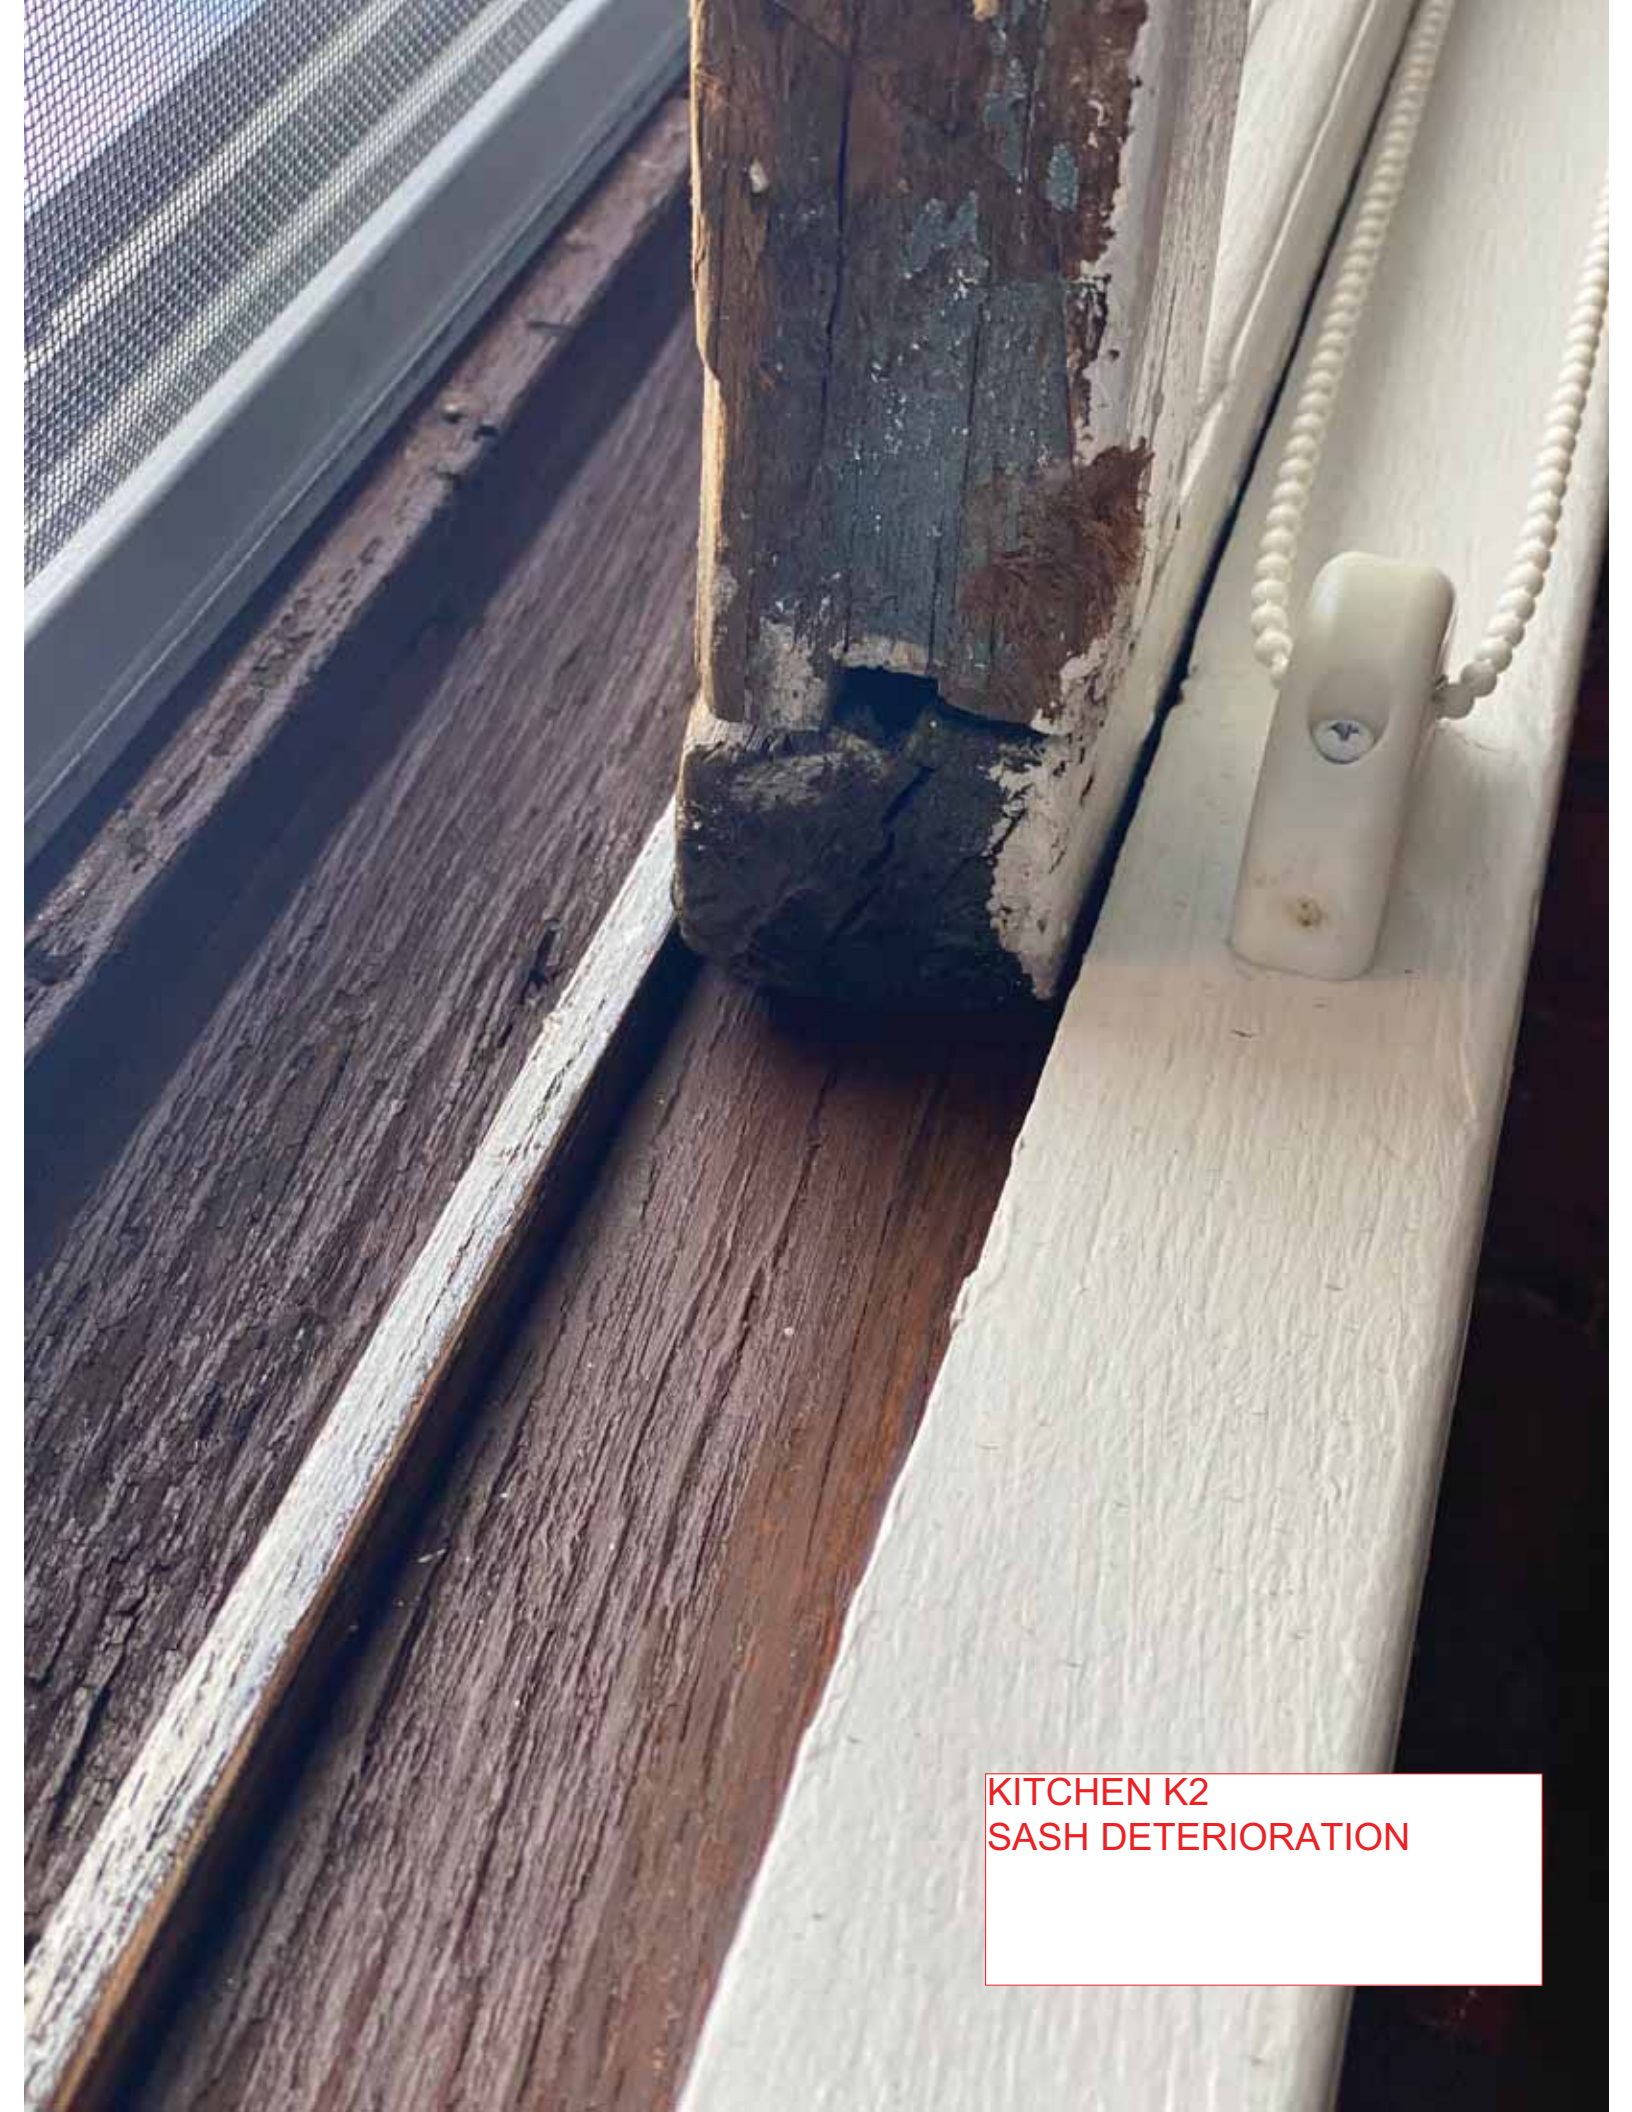
KITCHEN K2  
SASH DETERIORATION
