295 Commonwealth Ave #5c  
Floor Plan  
1/8" = 1'-0"

## 295 Commonwealth Ave #5c Window Elevations

295 Commonwealth Ave #5c  
**Window Details**

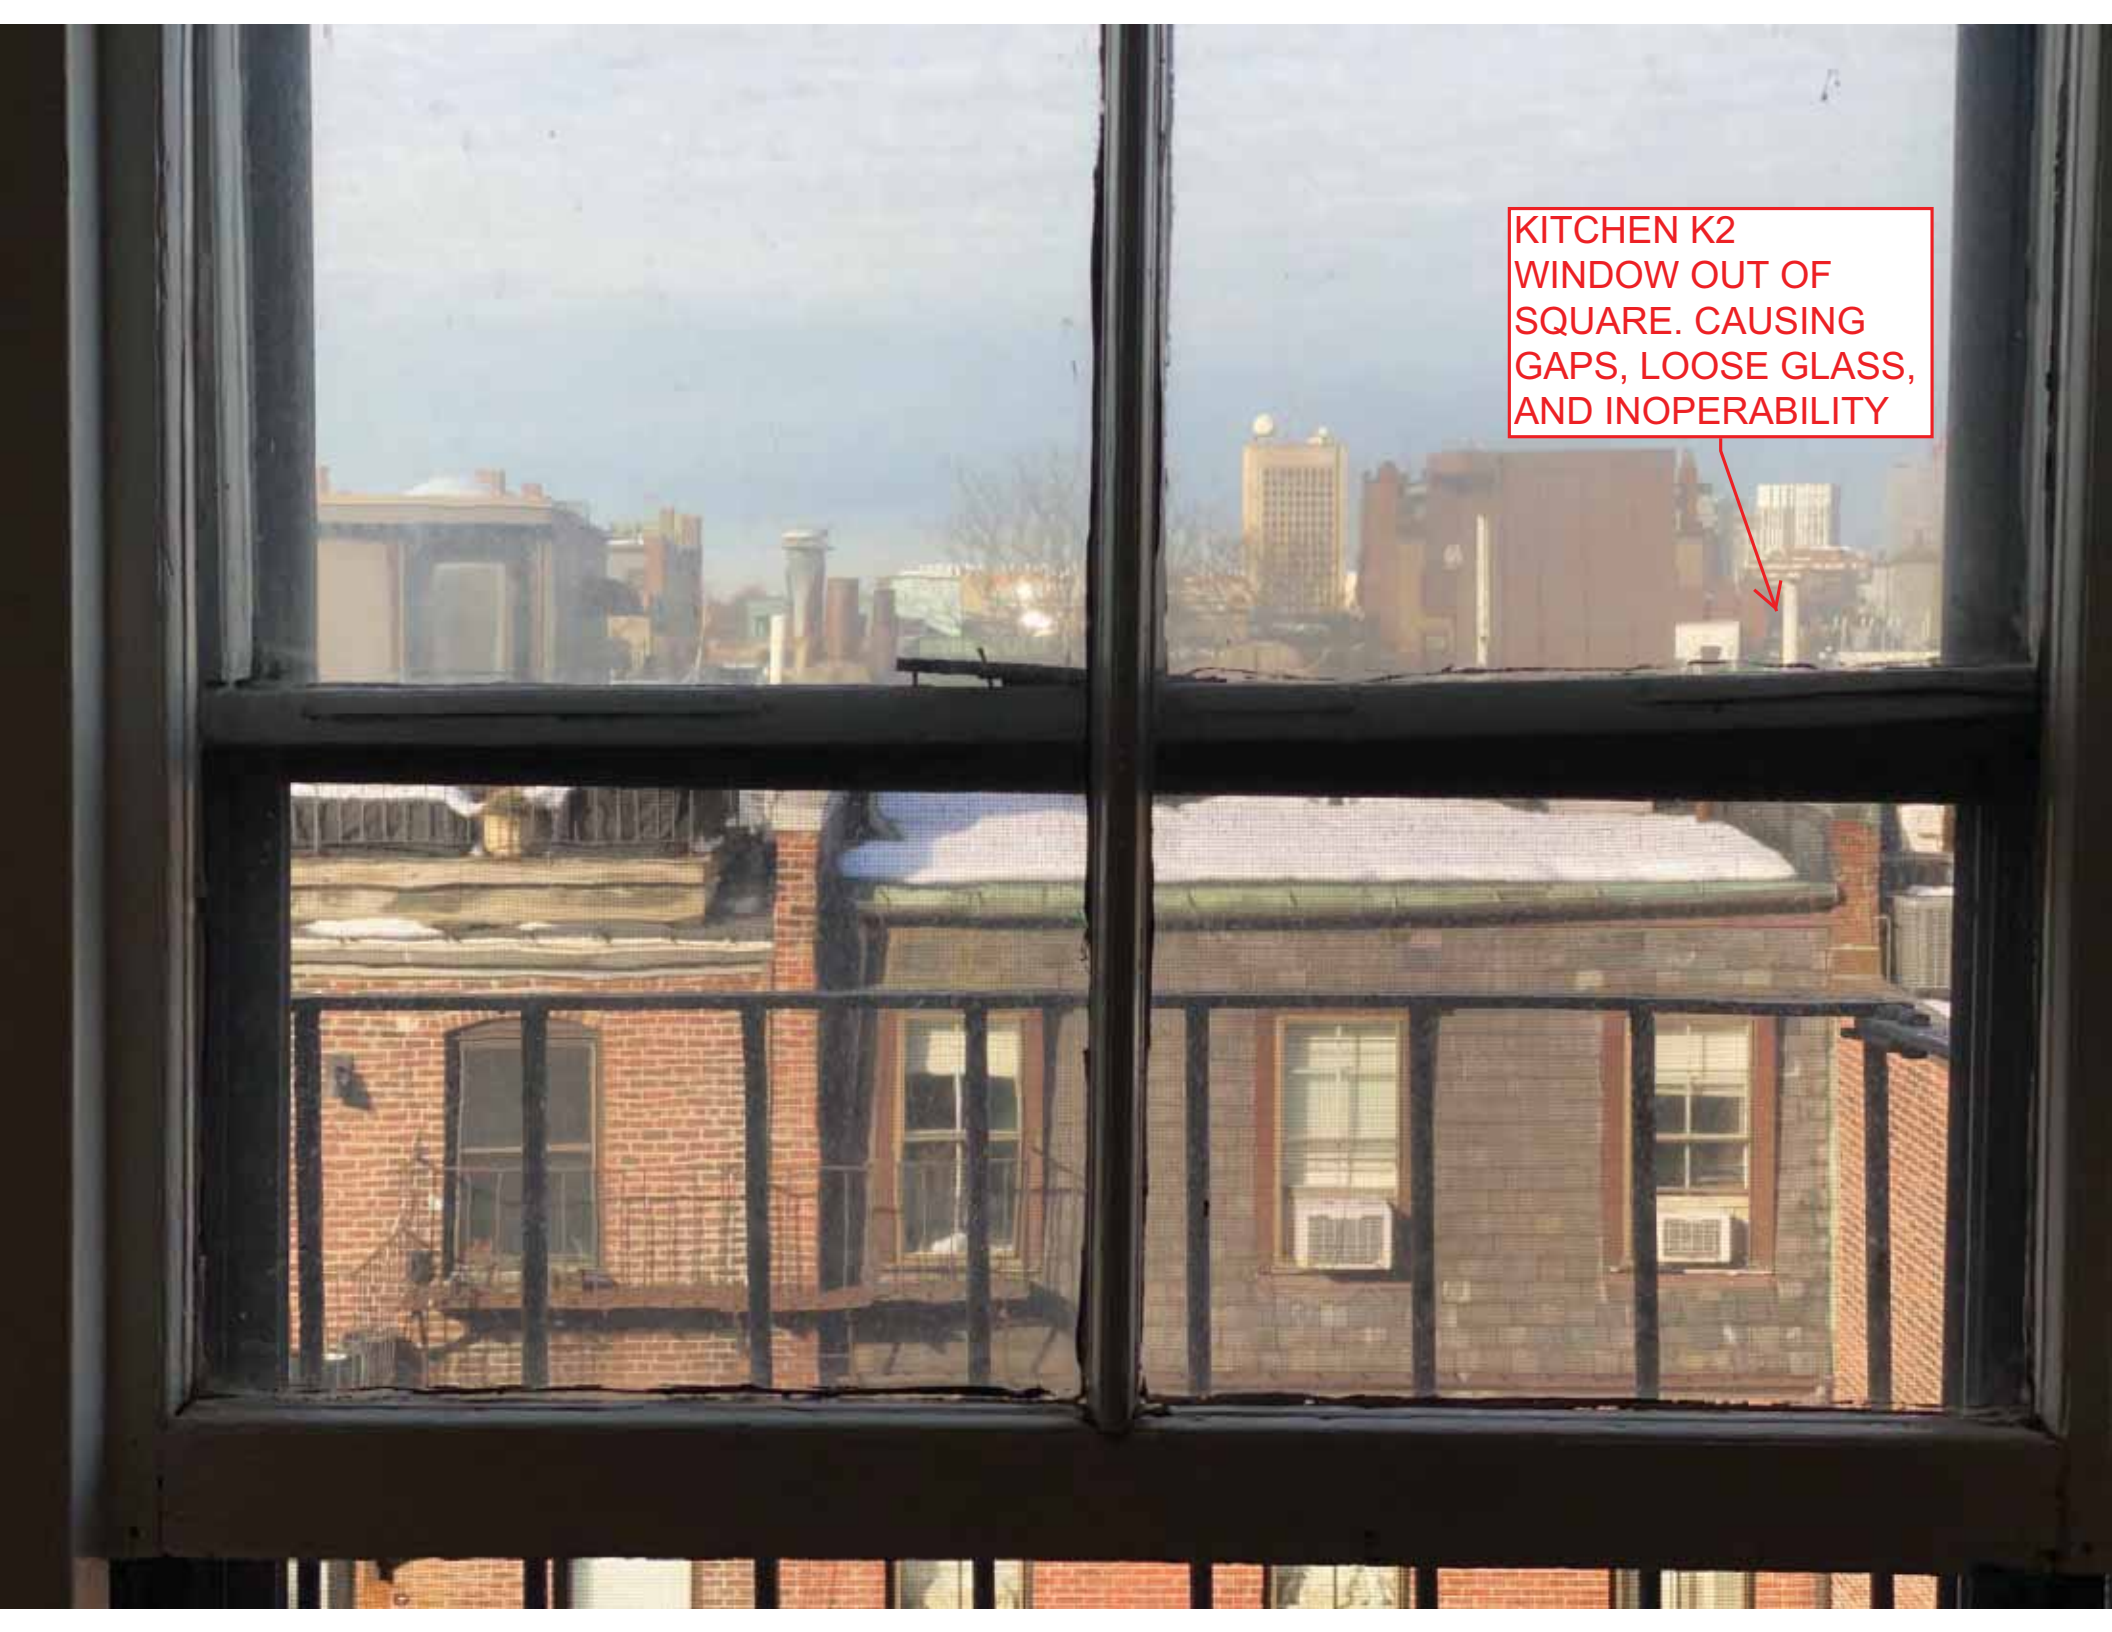
KITCHEN K2  
WINDOW OUT OF  
SQUARE. CAUSING  
GAPS, LOOSE GLASS,  
AND INOPERABILITY

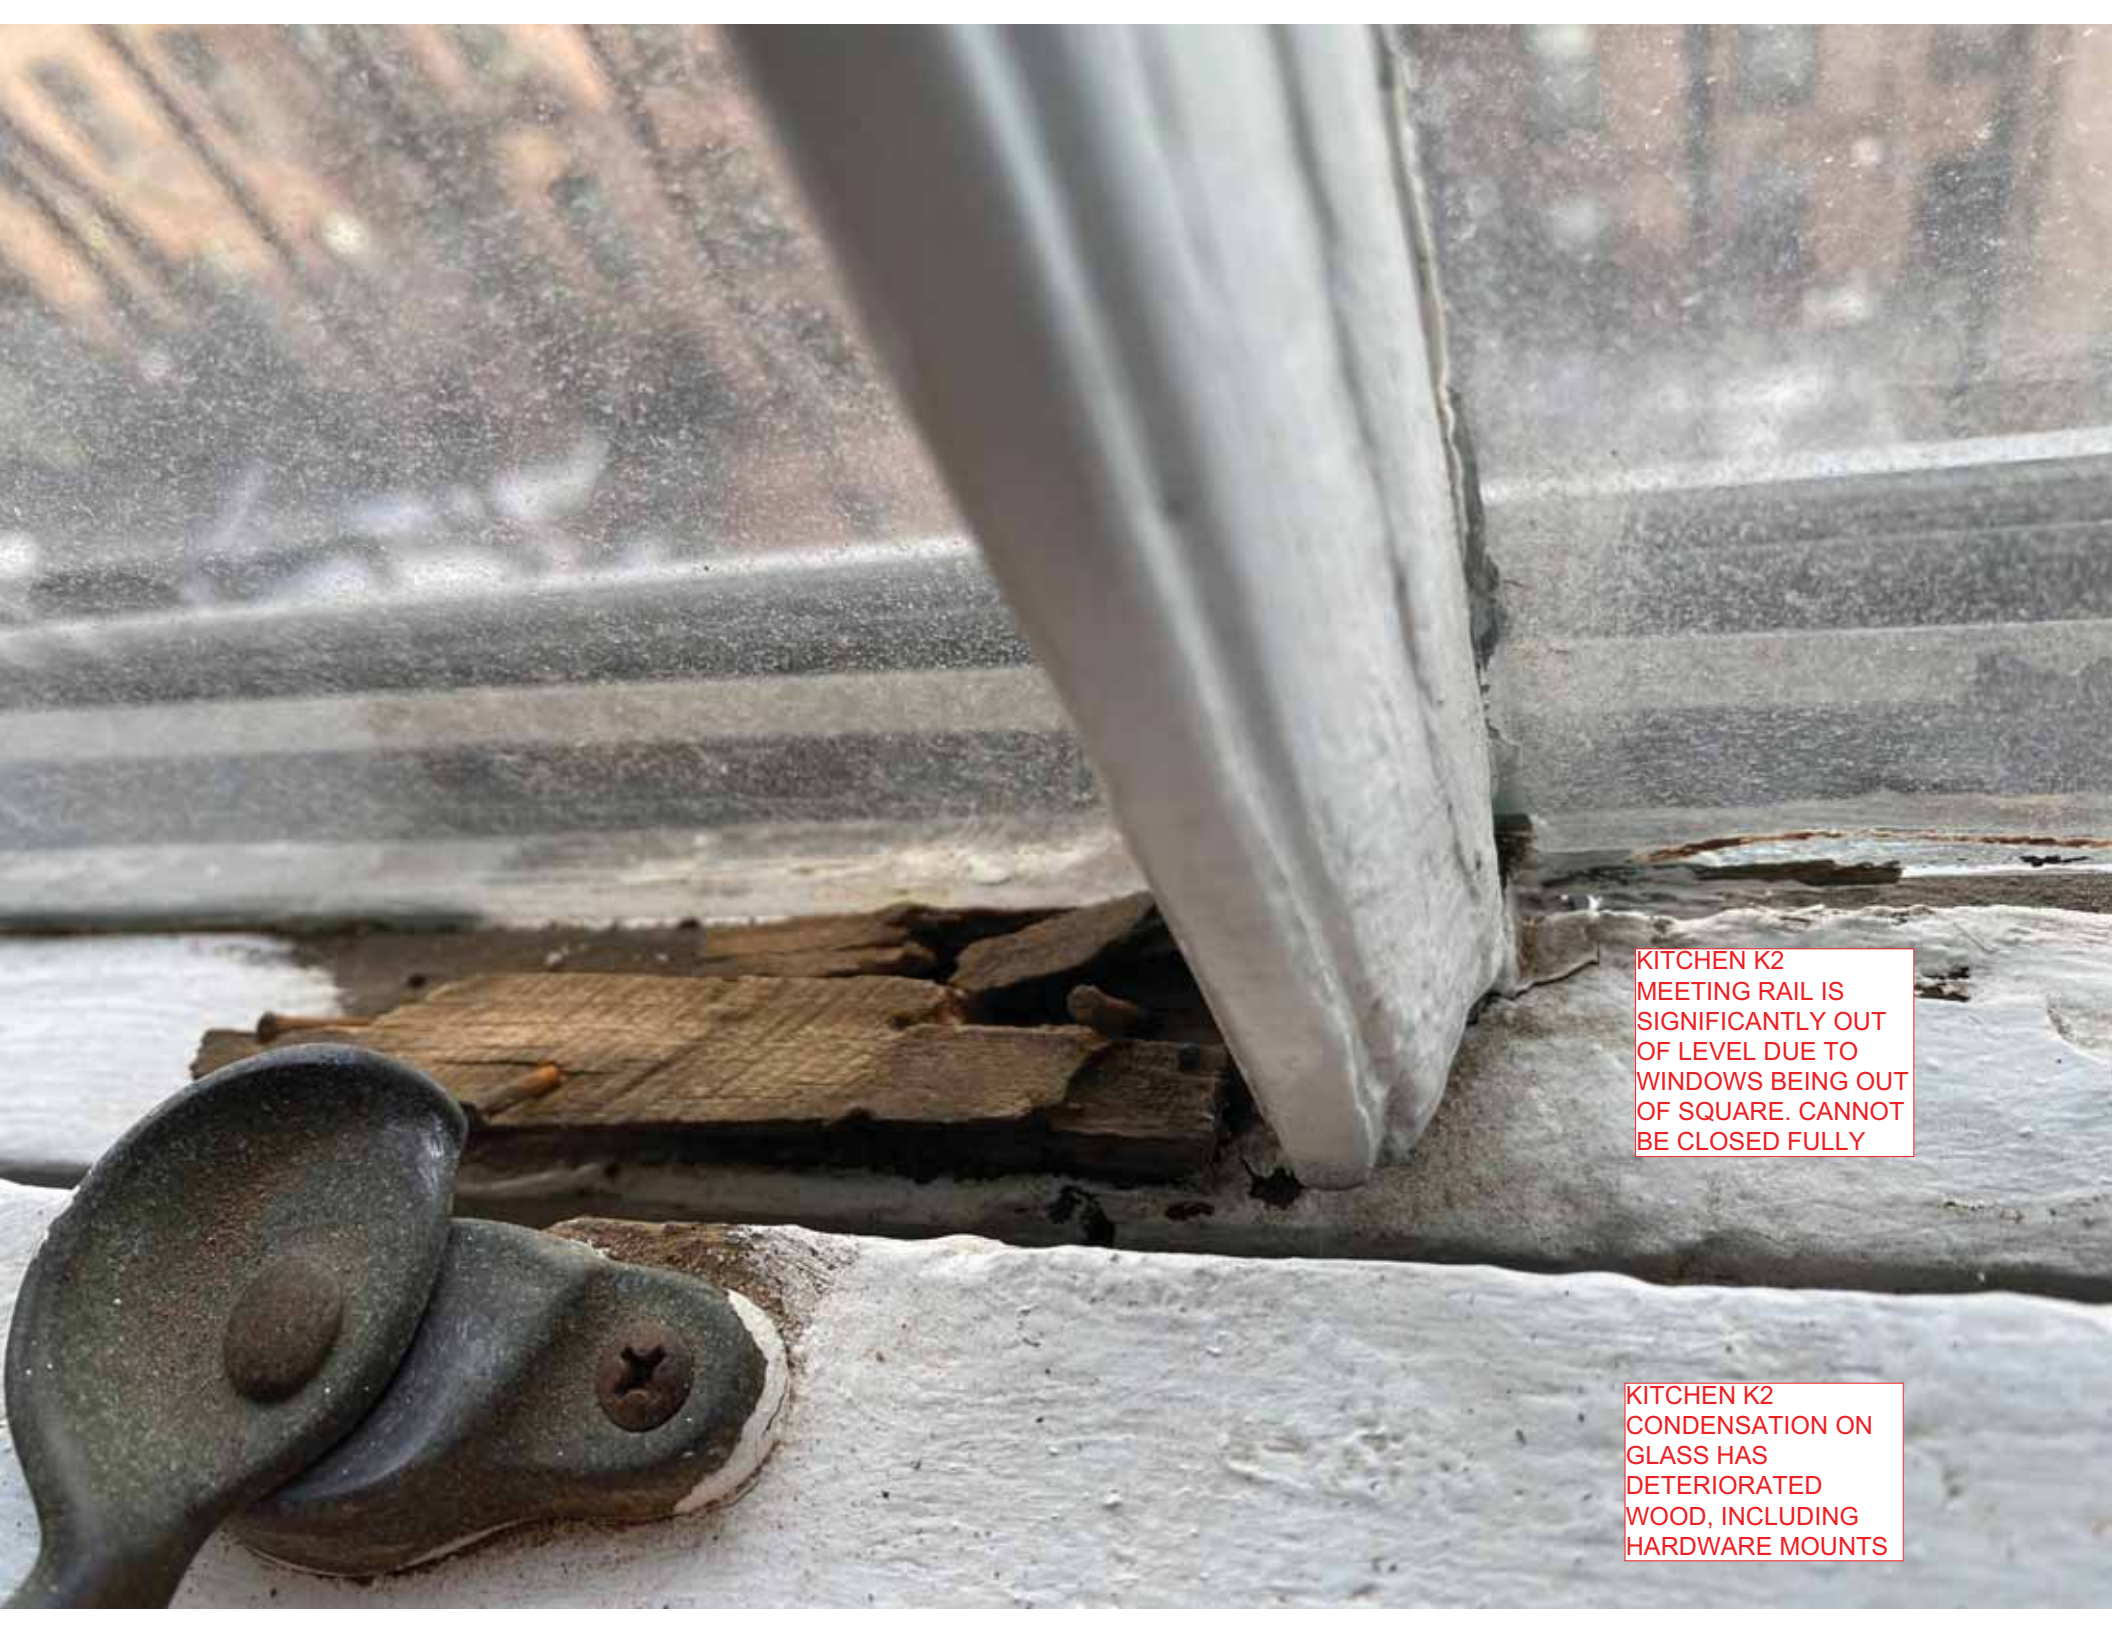
KITCHEN K2  
MEETING RAIL IS  
SIGNIFICANTLY OUT  
OF LEVEL DUE TO  
WINDOWS BEING OUT  
OF SQUARE. CANNOT  
BE CLOSED FULLY

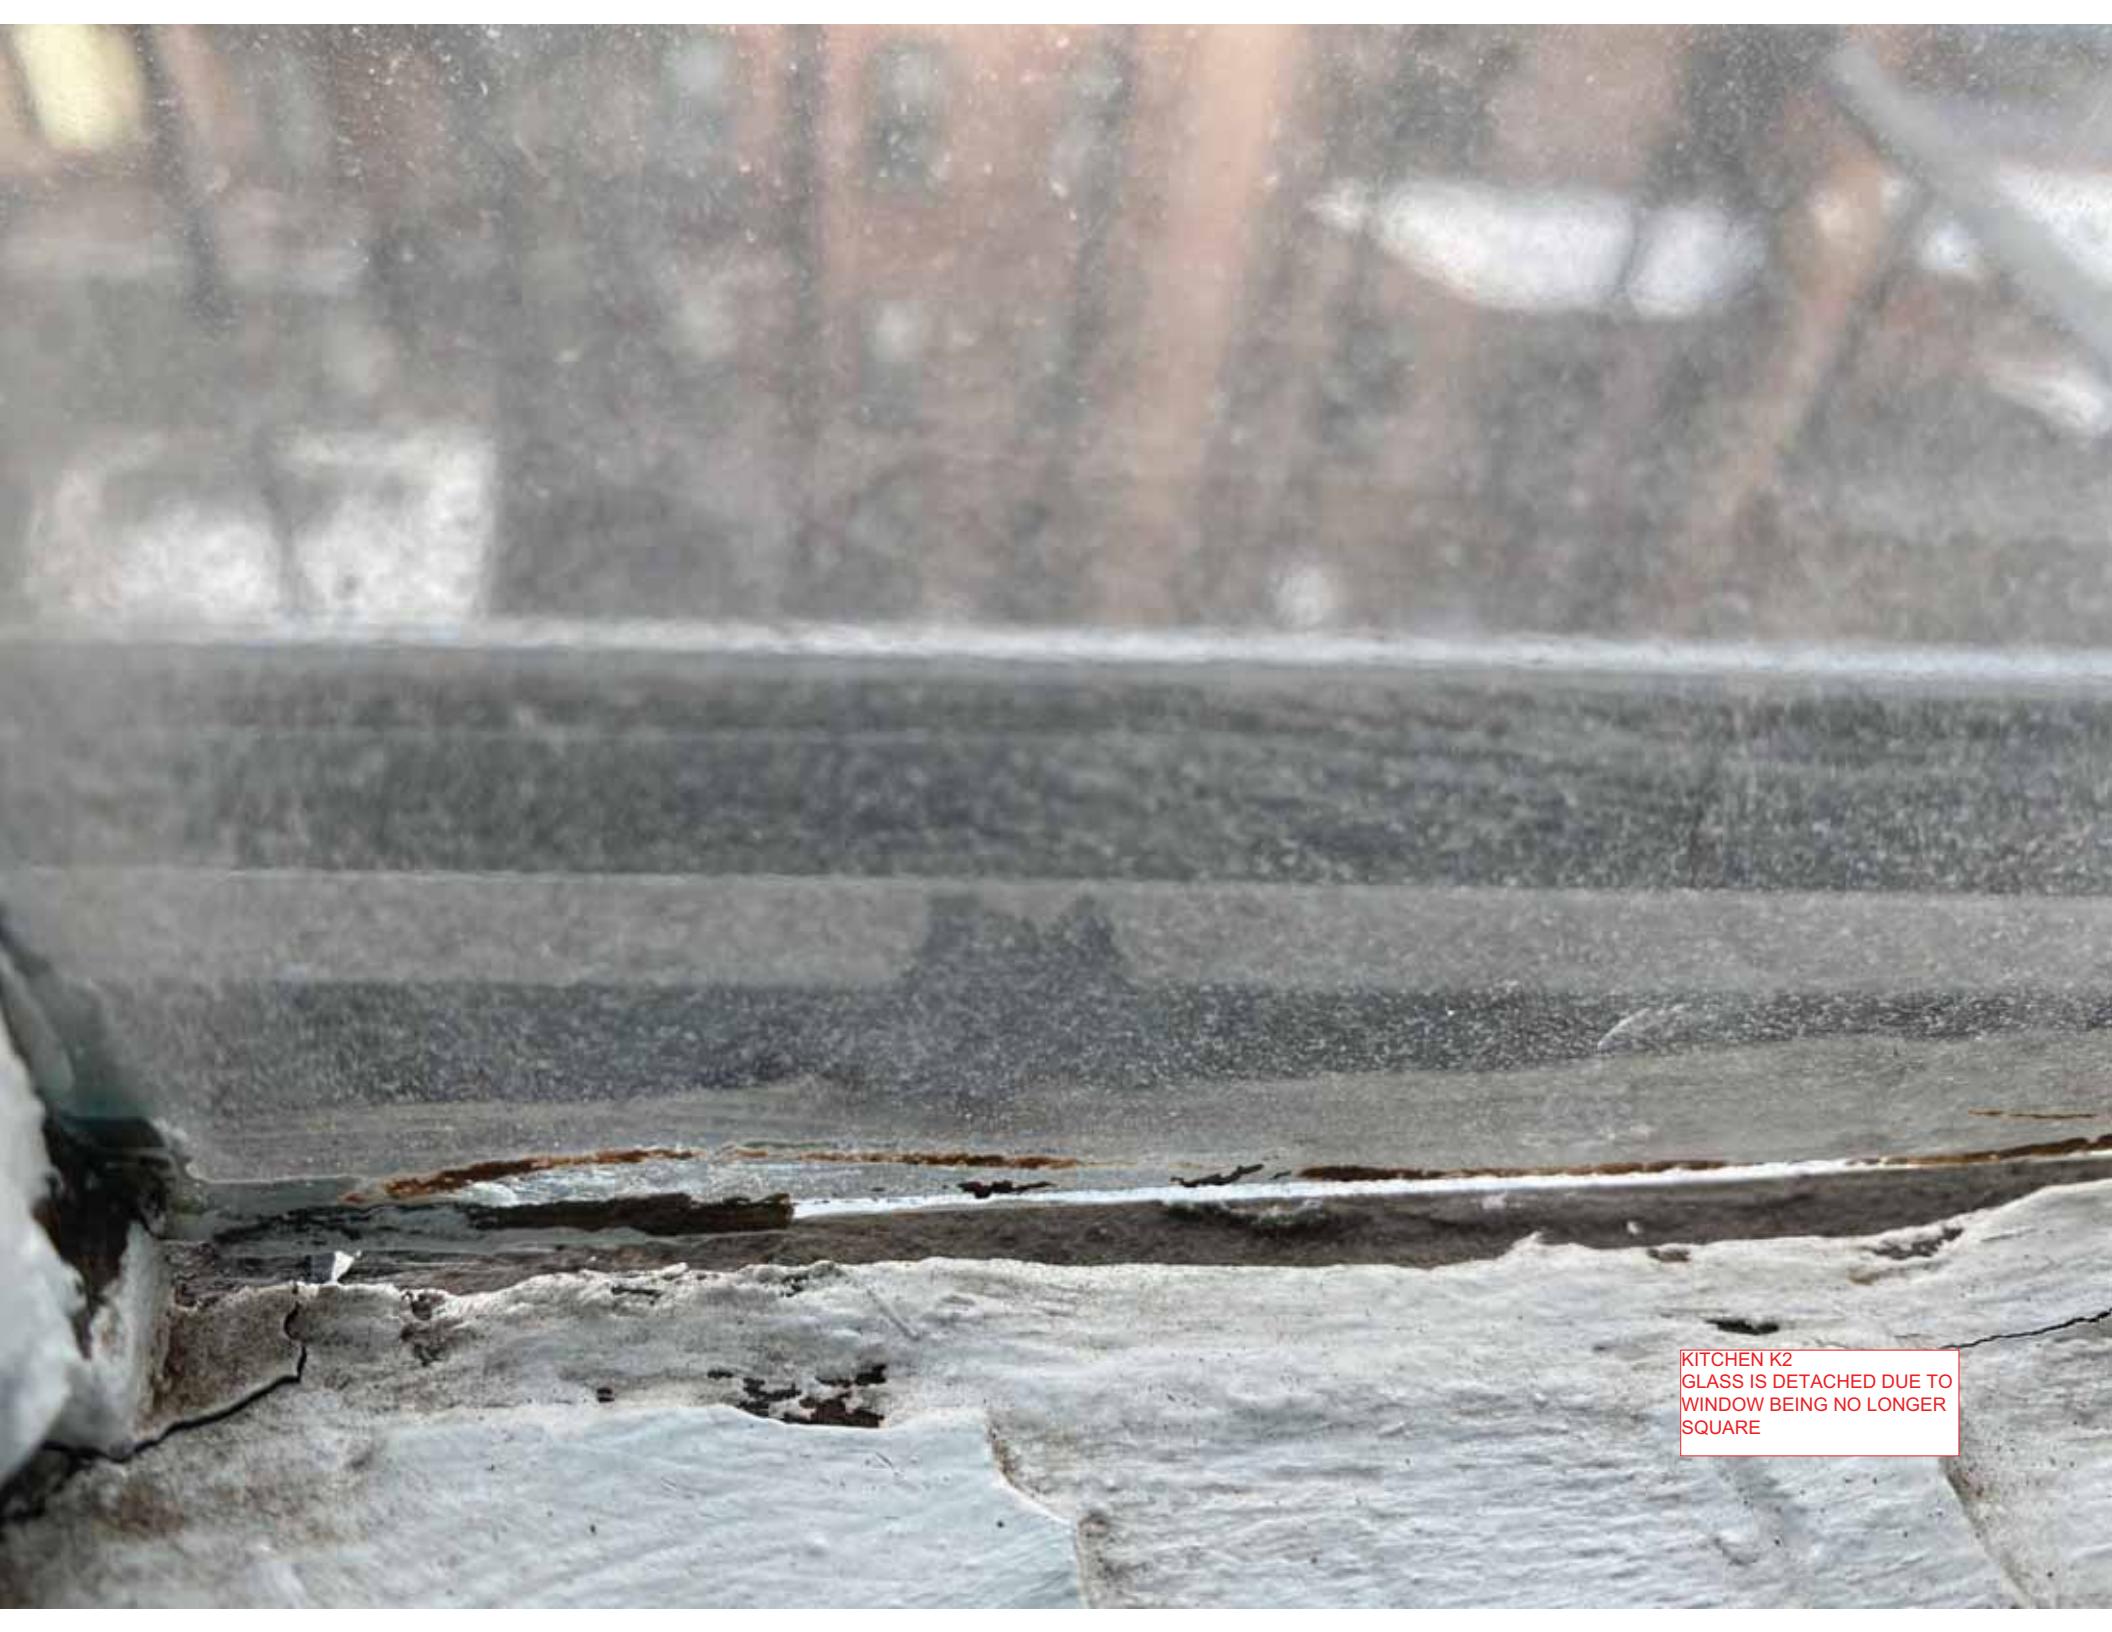
KITCHEN K2  
GLASS IS DETACHED DUE TO  
WINDOW BEING NO LONGER  
SQUARE

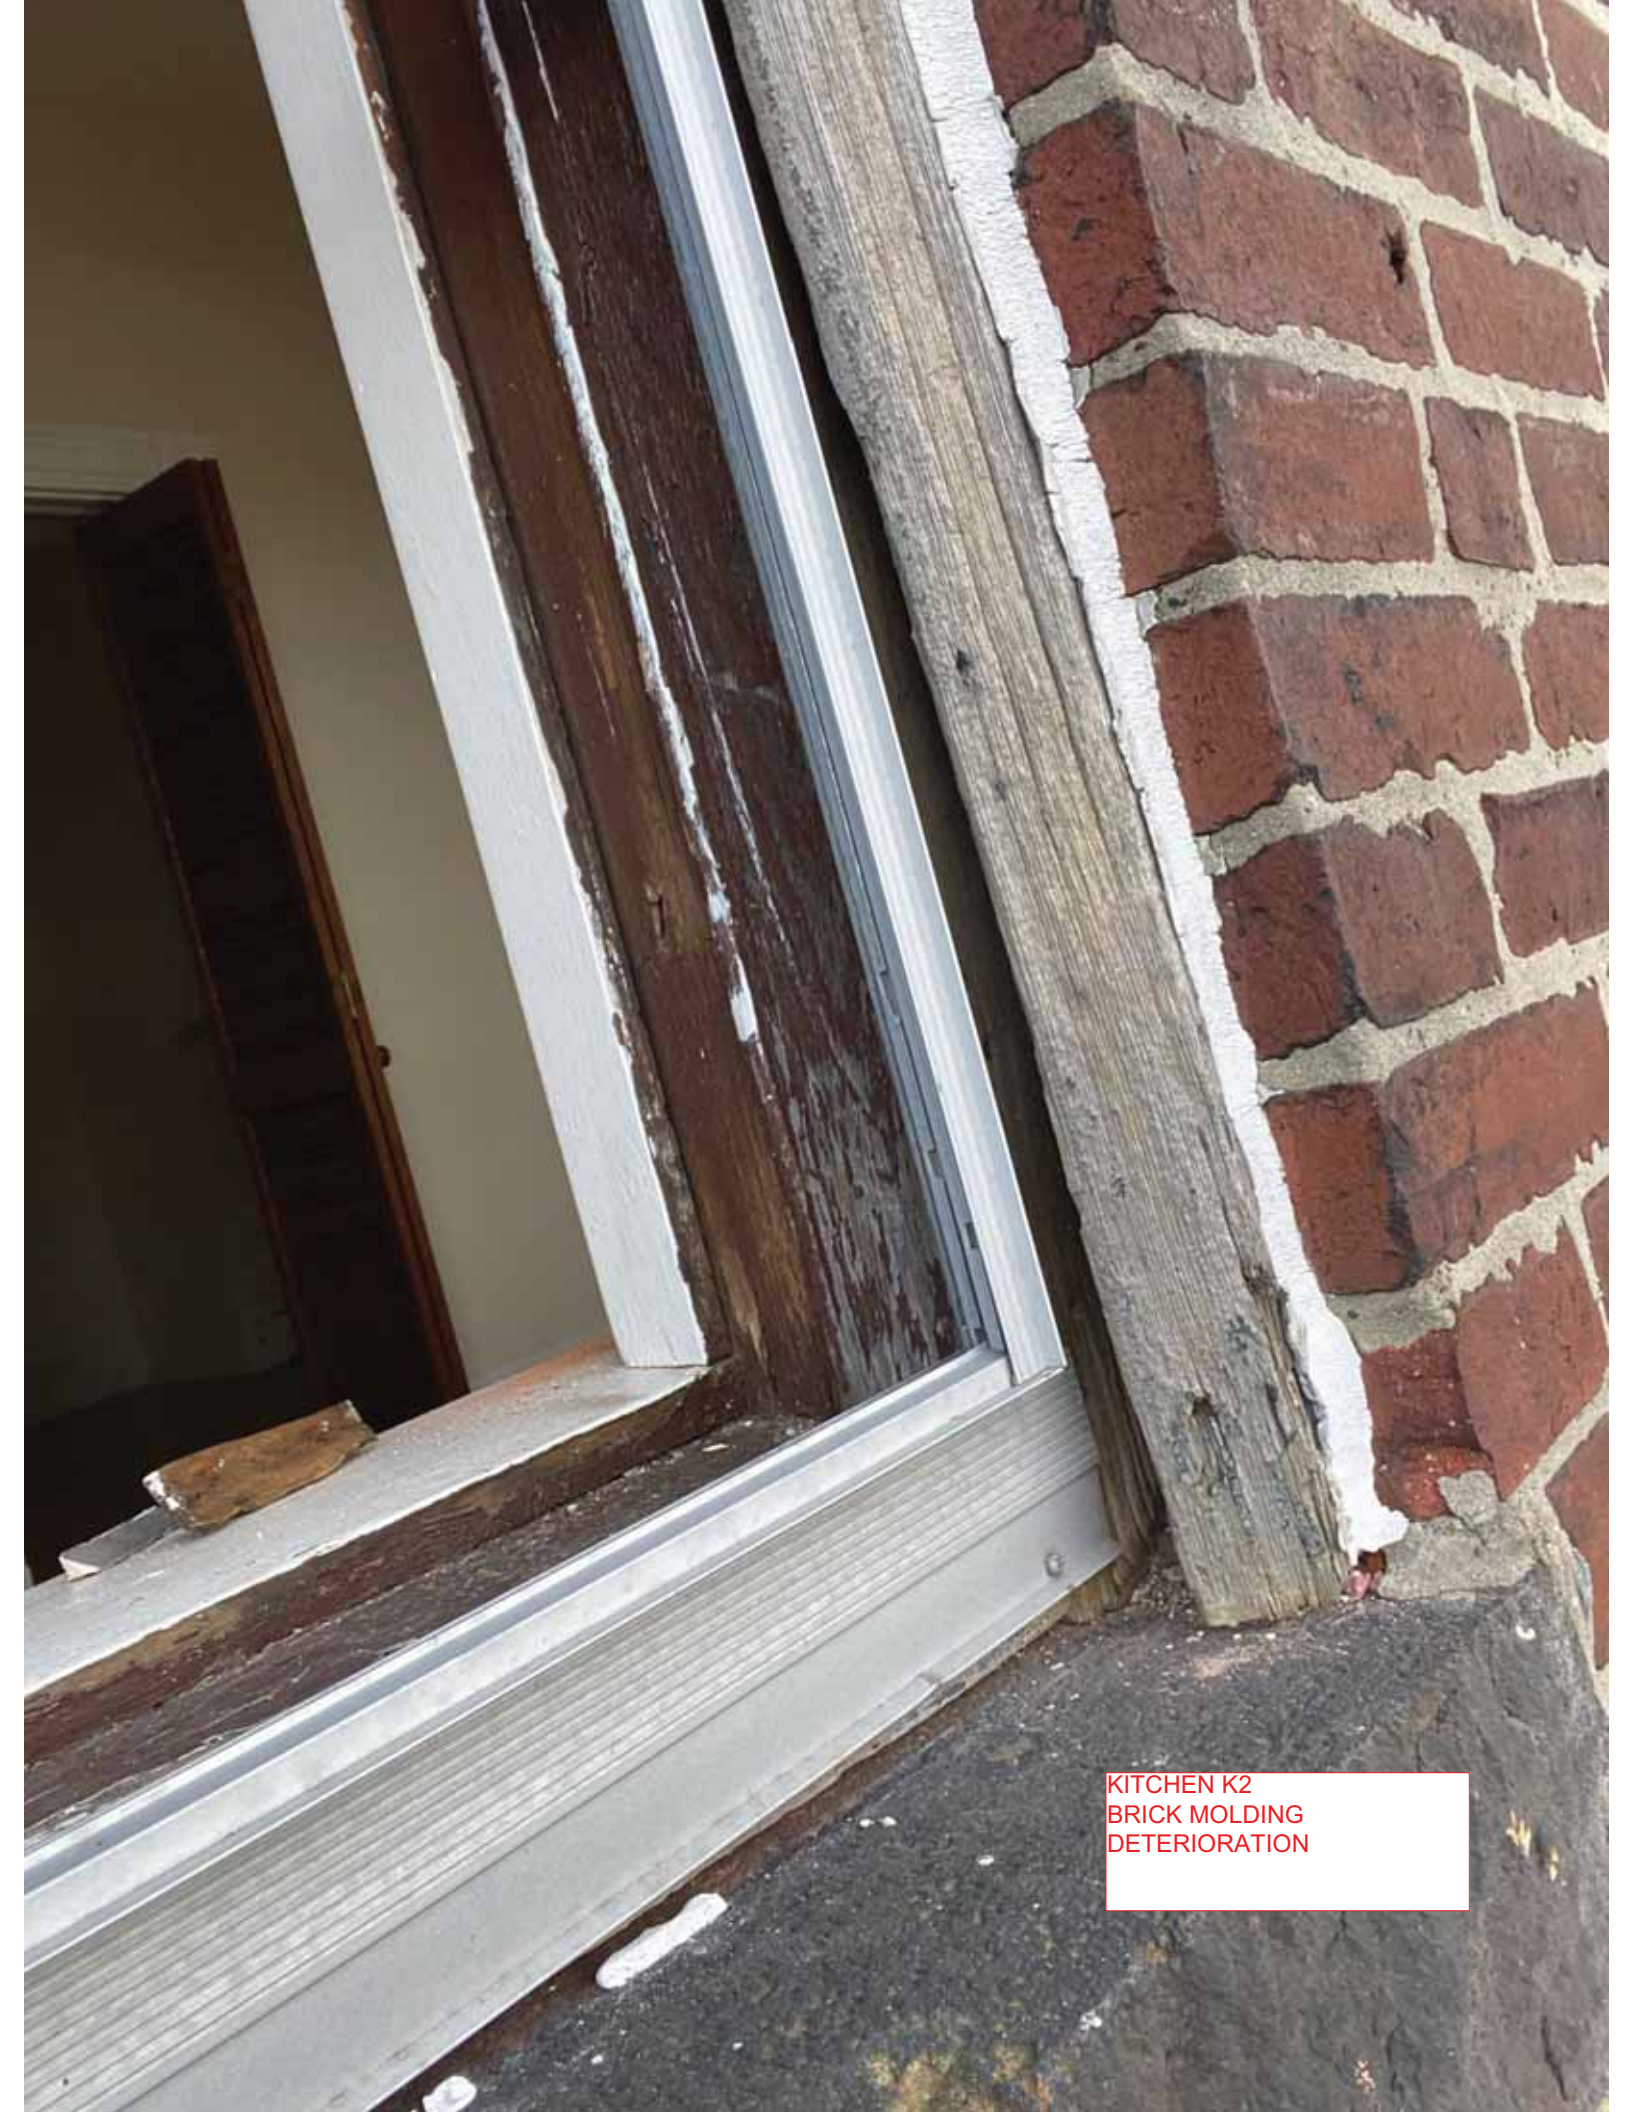
KITCHEN K2  
BRICK MOLDING  
DETERIORATION

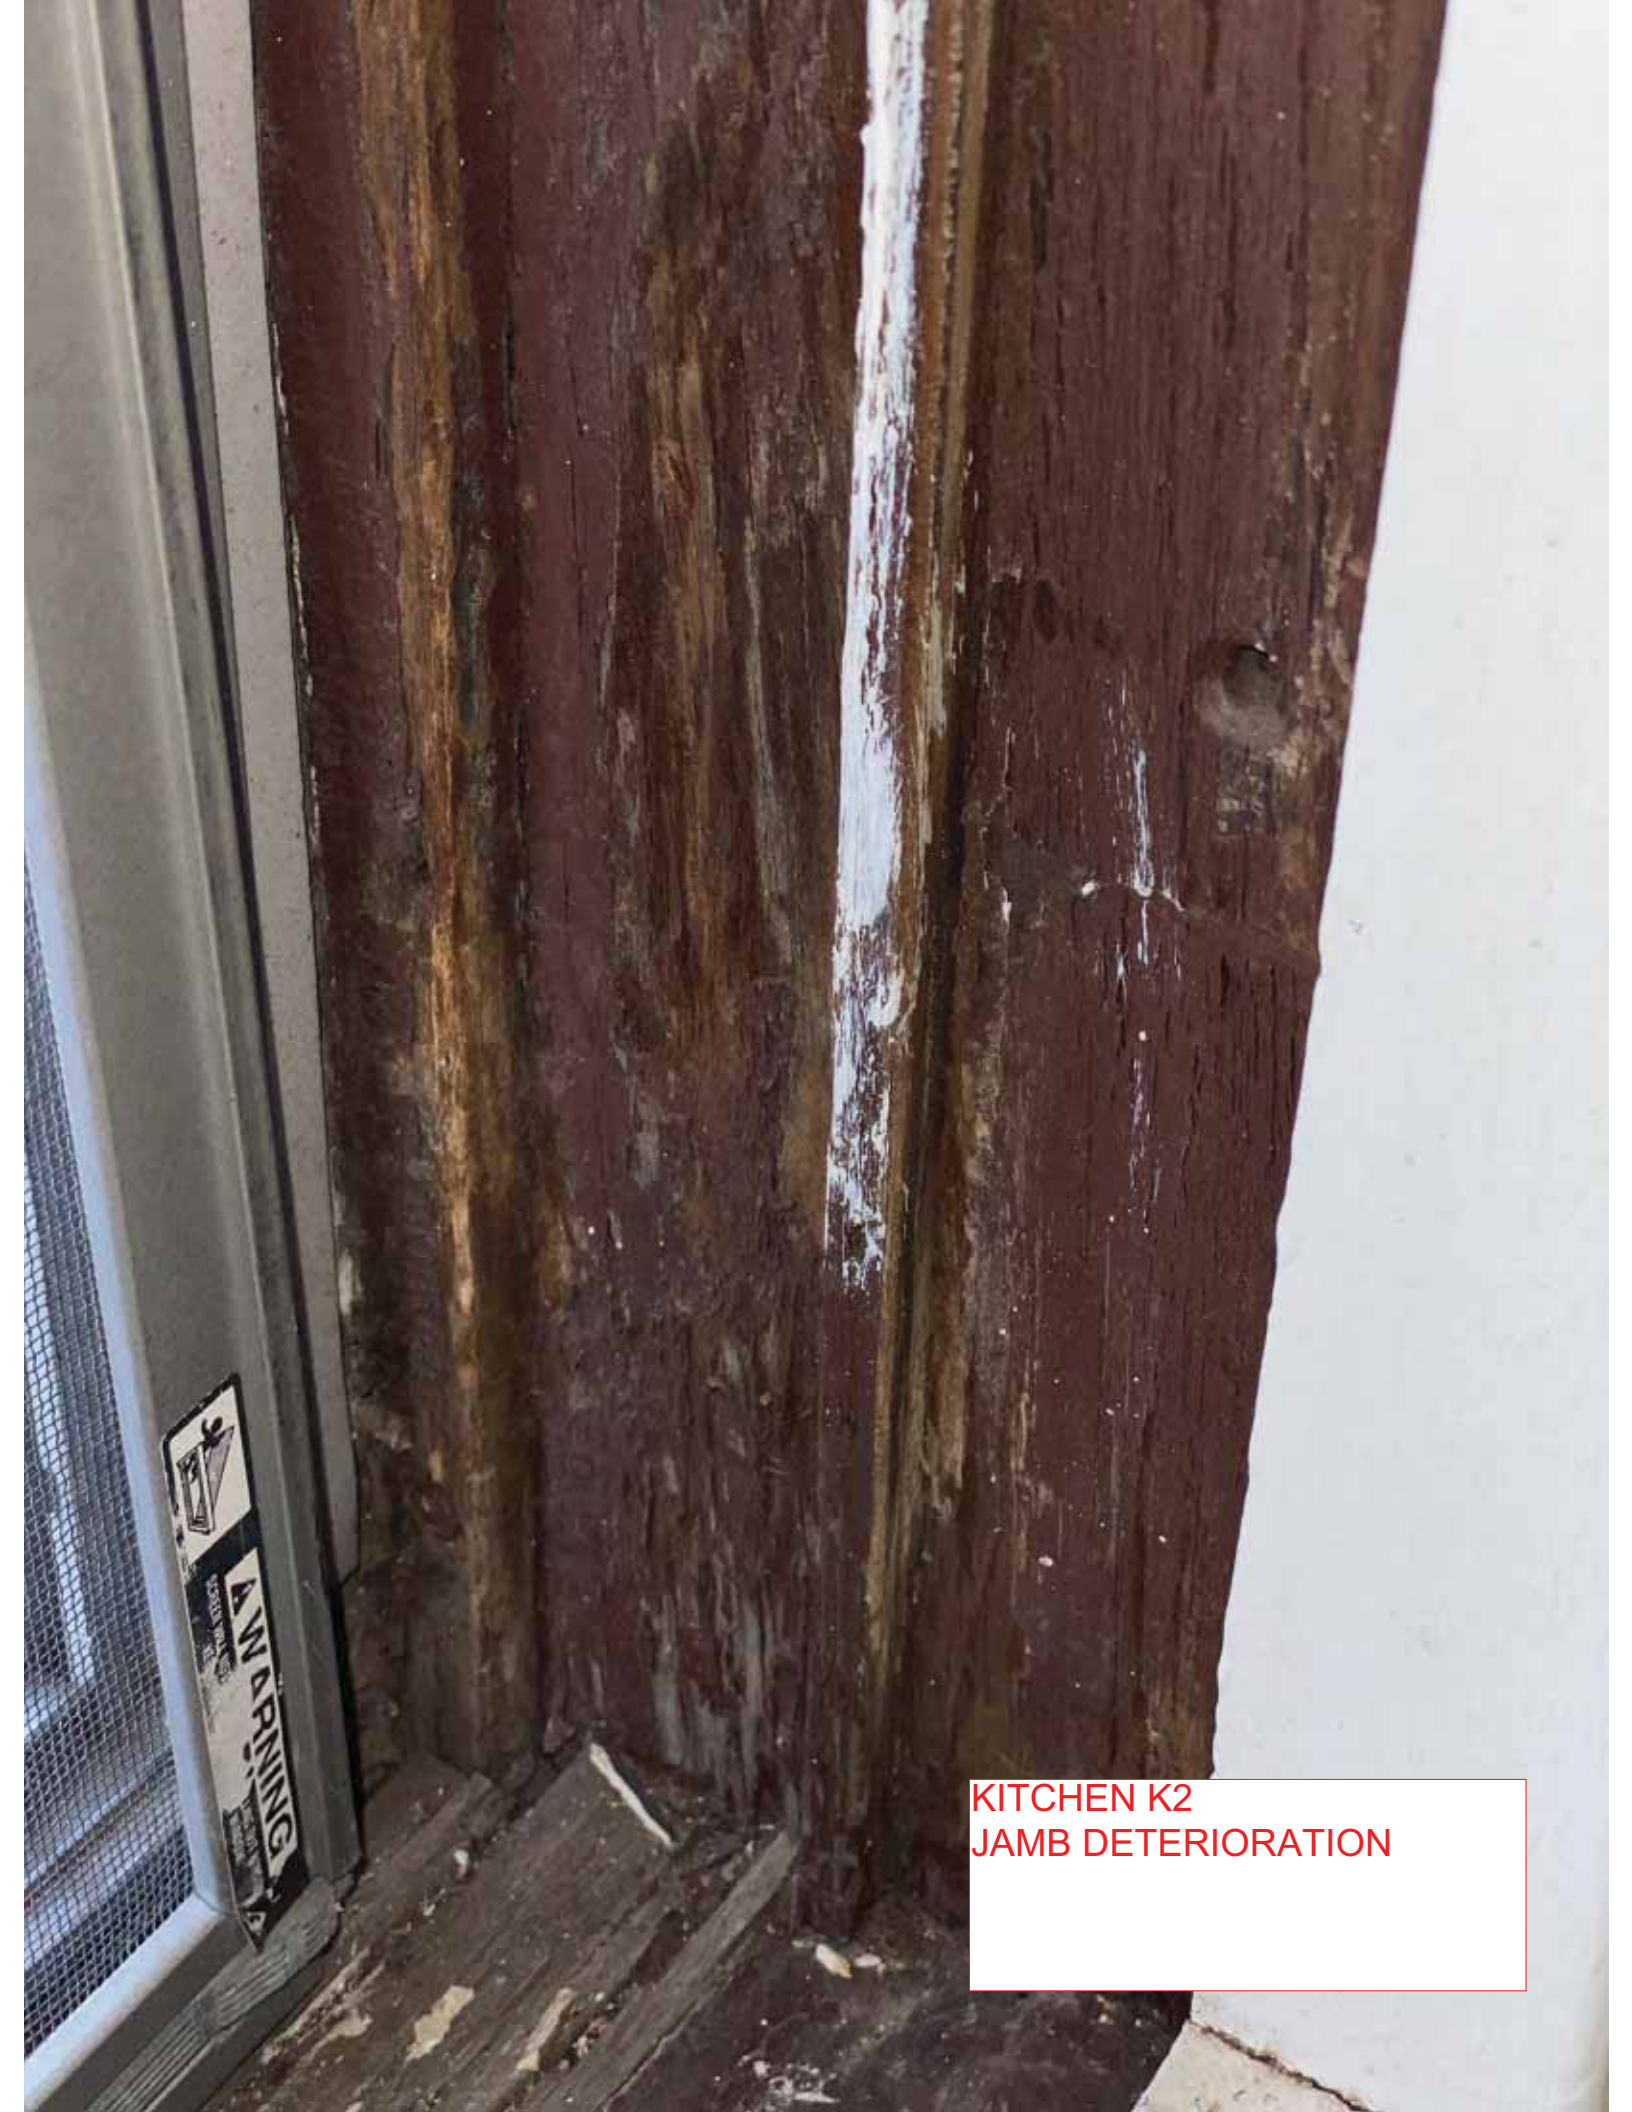
KITCHEN K2  
JAMB DETERIORATION

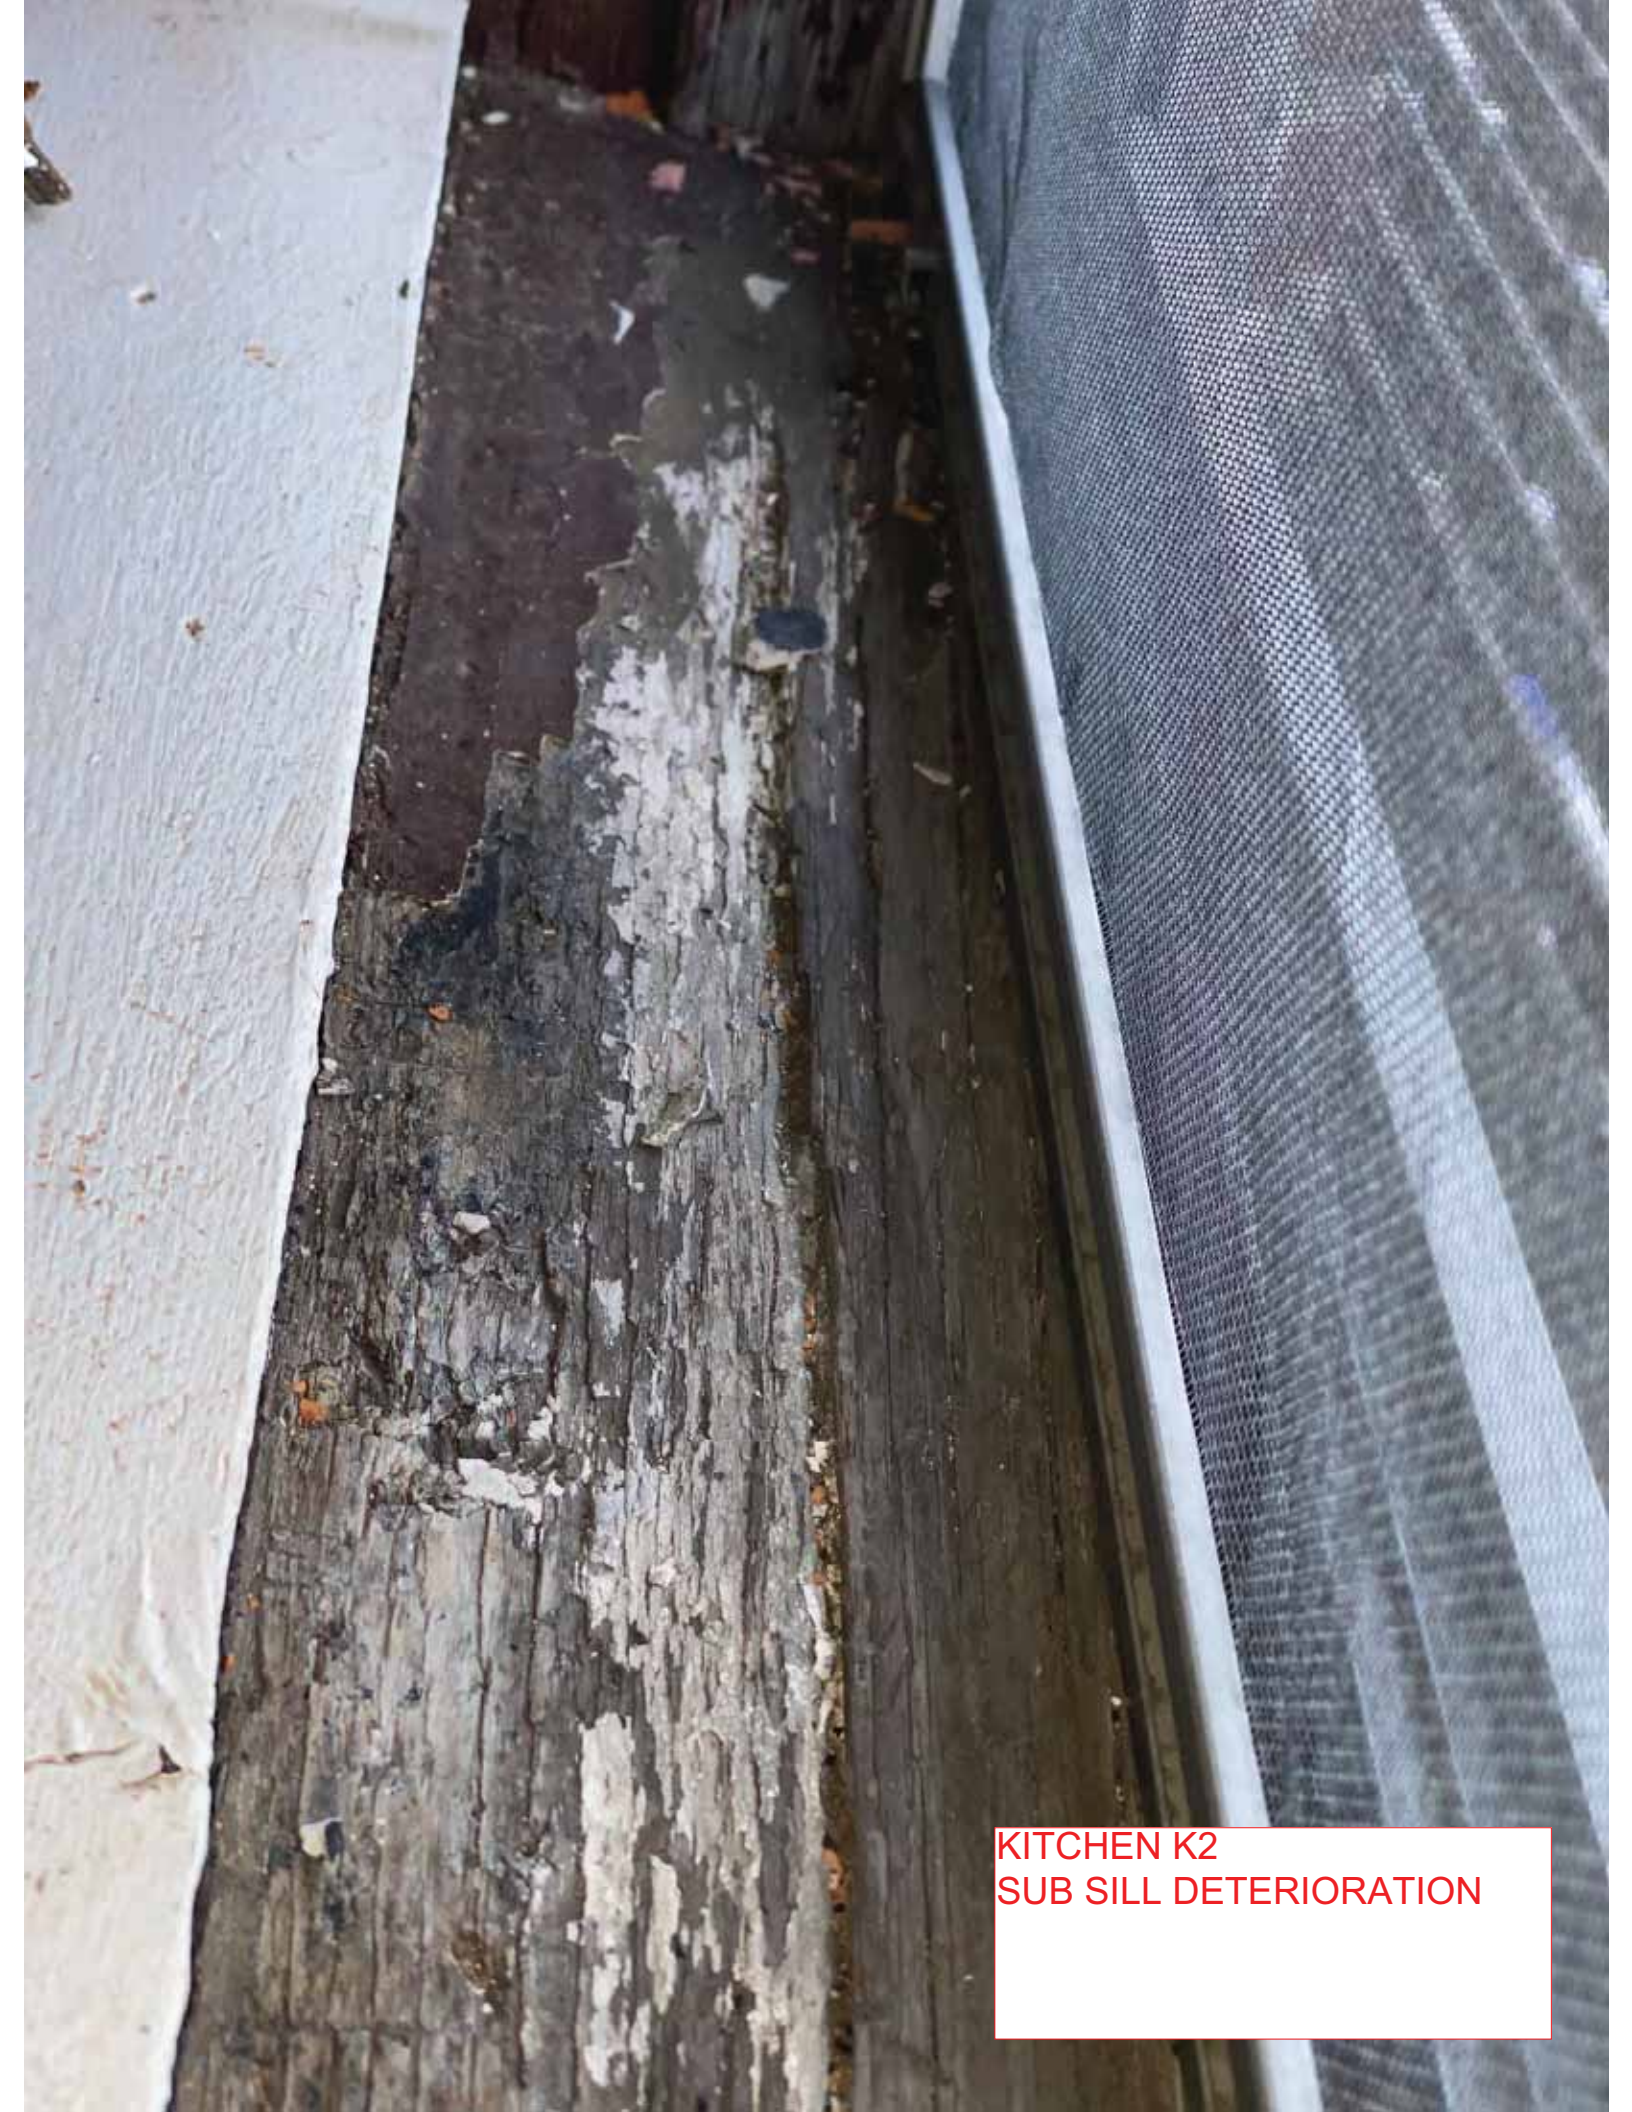
KITCHEN K2  
SUB SILL DETERIORATION
