295 Commonwealth Ave #5c  
Floor Plan  
1/8" = 1'-0"

## 295 Commonwealth Ave #5c Window Elevations

295 Commonwealth Ave #5c  
**Window Details**

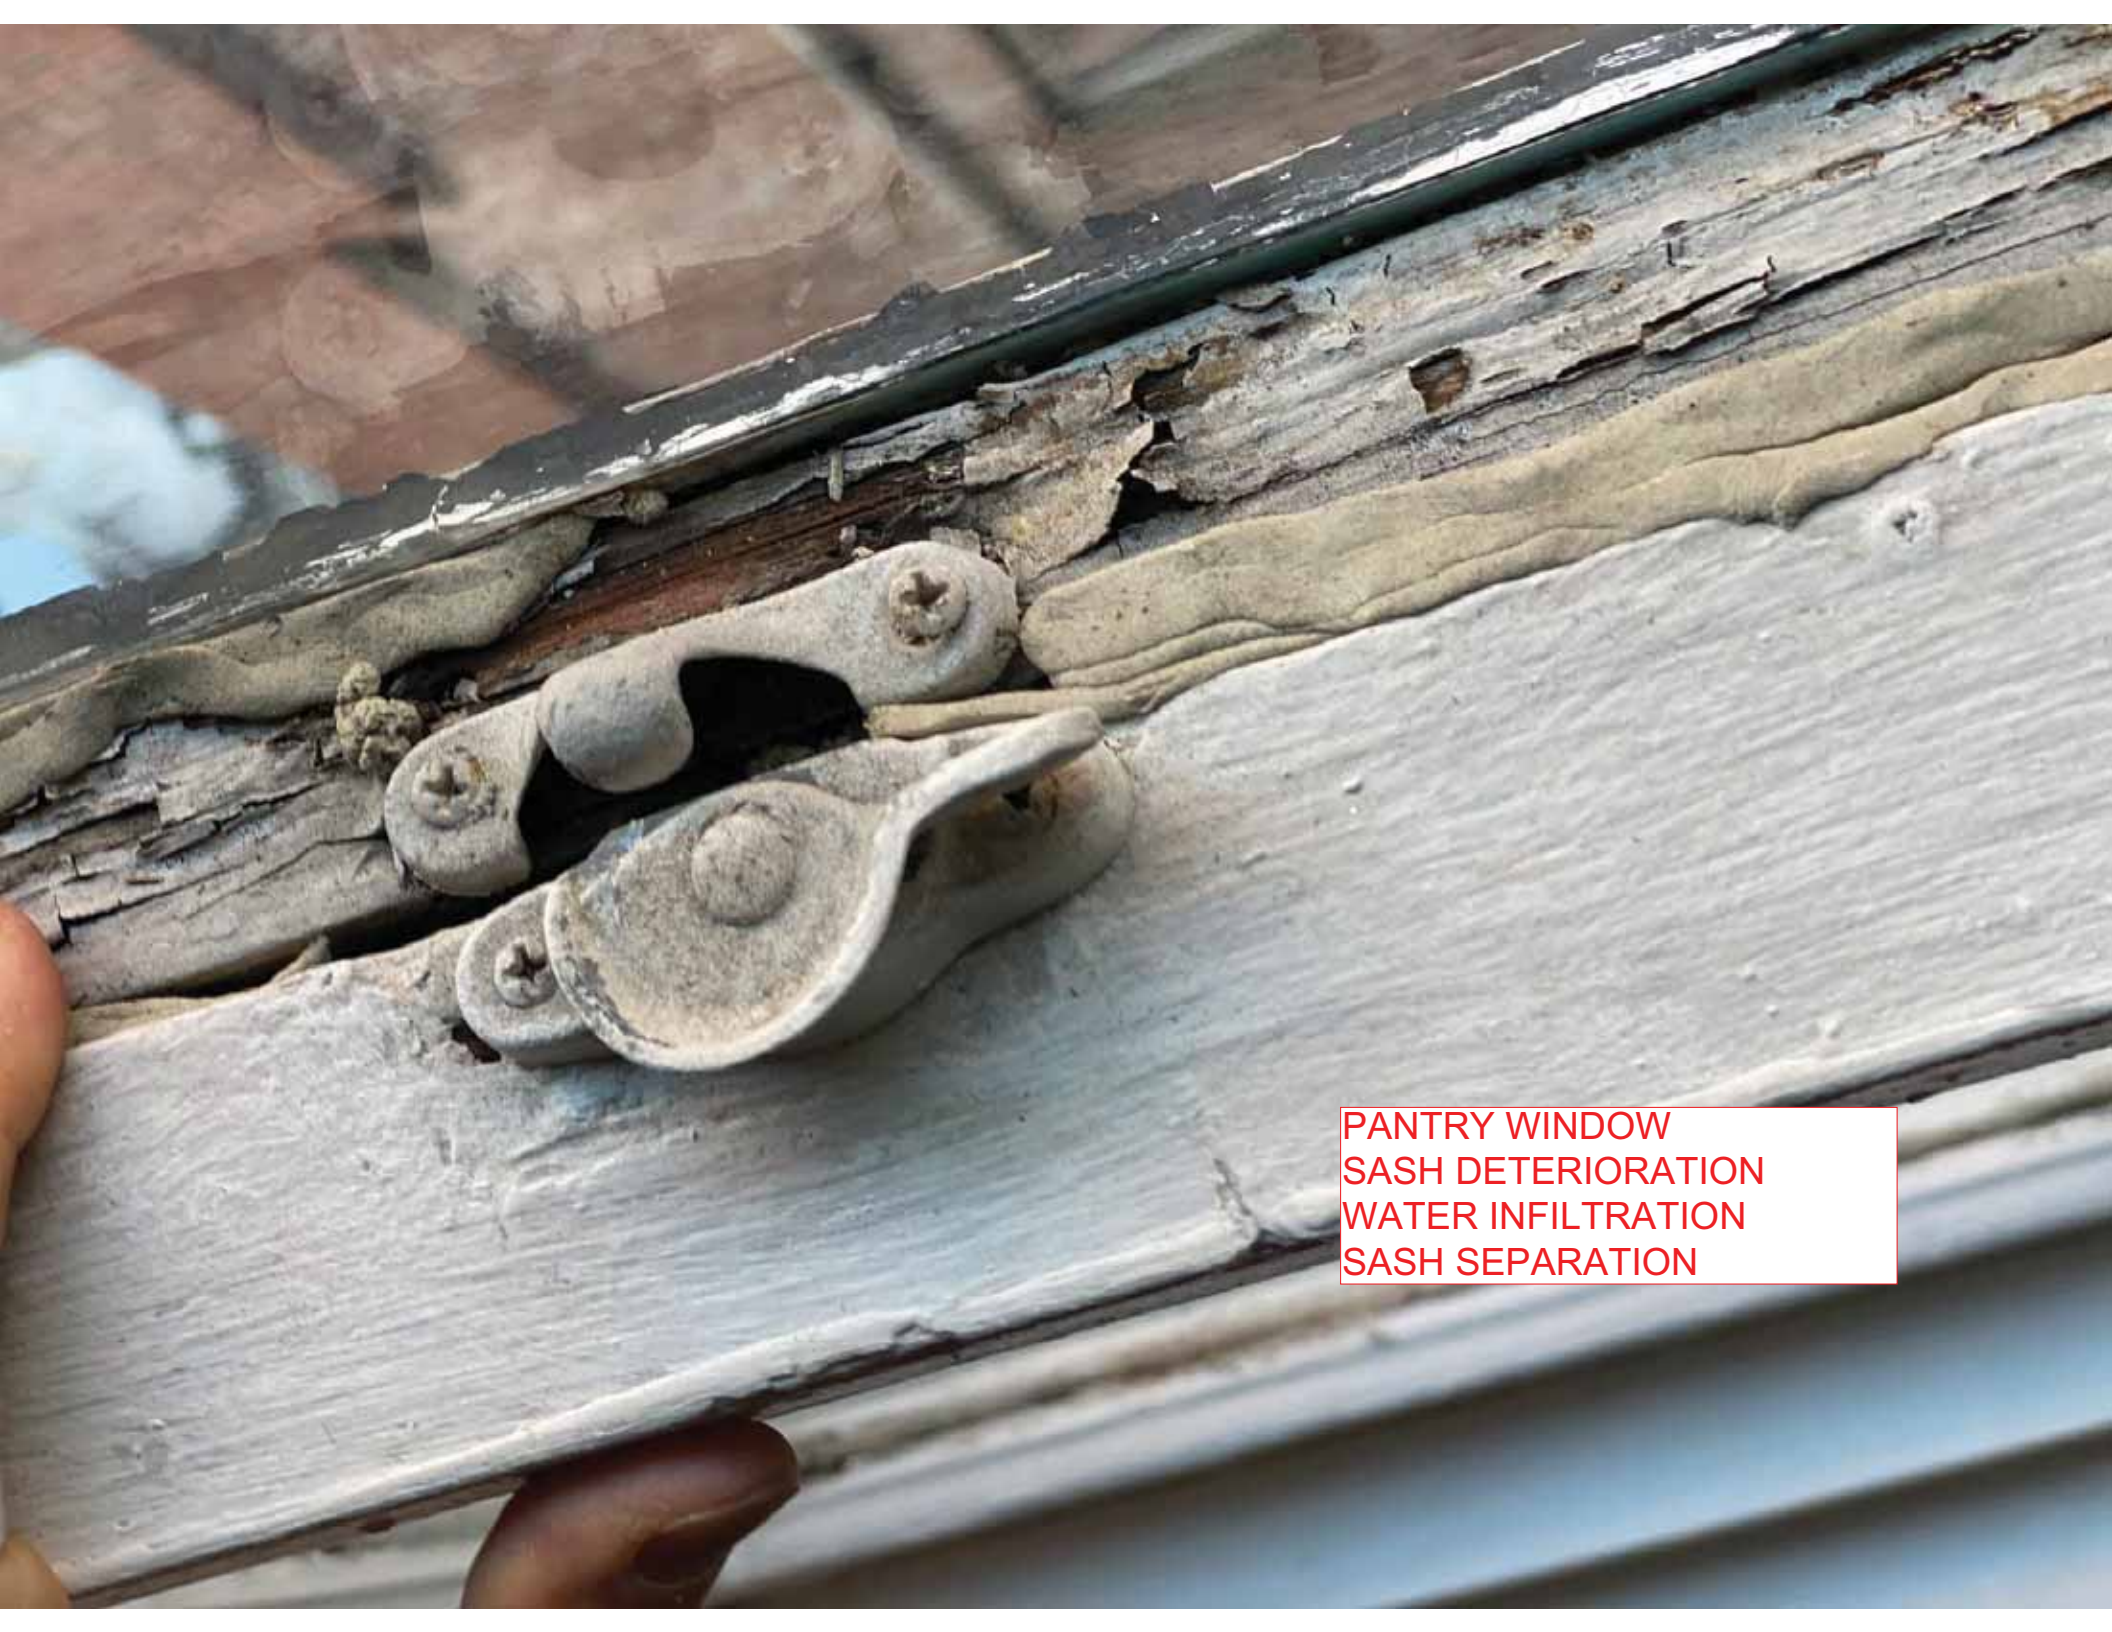
PANTRY WINDOW  
SASH DETERIORATION  
WATER INFILTRATION  
SASH SEPARATION

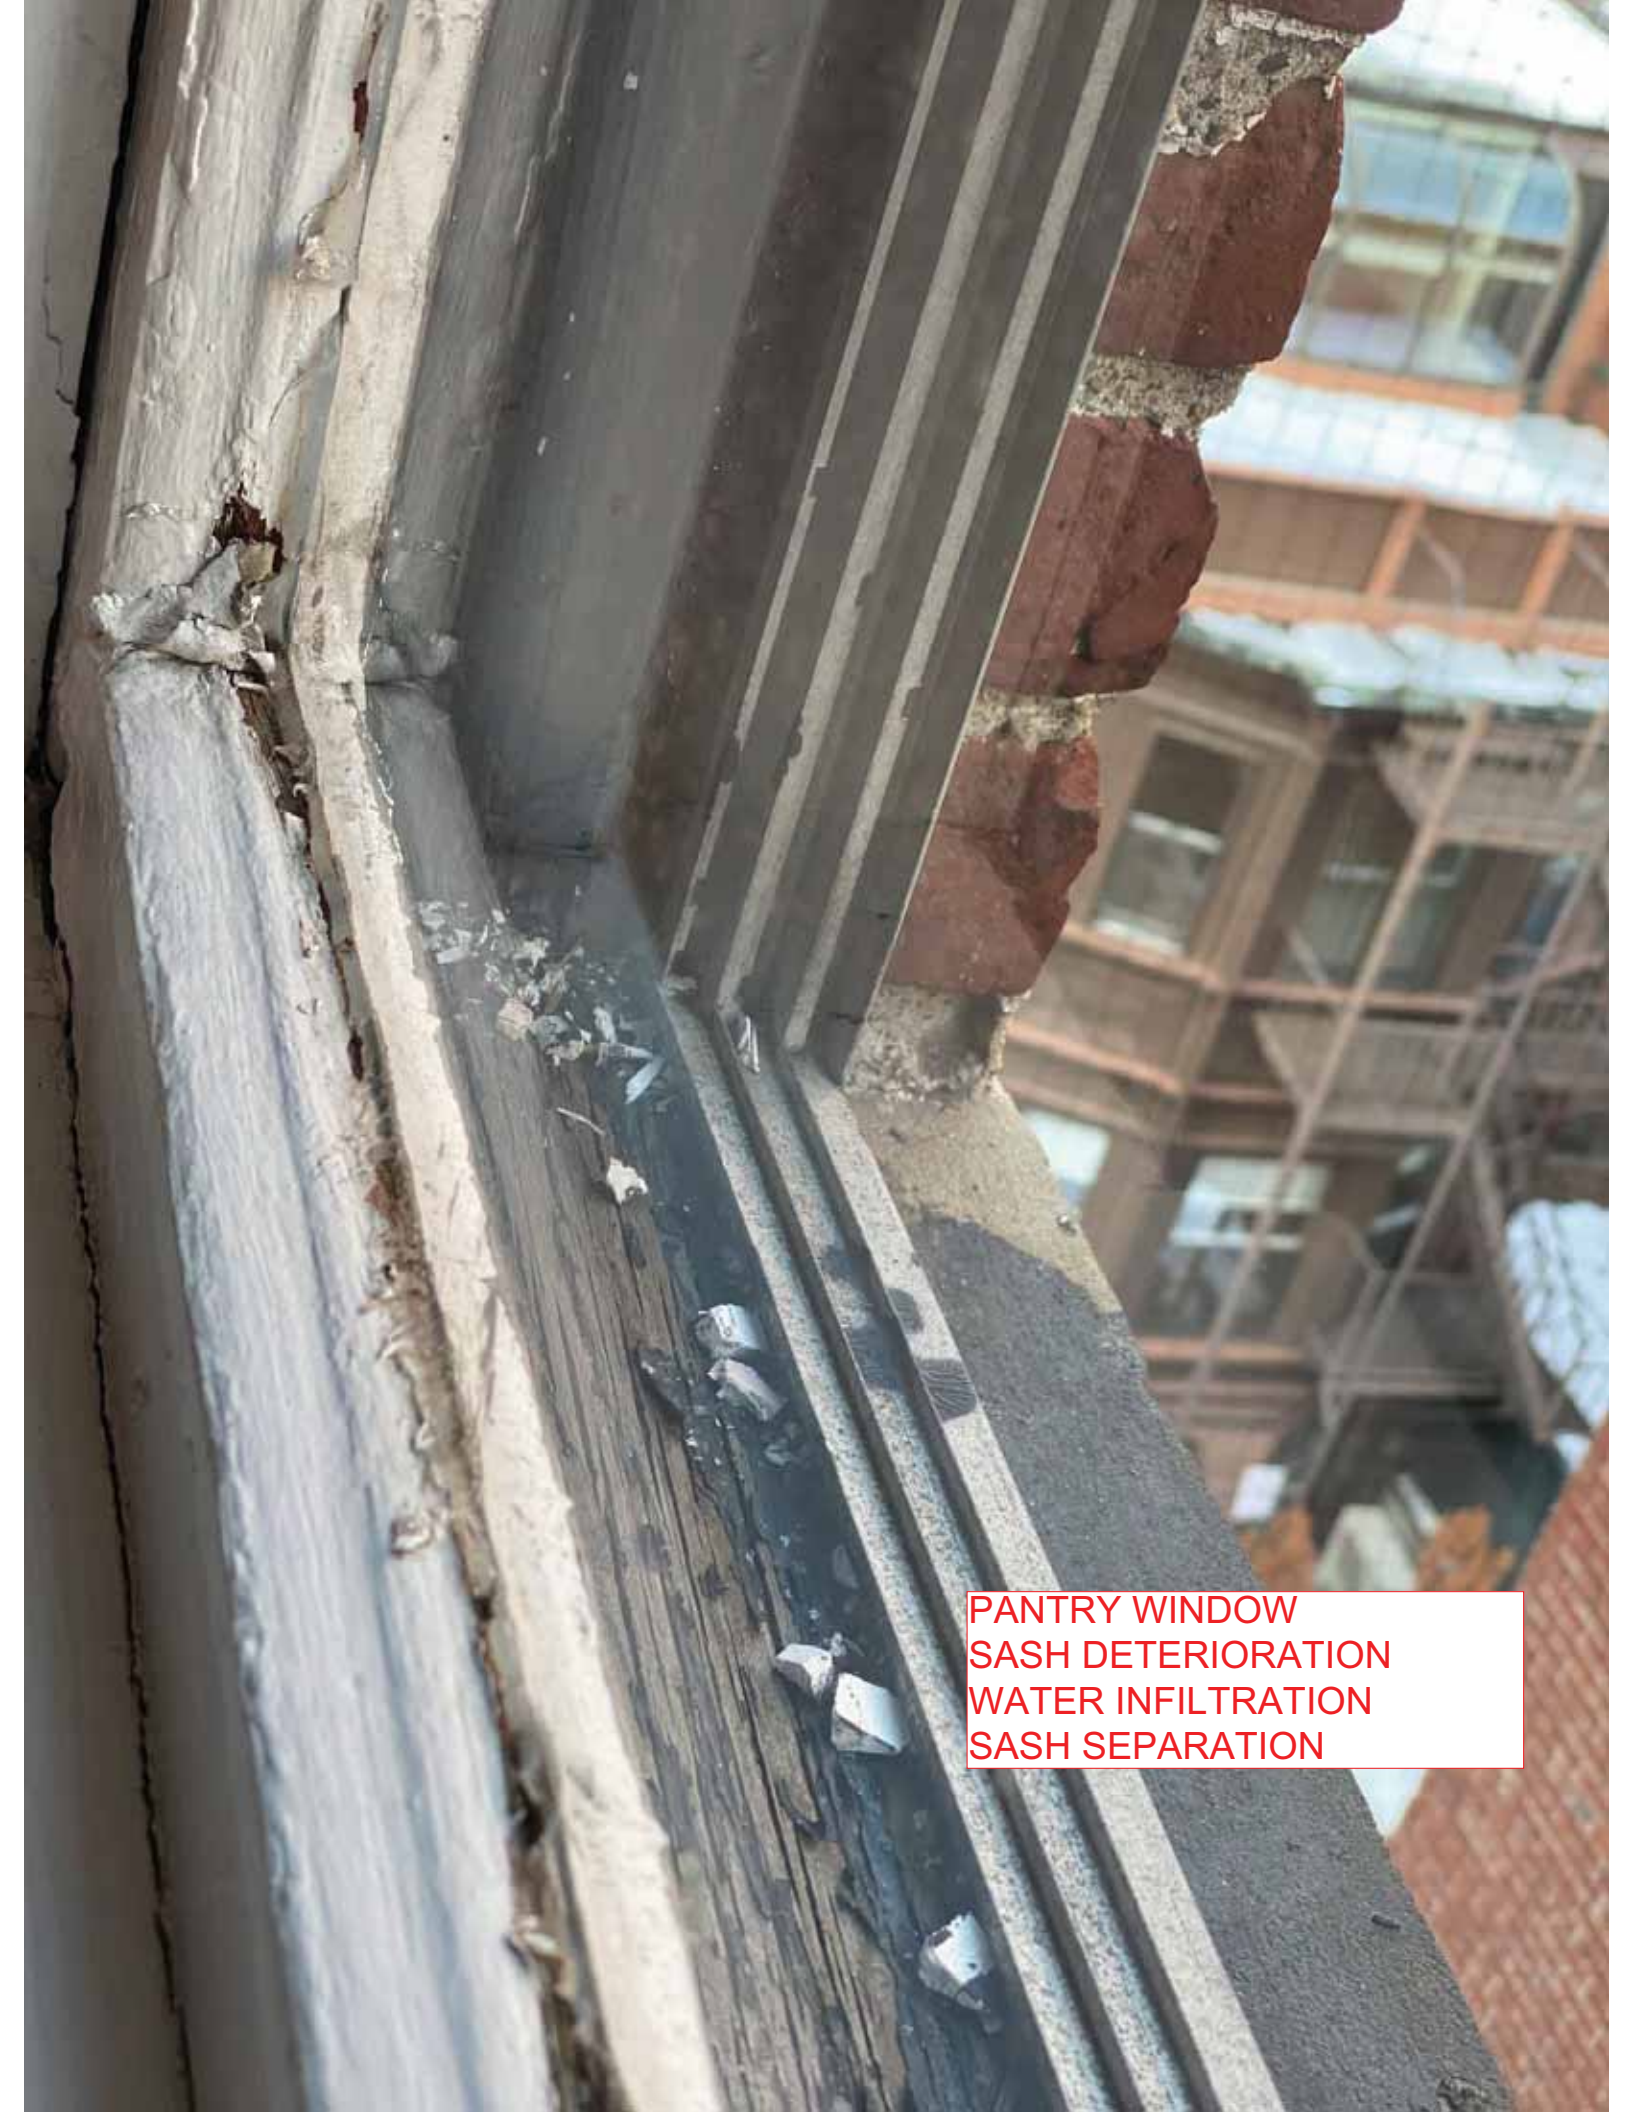
PANTRY WINDOW  
SASH DETERIORATION  
WATER INFILTRATION  
SASH SEPARATION

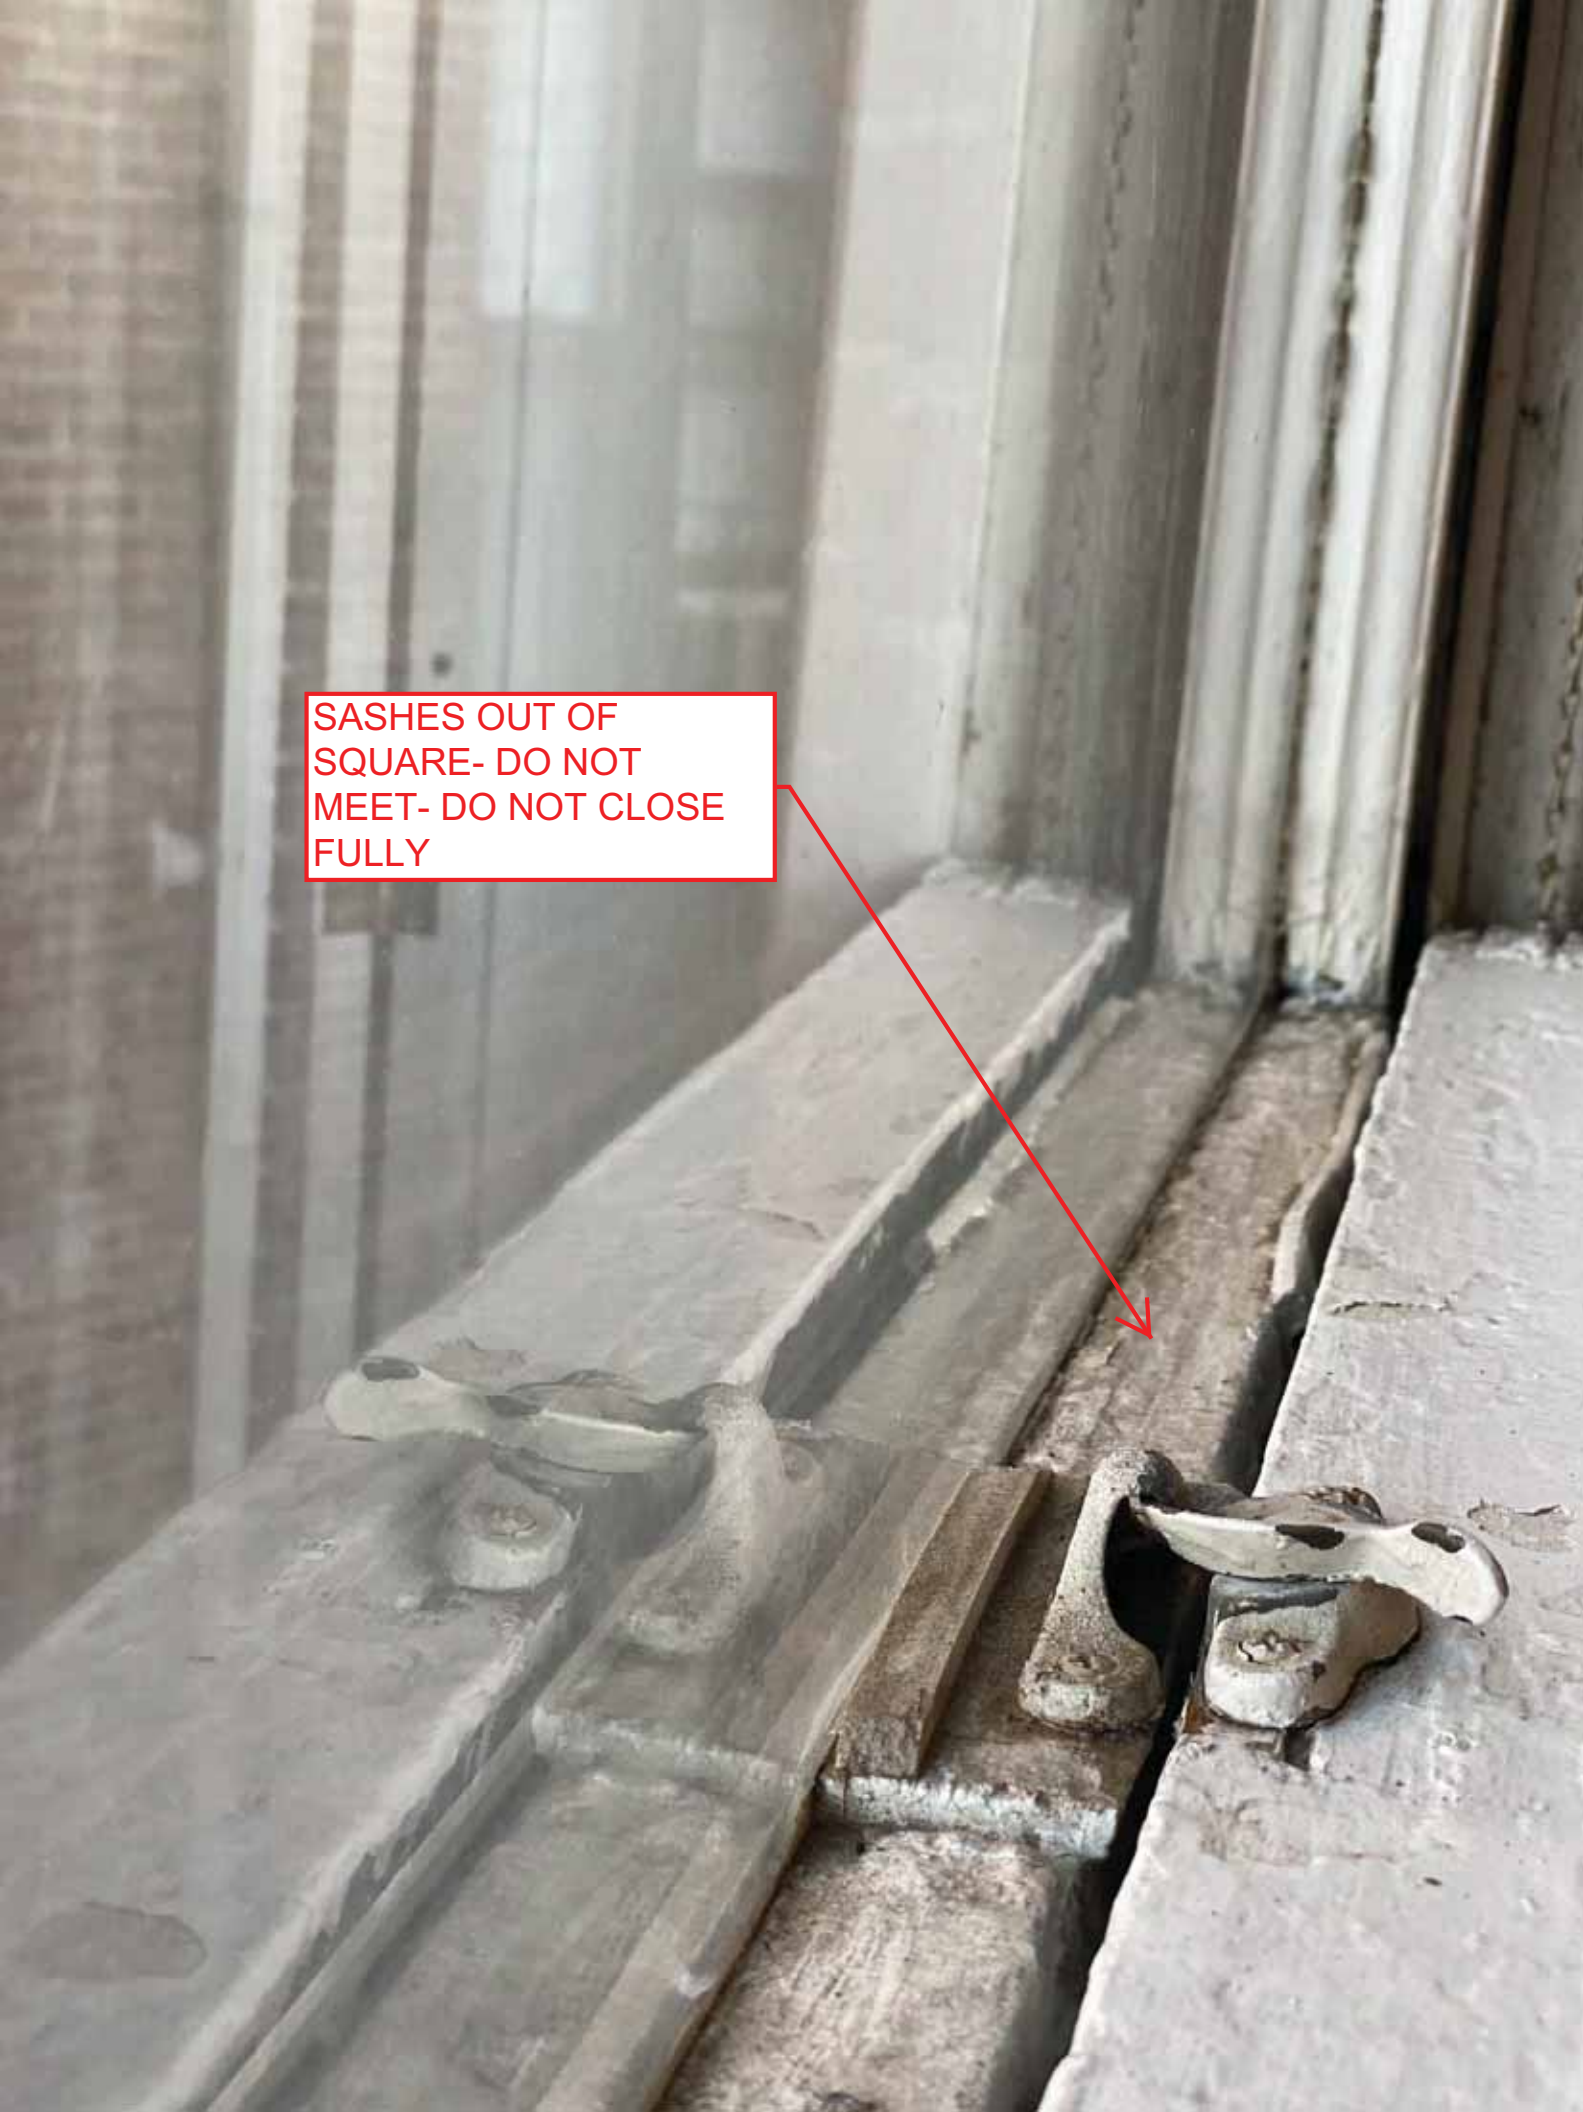
FRAME HAS SAGGED,  
BINDING

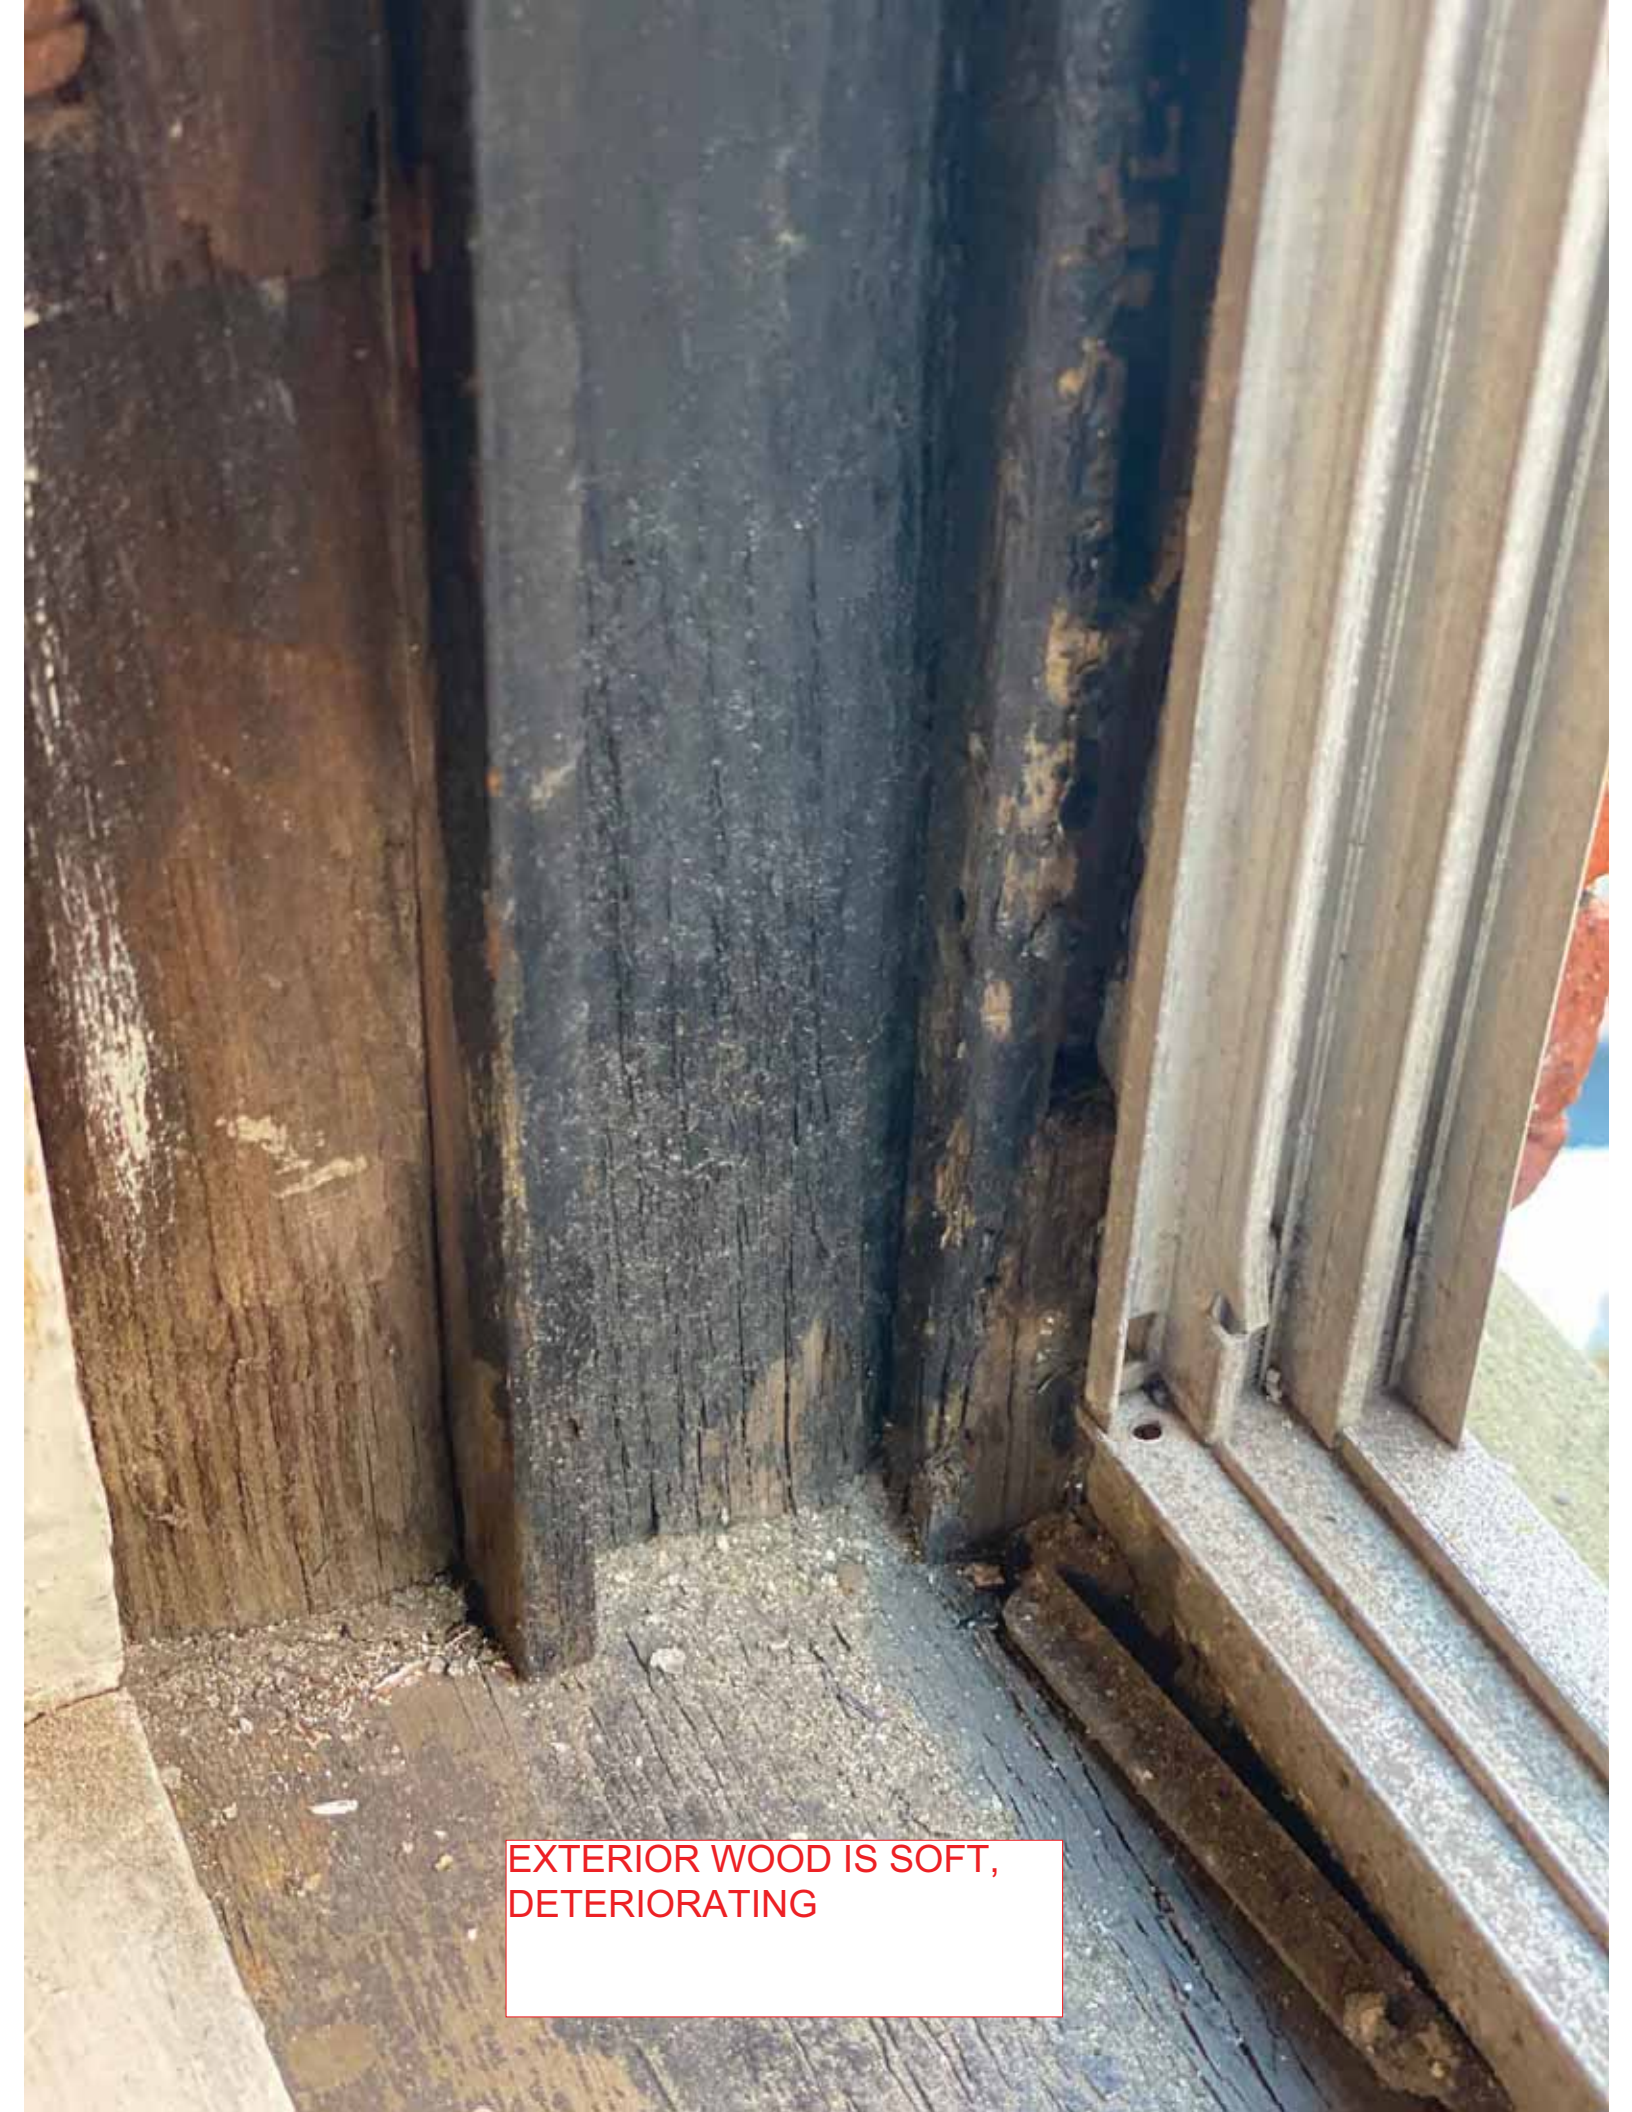
EXTERIOR WOOD IS SOFT,  
DETERIORATING

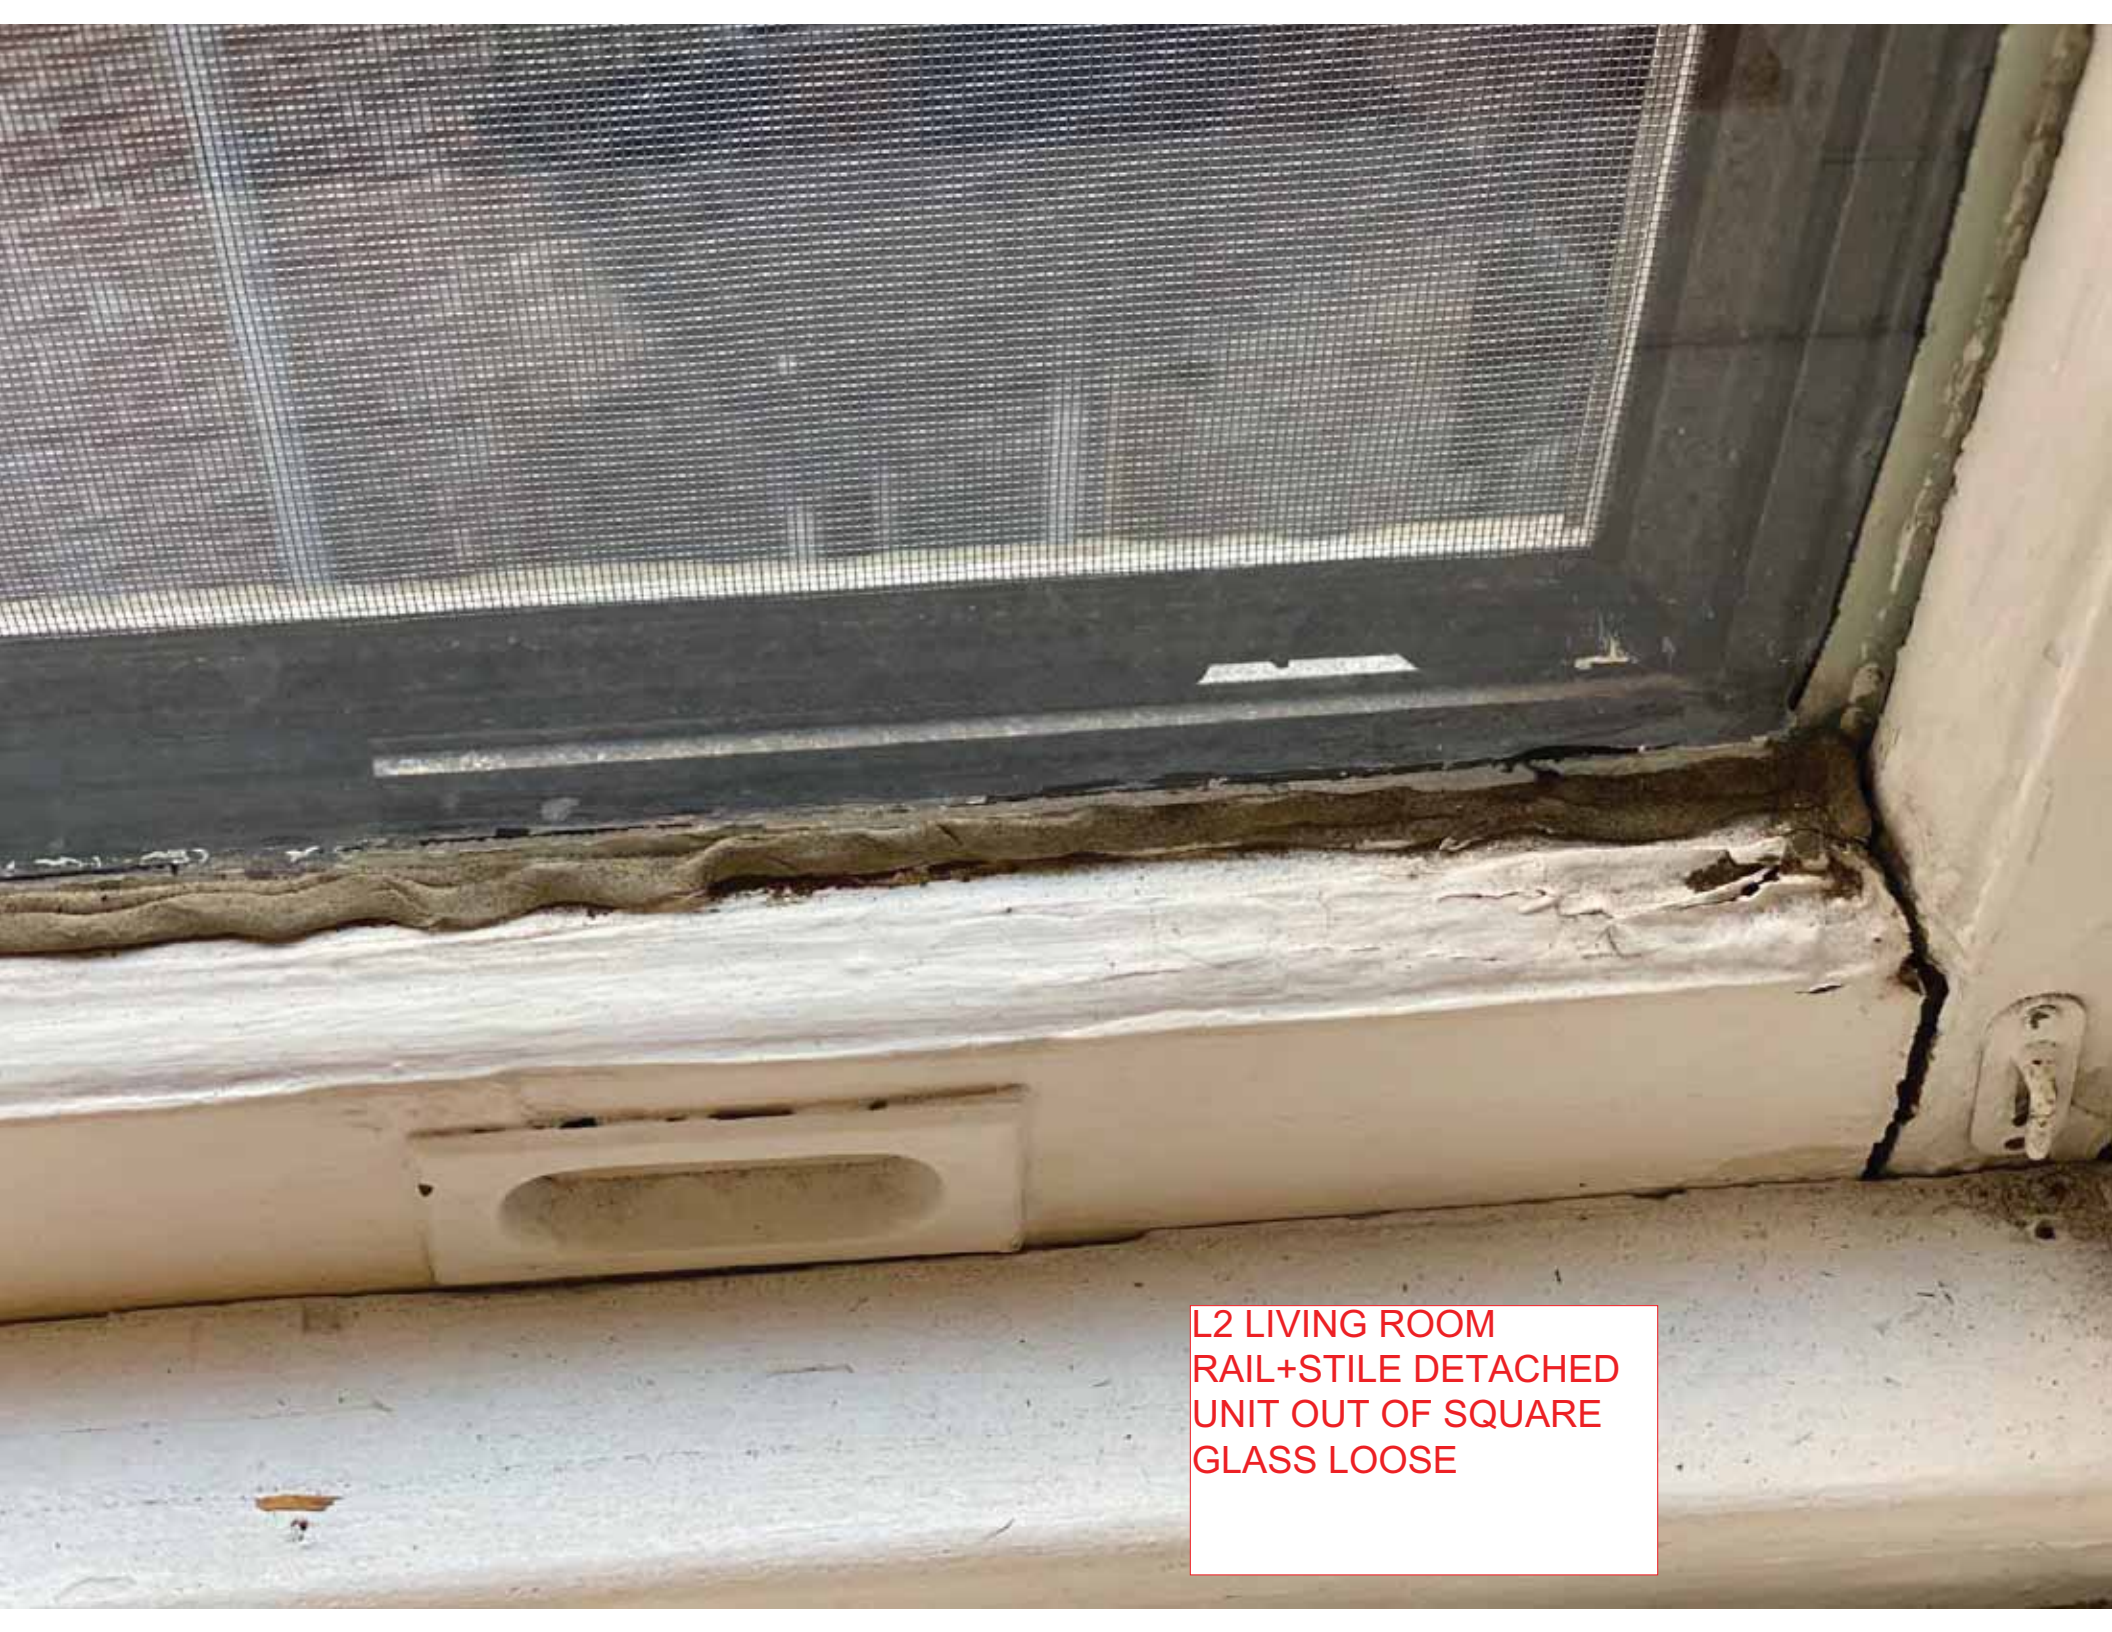
L2 LIVING ROOM  
RAIL+STILE DETACHED  
UNIT OUT OF SQUARE  
GLASS LOOSE

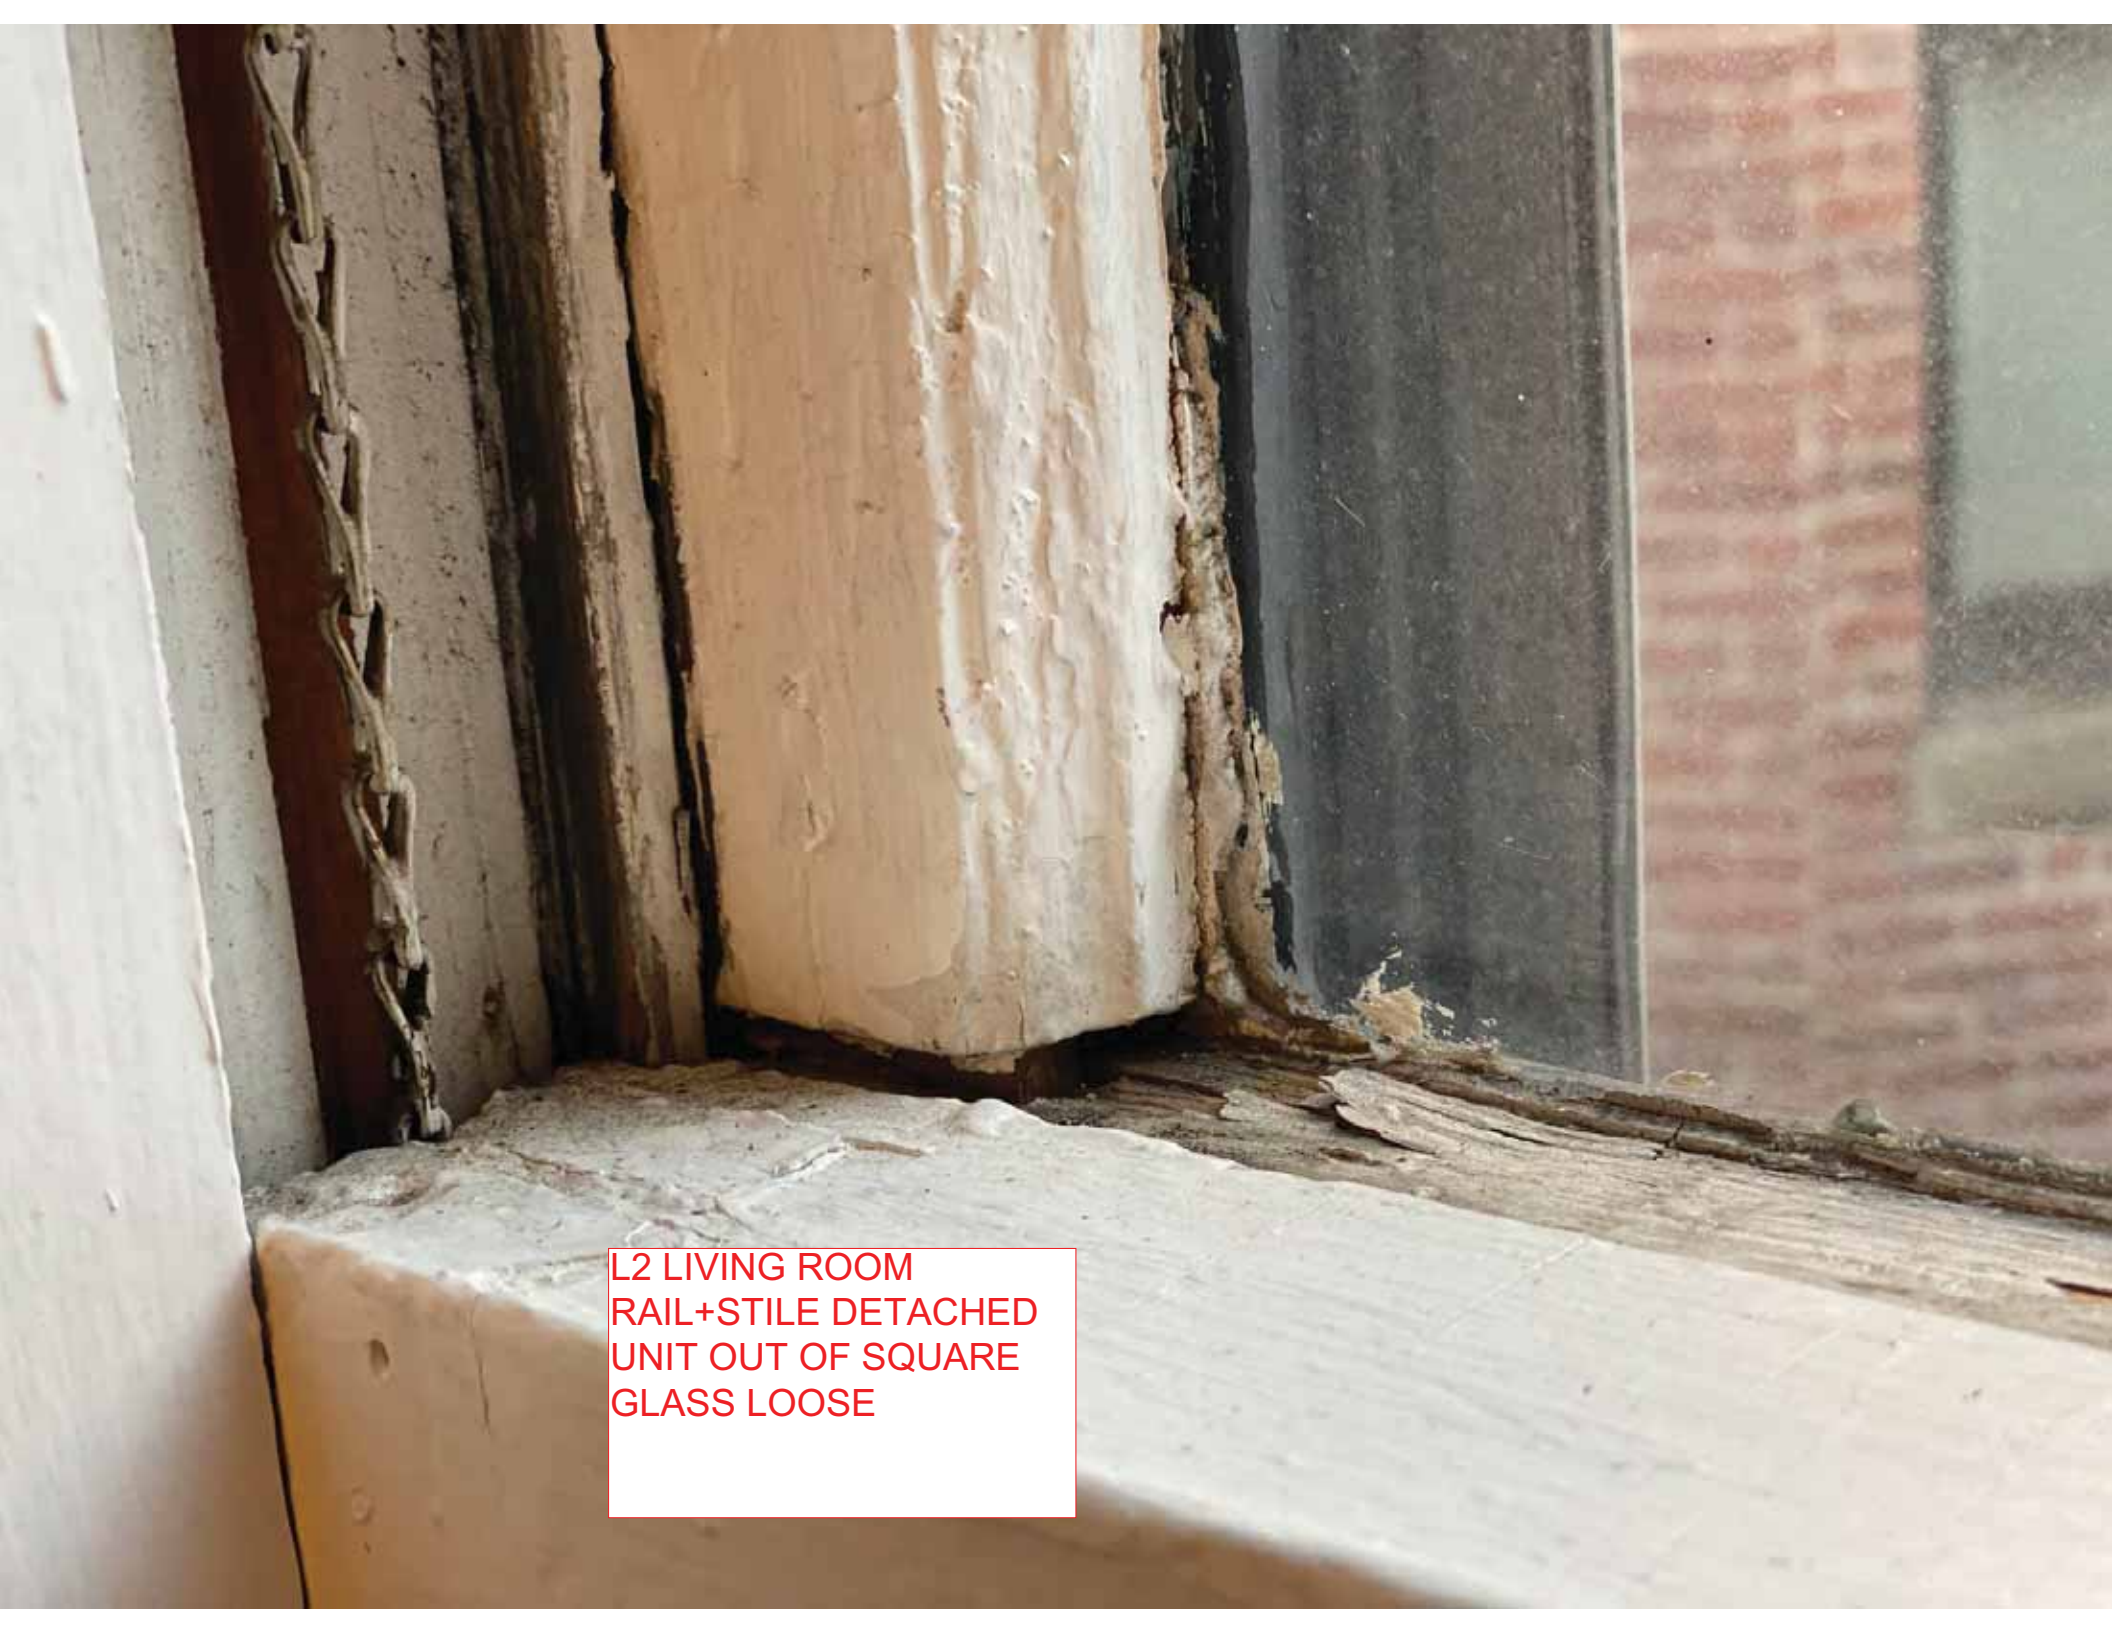
L2 LIVING ROOM  
RAIL+STILE DETACHED  
UNIT OUT OF SQUARE  
GLASS LOOSE
