295 Commonwealth Ave #5c  
Floor Plan  
1/8" = 1'-0"

## 295 Commonwealth Ave #5c Window Elevations

295 Commonwealth Ave #5c  
**Window Details**

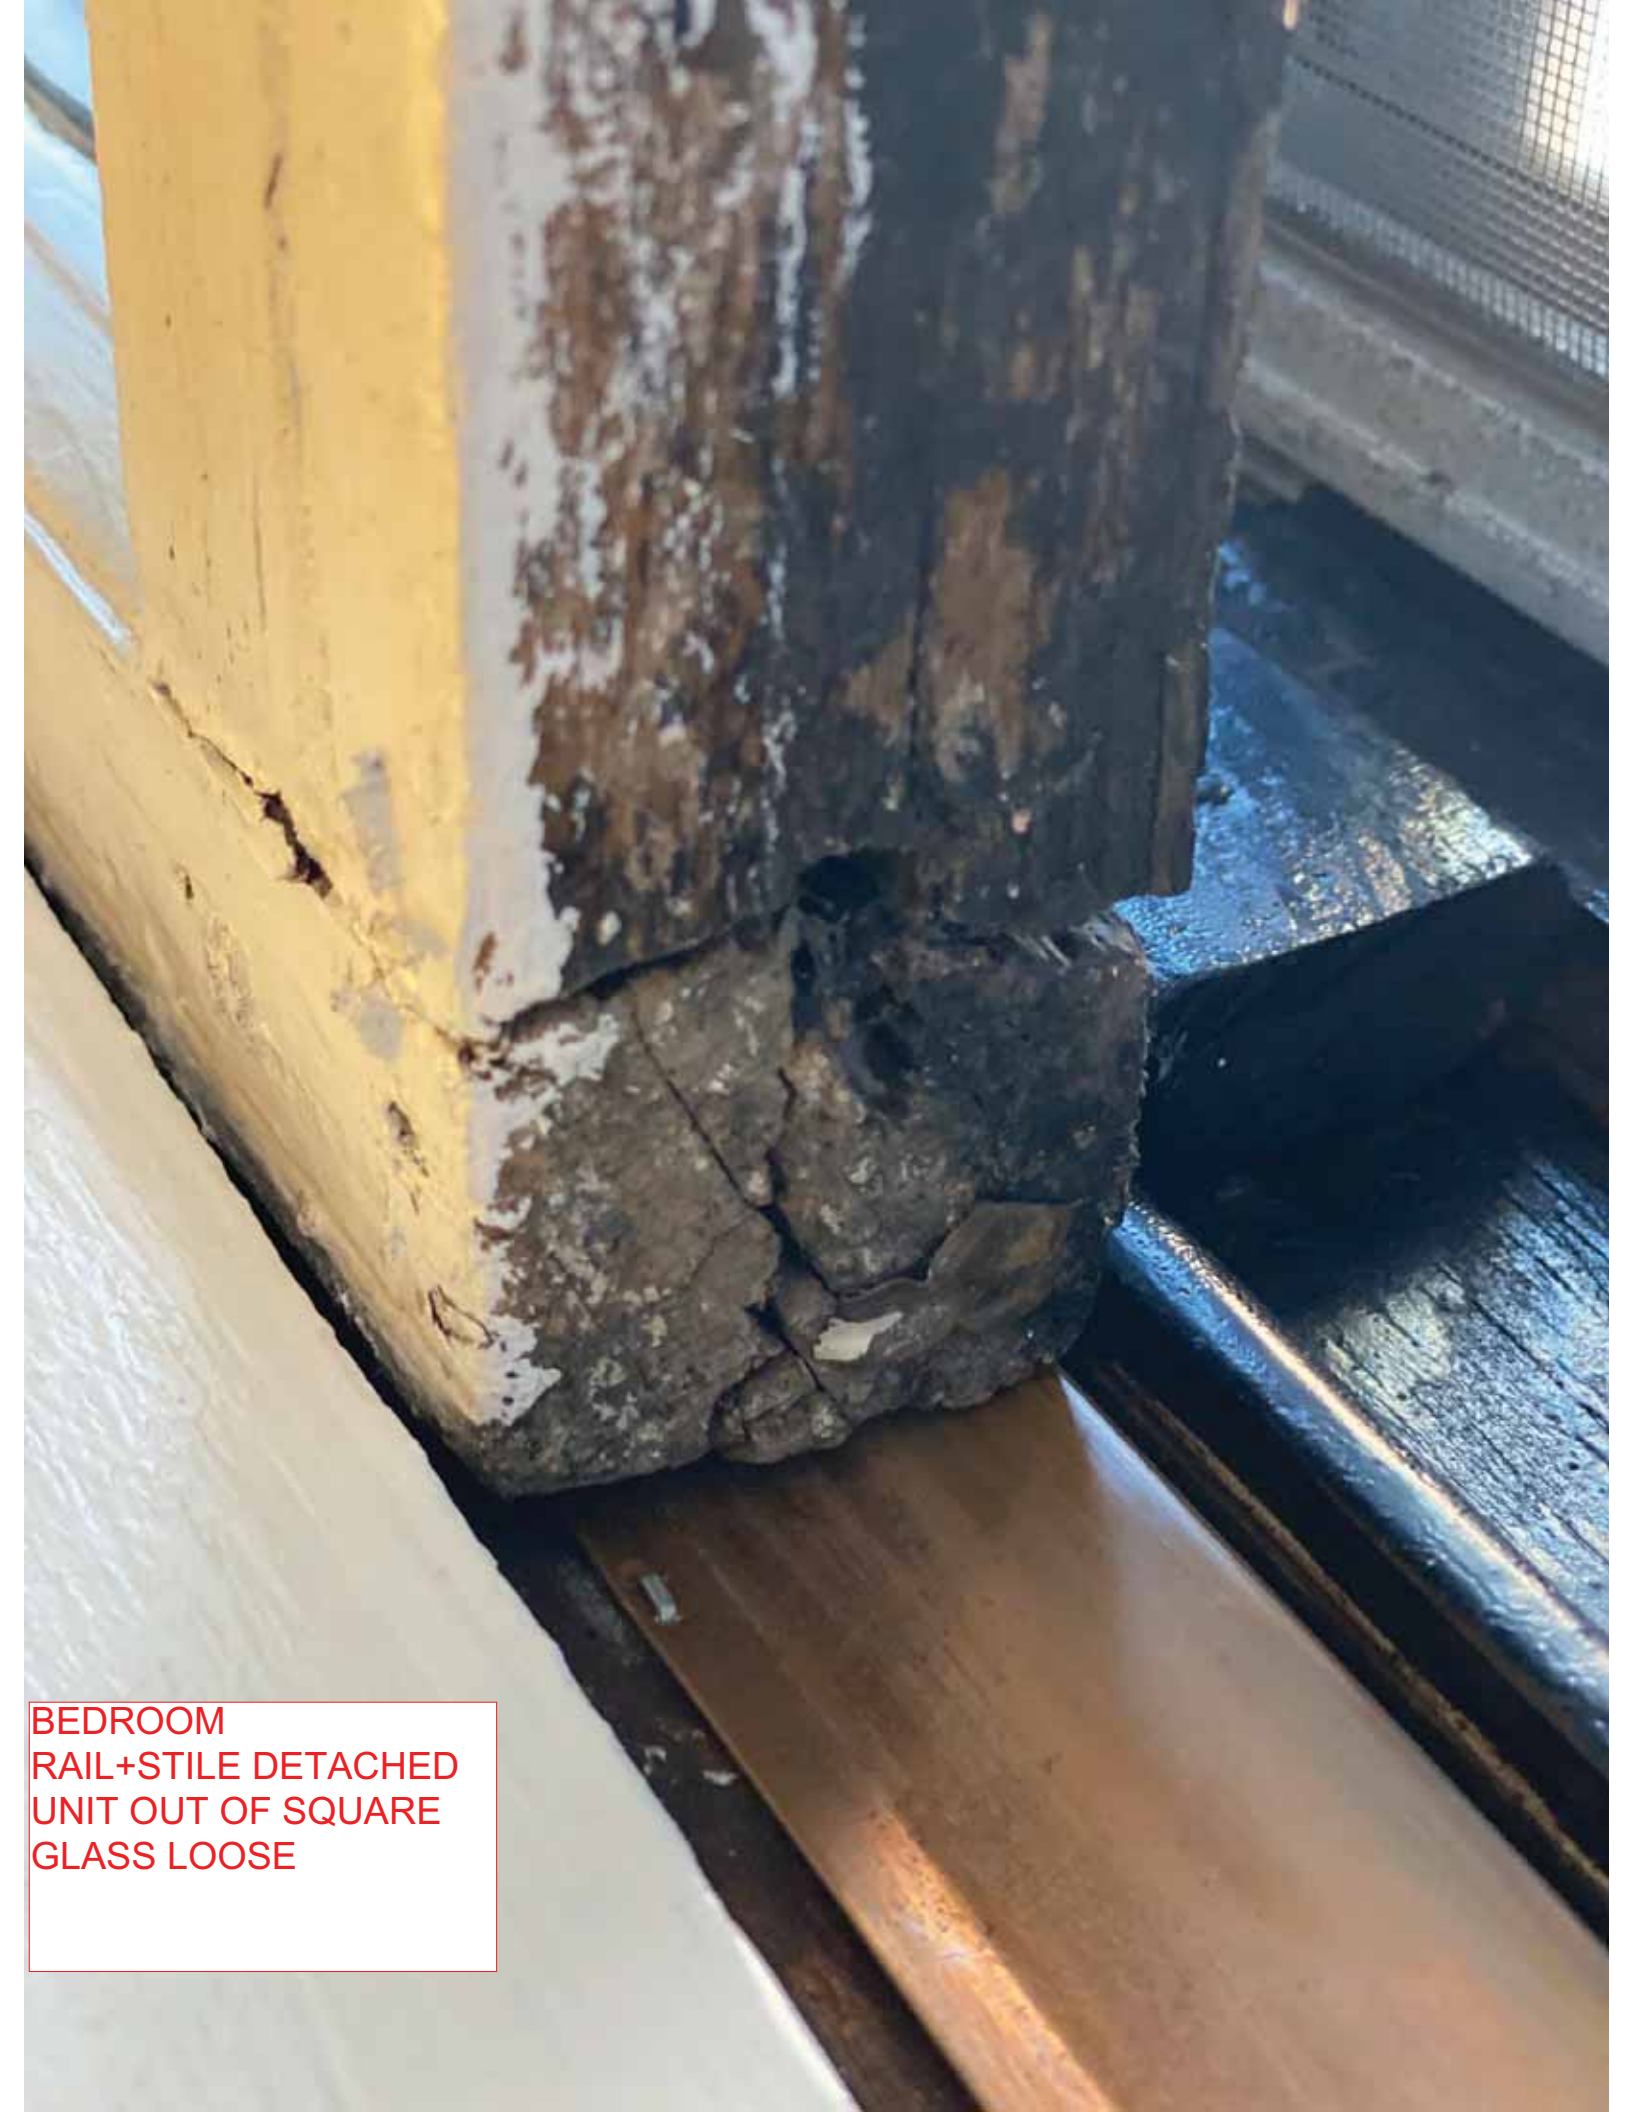
BEDROOM  
RAIL+STILE DETACHED  
UNIT OUT OF SQUARE  
GLASS LOOSE

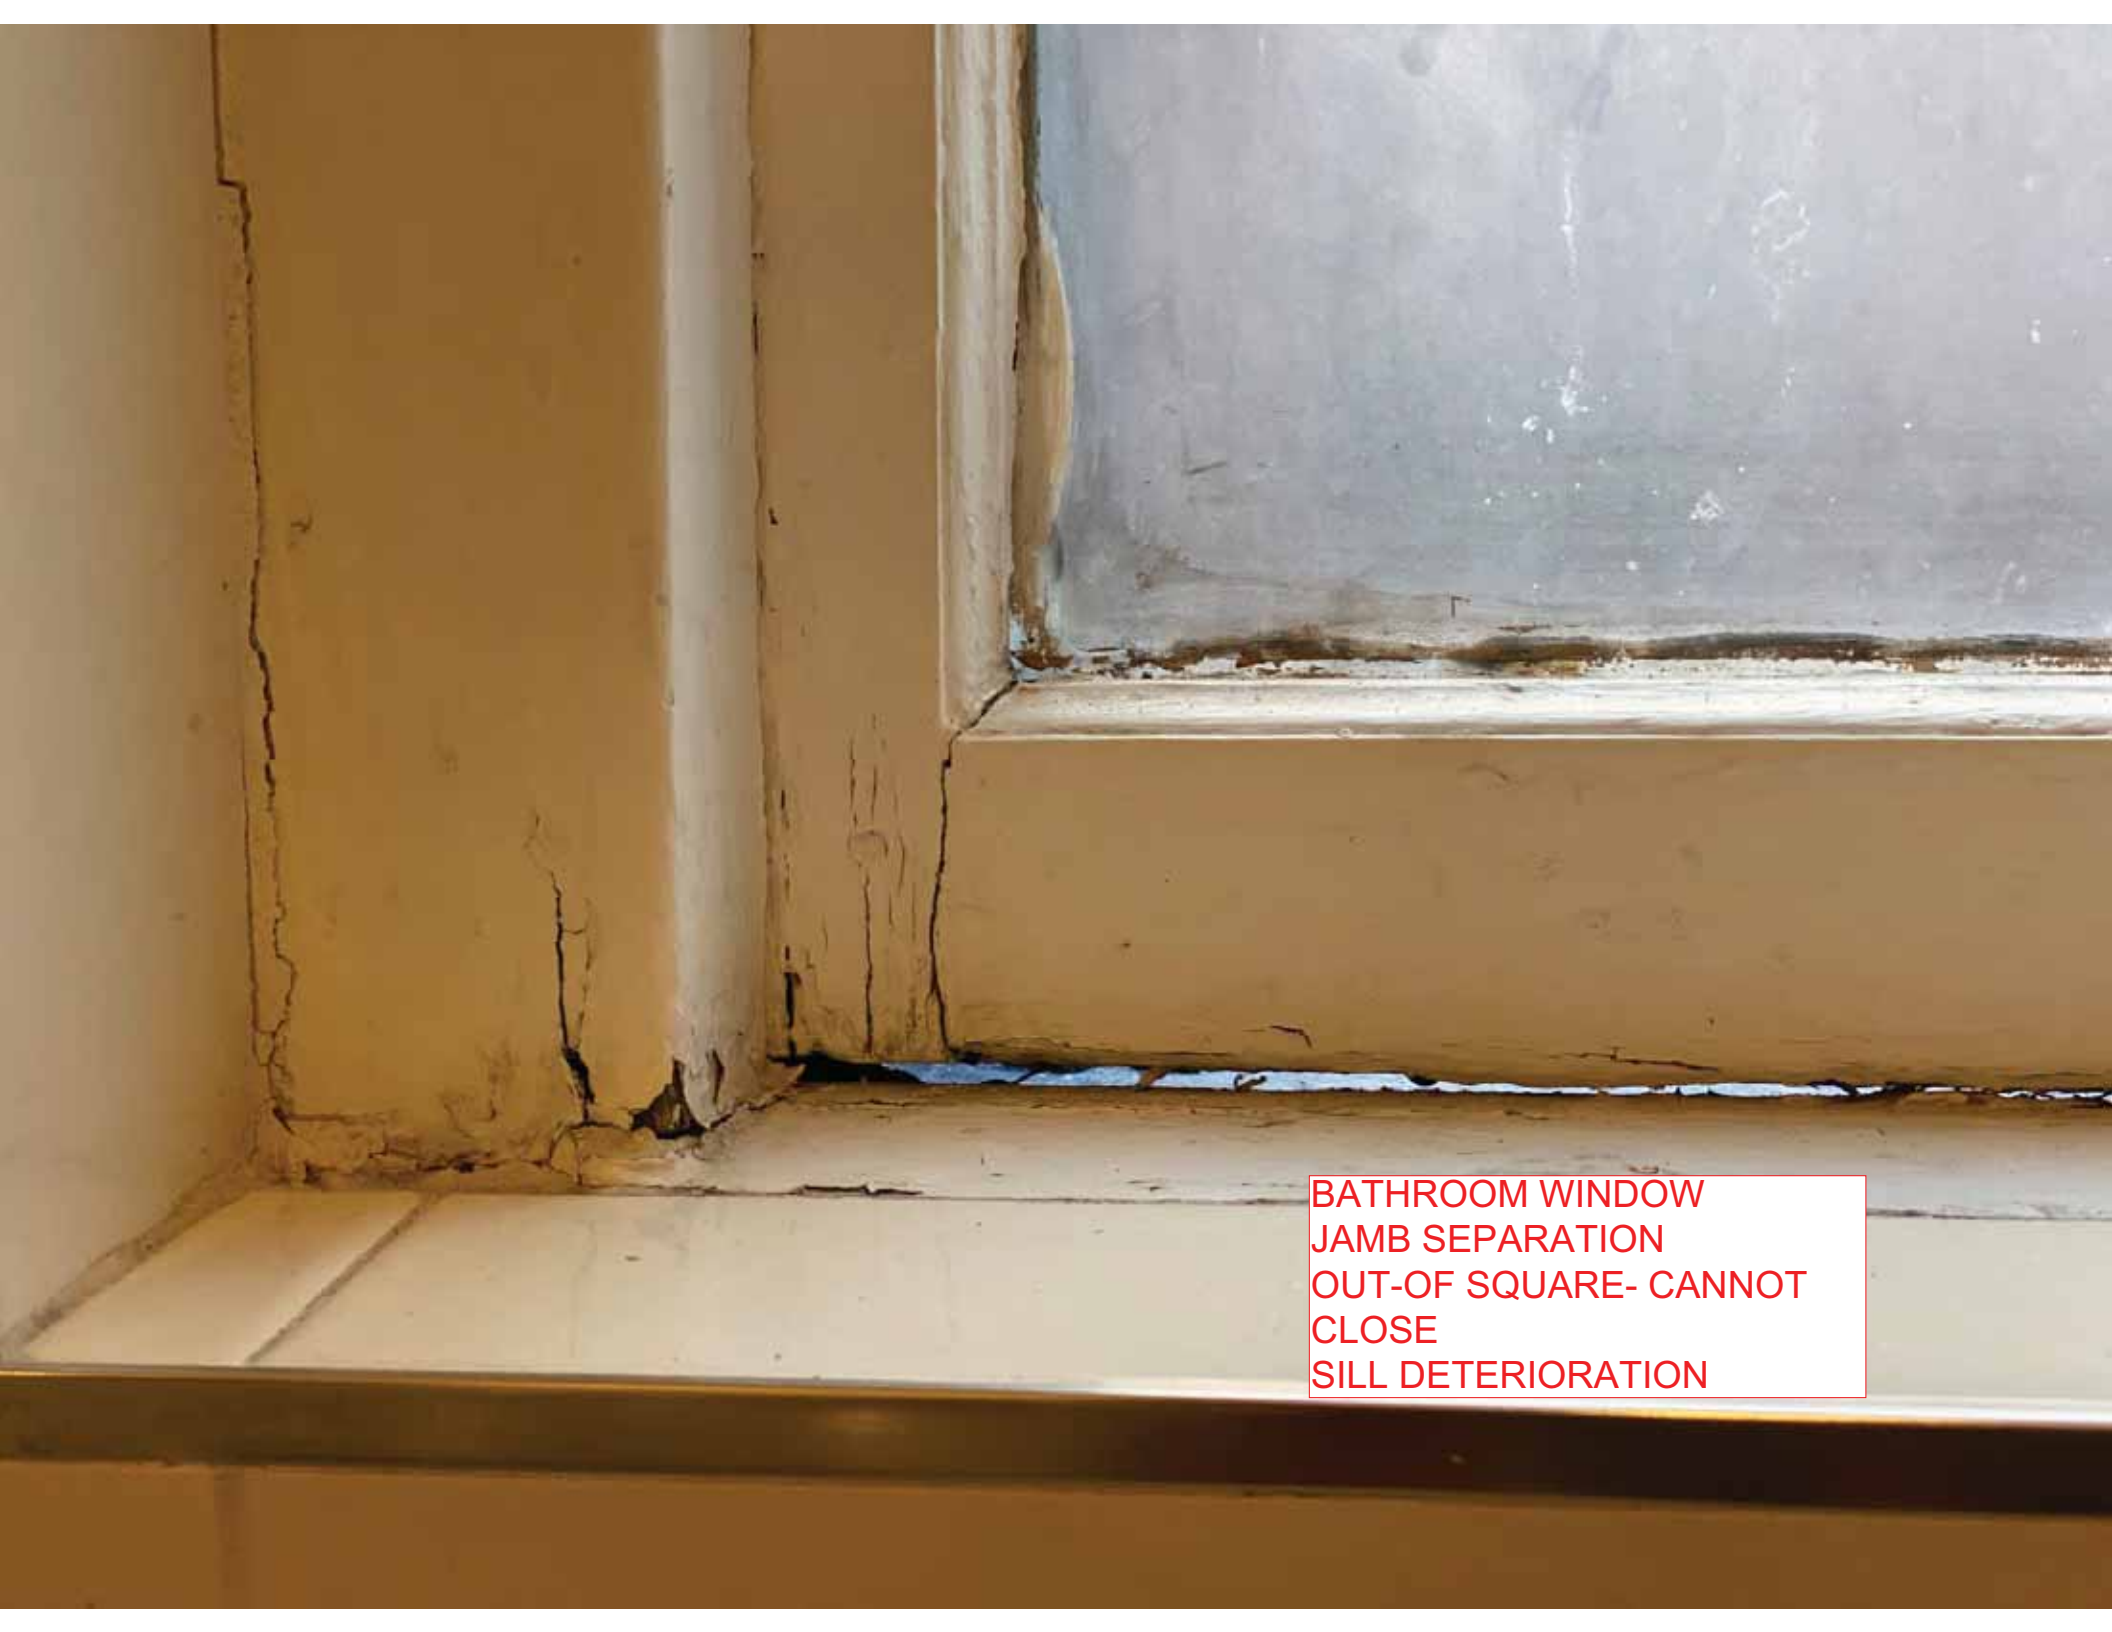
BATHROOM WINDOW  
JAMB SEPARATION  
OUT-OF SQUARE- CANNOT  
CLOSE  
SILL DETERIORATION

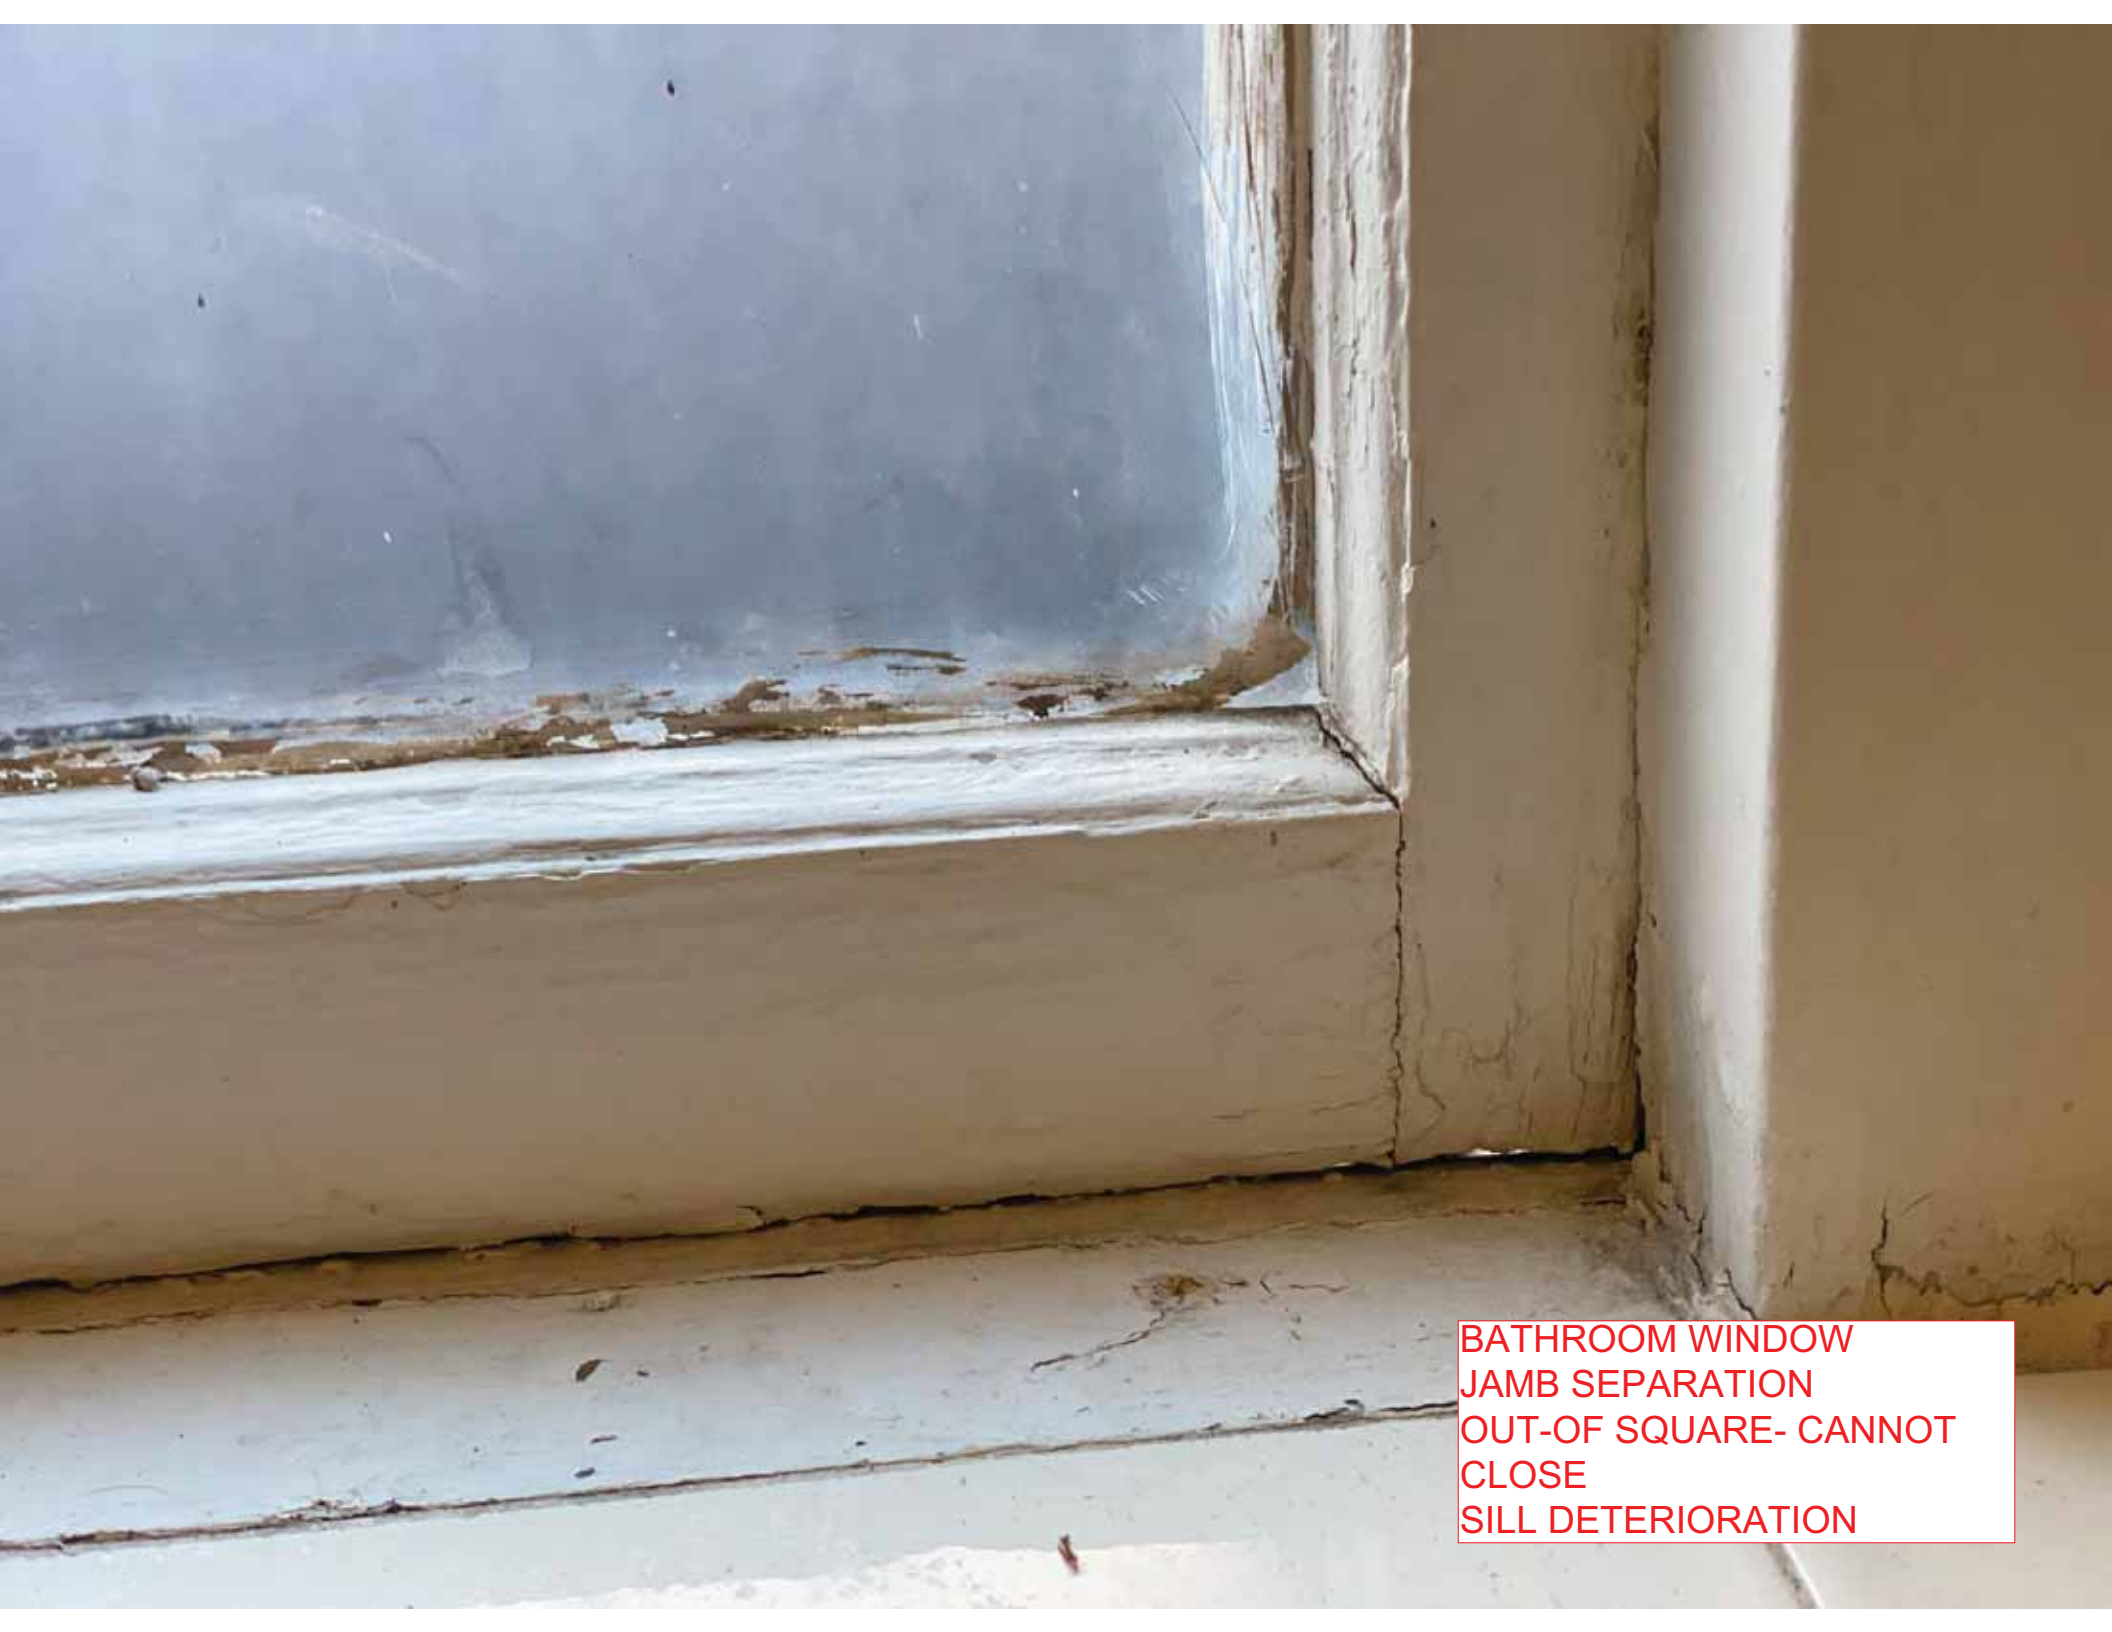
BATHROOM WINDOW  
JAMB SEPARATION  
OUT-OF SQUARE- CANNOT  
CLOSE  
SILL DETERIORATION
