Historic
Commission
Hearing
September 7, 2022

20 Union Park, #1

Boston, MA

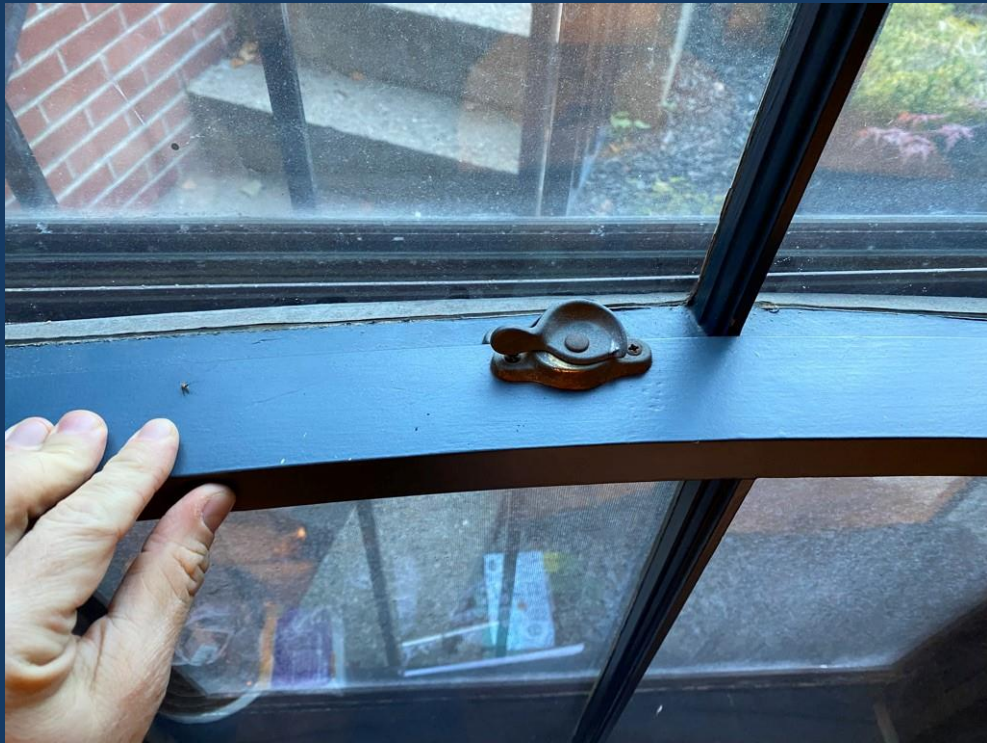
BOWED WINDOW #1 – BEDROOM

- **Windows have rot**
- **Muntin's have different widths**
- **Bottom rails have been damaged & require build up to get to correct rail size**
- **Excessive sanding & modification which created gaps and require replacement**
- **Interior profile has been changed from original**
