59 East Springfield Street: Existing Condition Photo of Front of Building

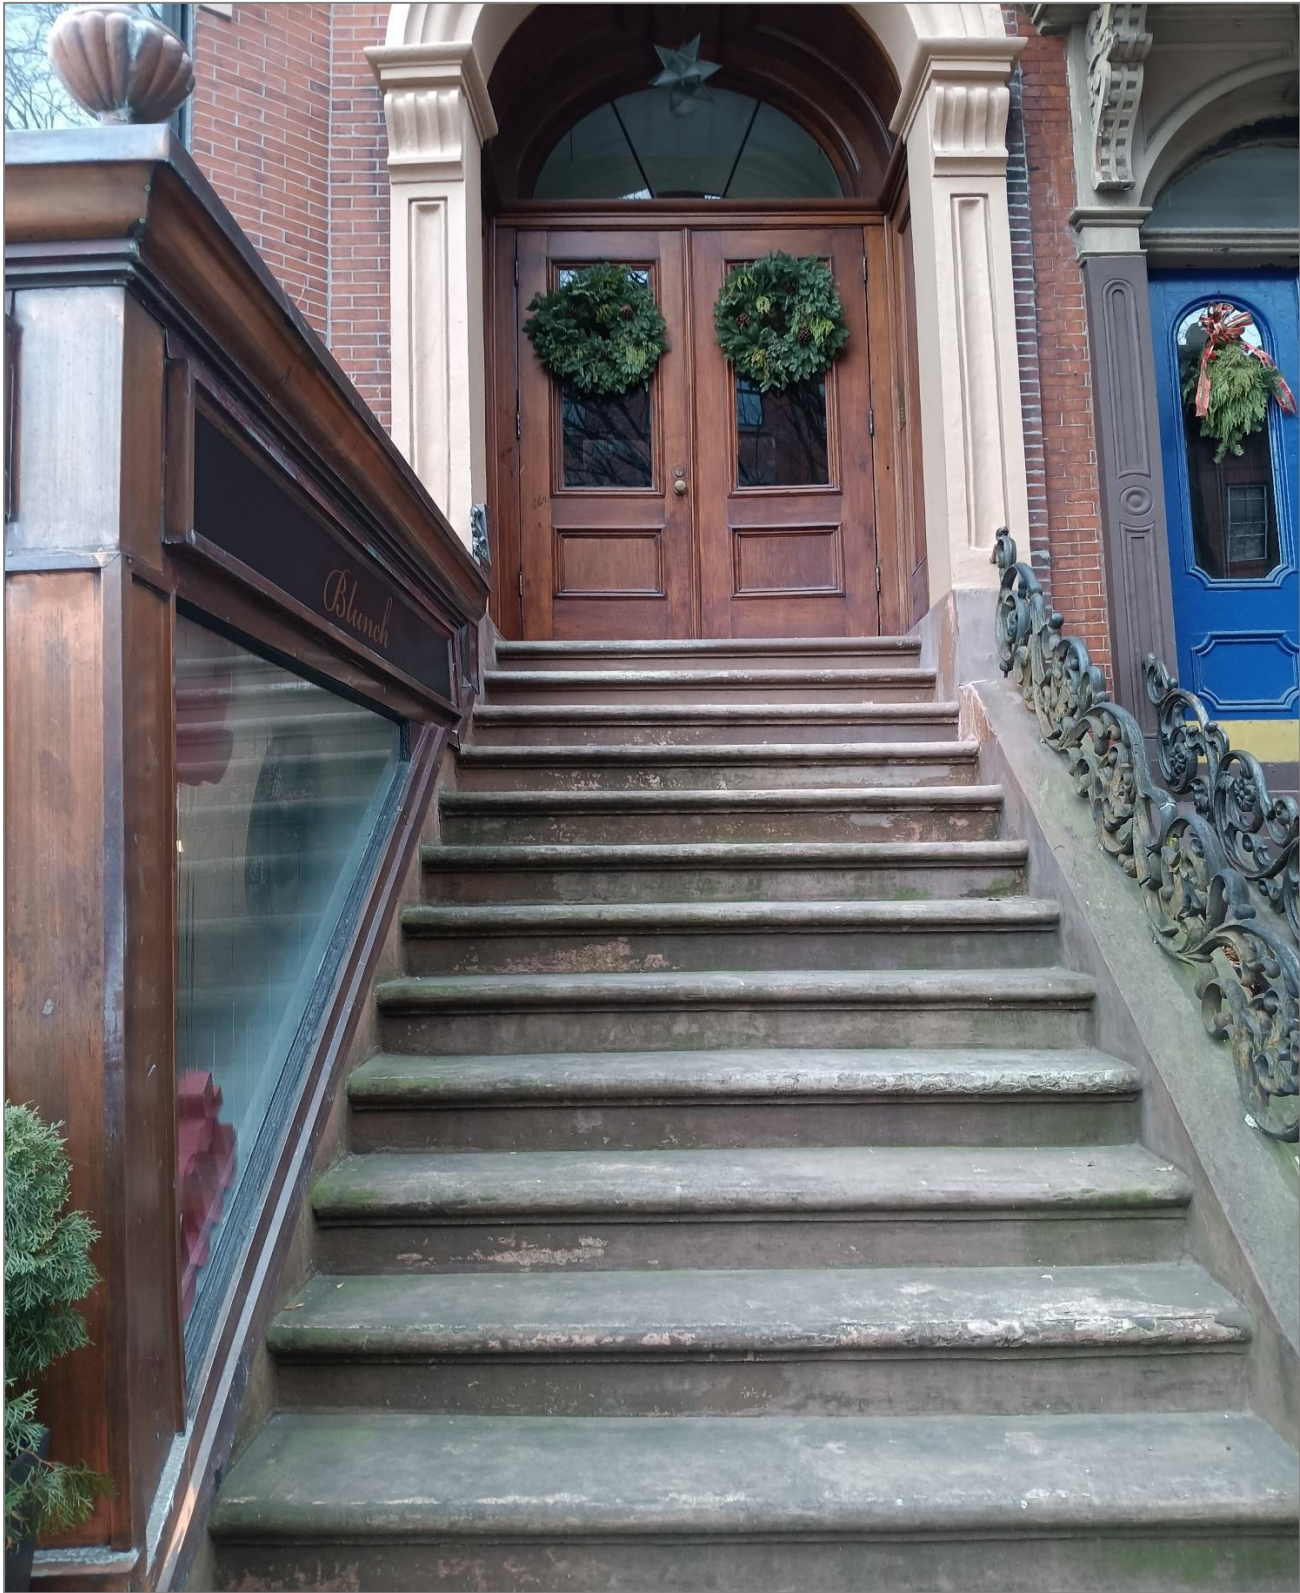
59 East Springfield Street: Existing Condition Photo of Front Entry Steps

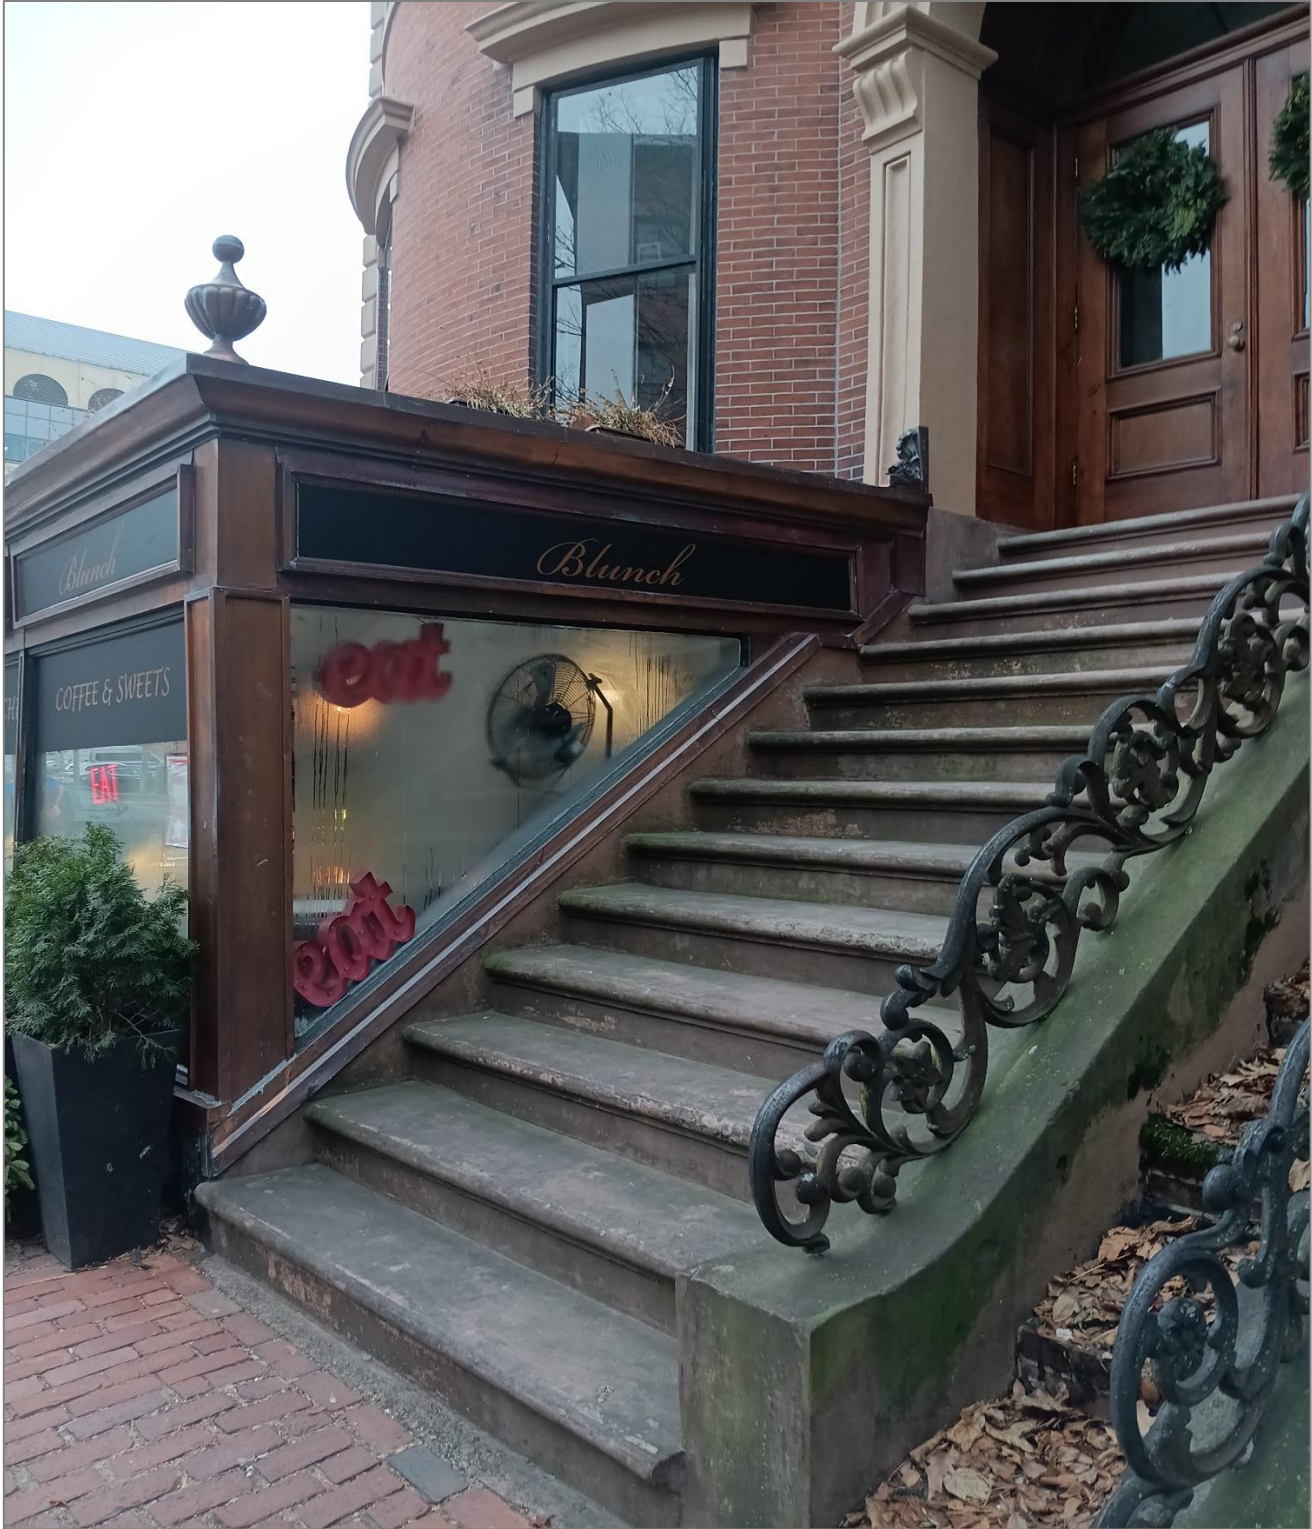
59 East Springfield Street: Existing Condition Photo of Steps and Restaurant (Side of Proposed Railing)

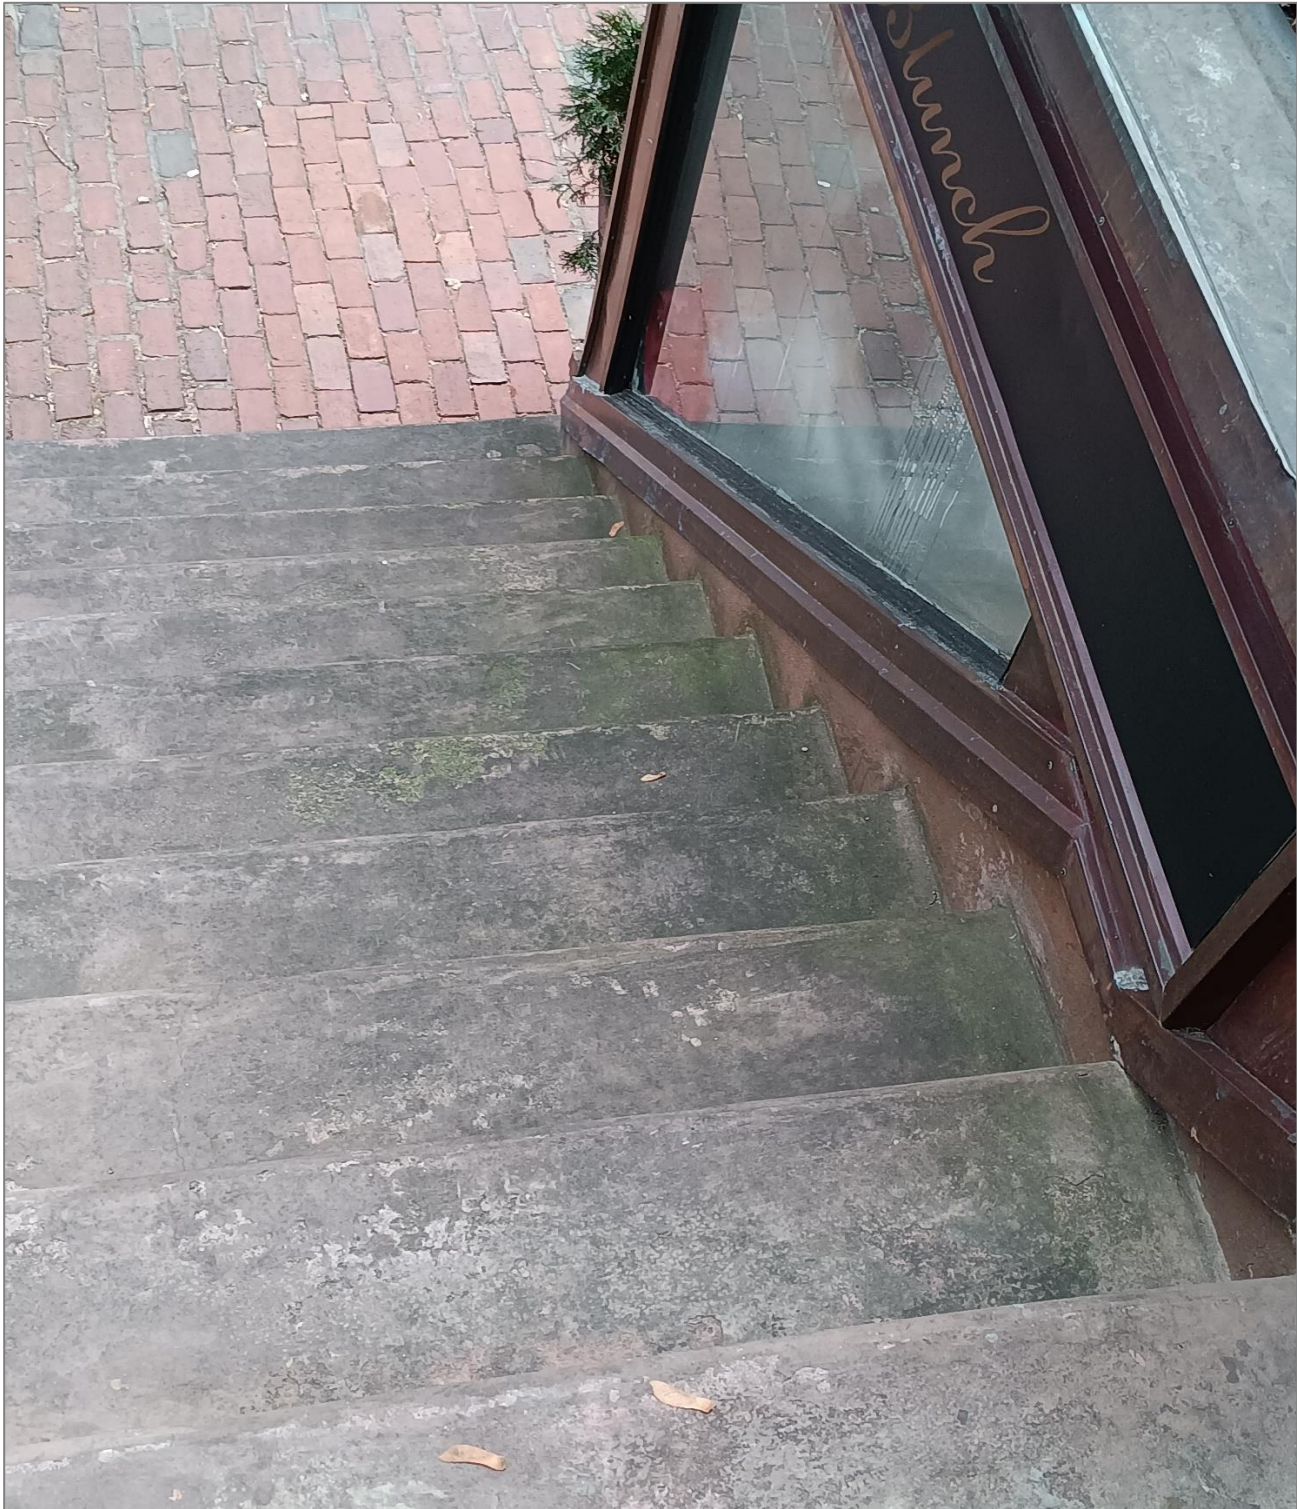
59 East Springfield Street: Existing Condition Photo of Front Steps, View Down from Top Landing
