1 ELMWOOD

HPACD DESIGN REVIEW 2

10/24/2024

TRIPLE W DEVELOPMENT 1 ELMWOOD ST
WEST WORK

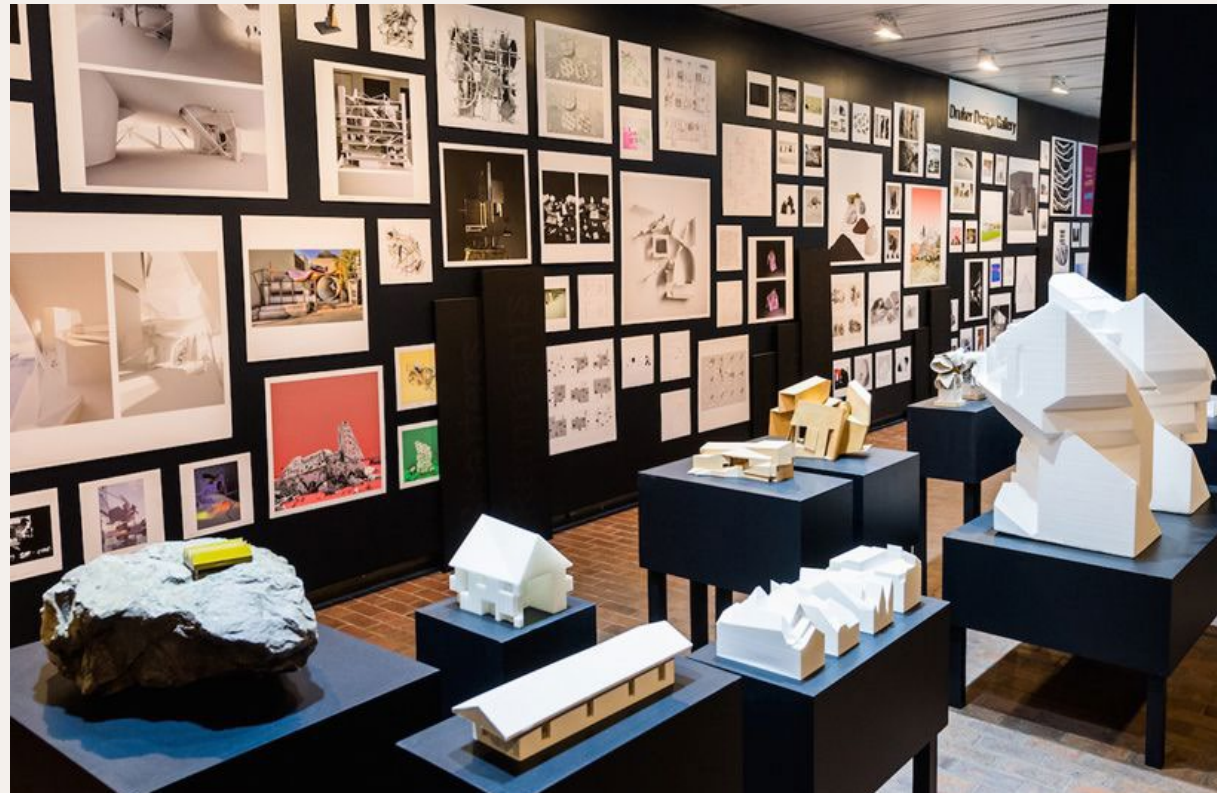
OPTION A: Online Archive + Exhibition

Make the research publicly accessible via online archive and exhibition.

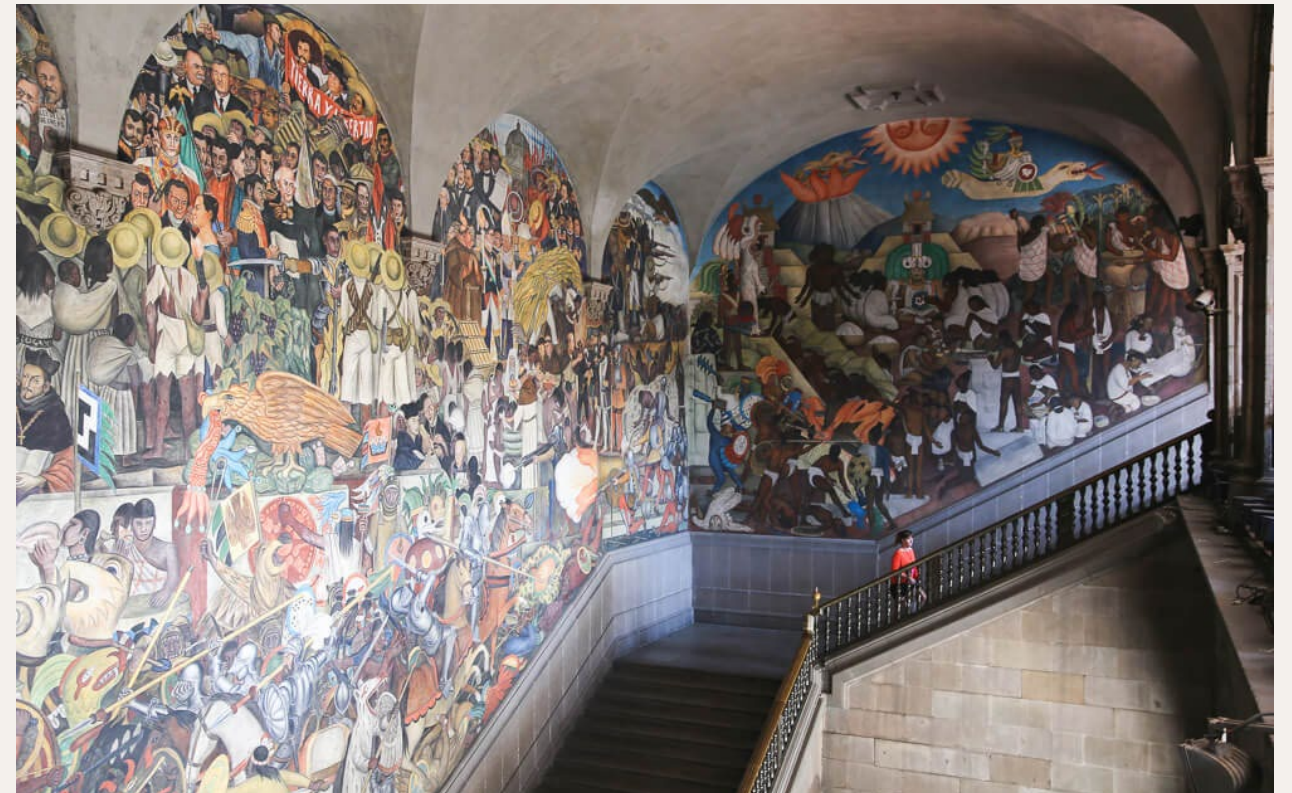
OPTION B: Online Archive + Mural

Artistic re-creation of neighborhood history in the form of a mural.

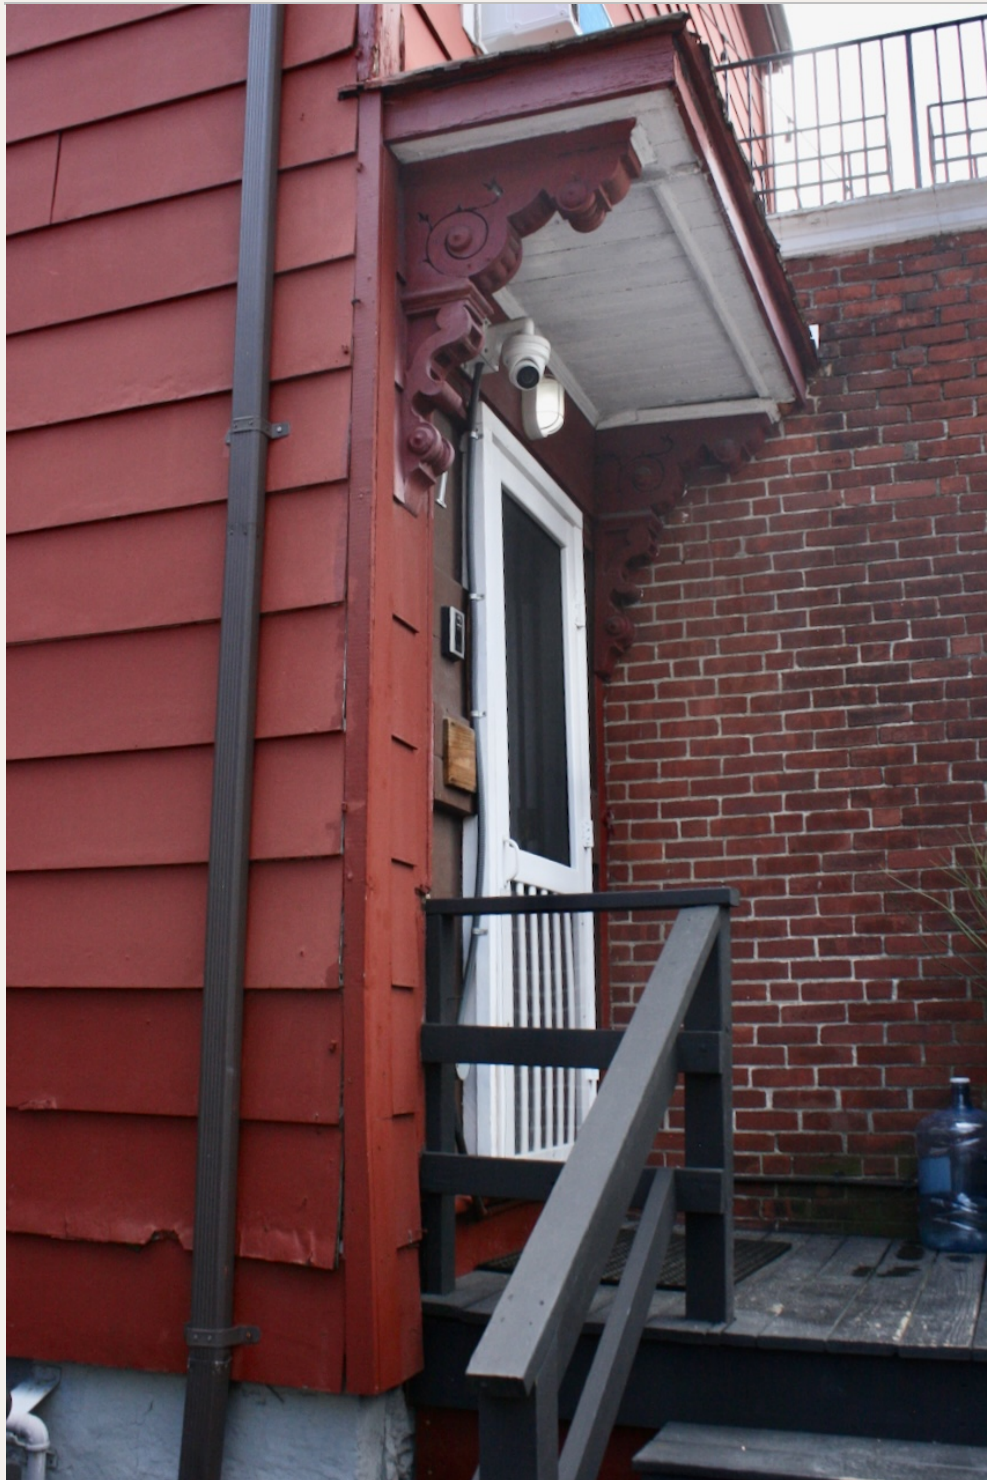
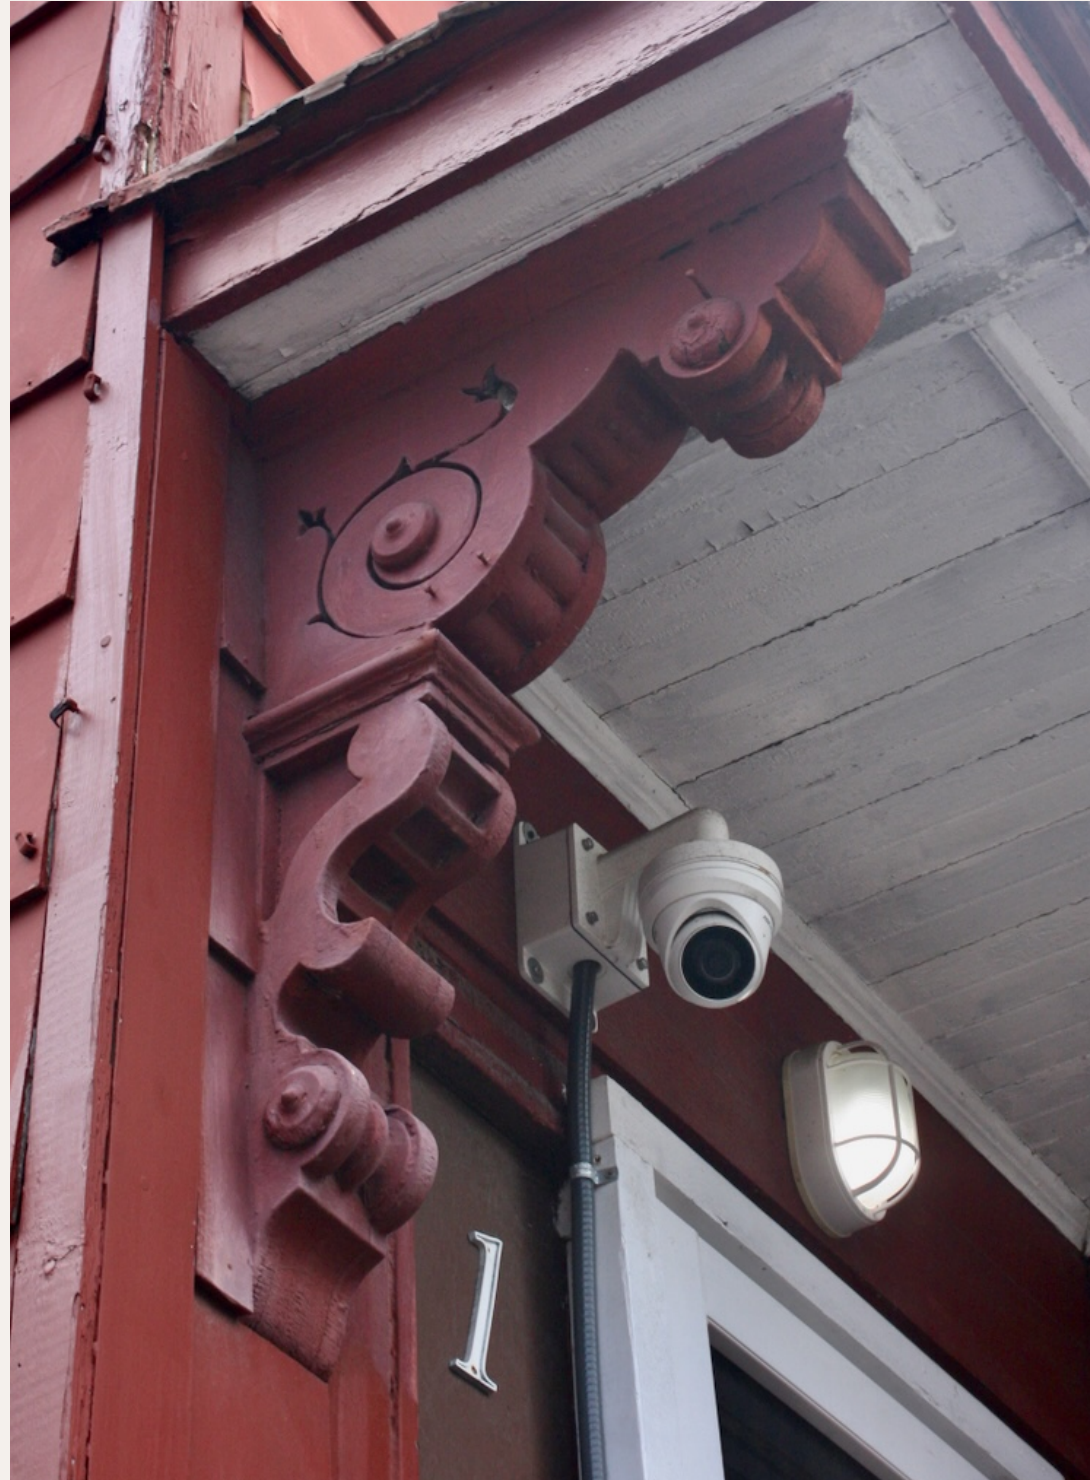
Photo:
West entrance: Bracket detail

The existing historic features, such as the bracket detail at the west entrance, can be highlighted and showcased in the common areas.

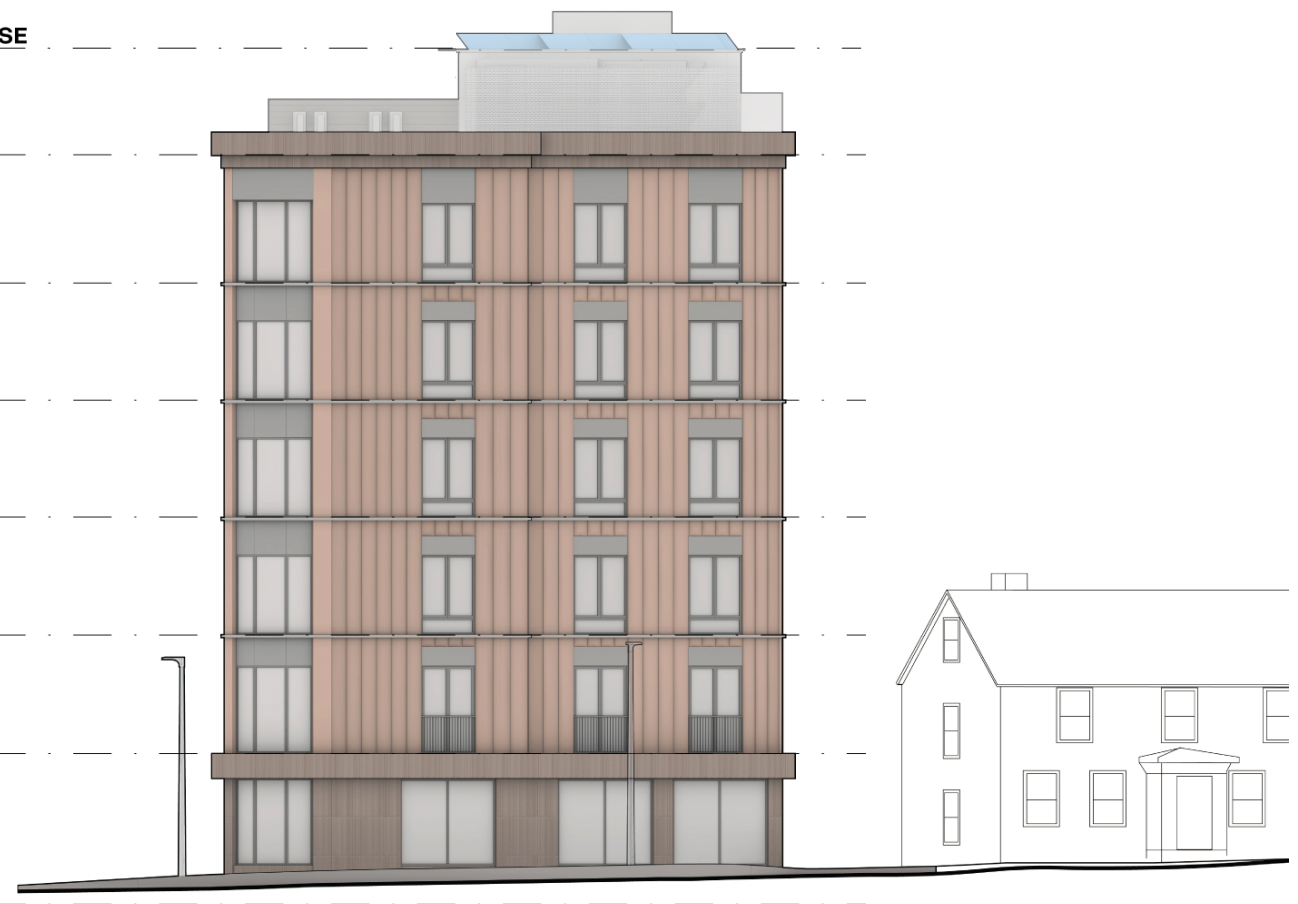
1 NORTH ELEVATION

ROXBURY STREET

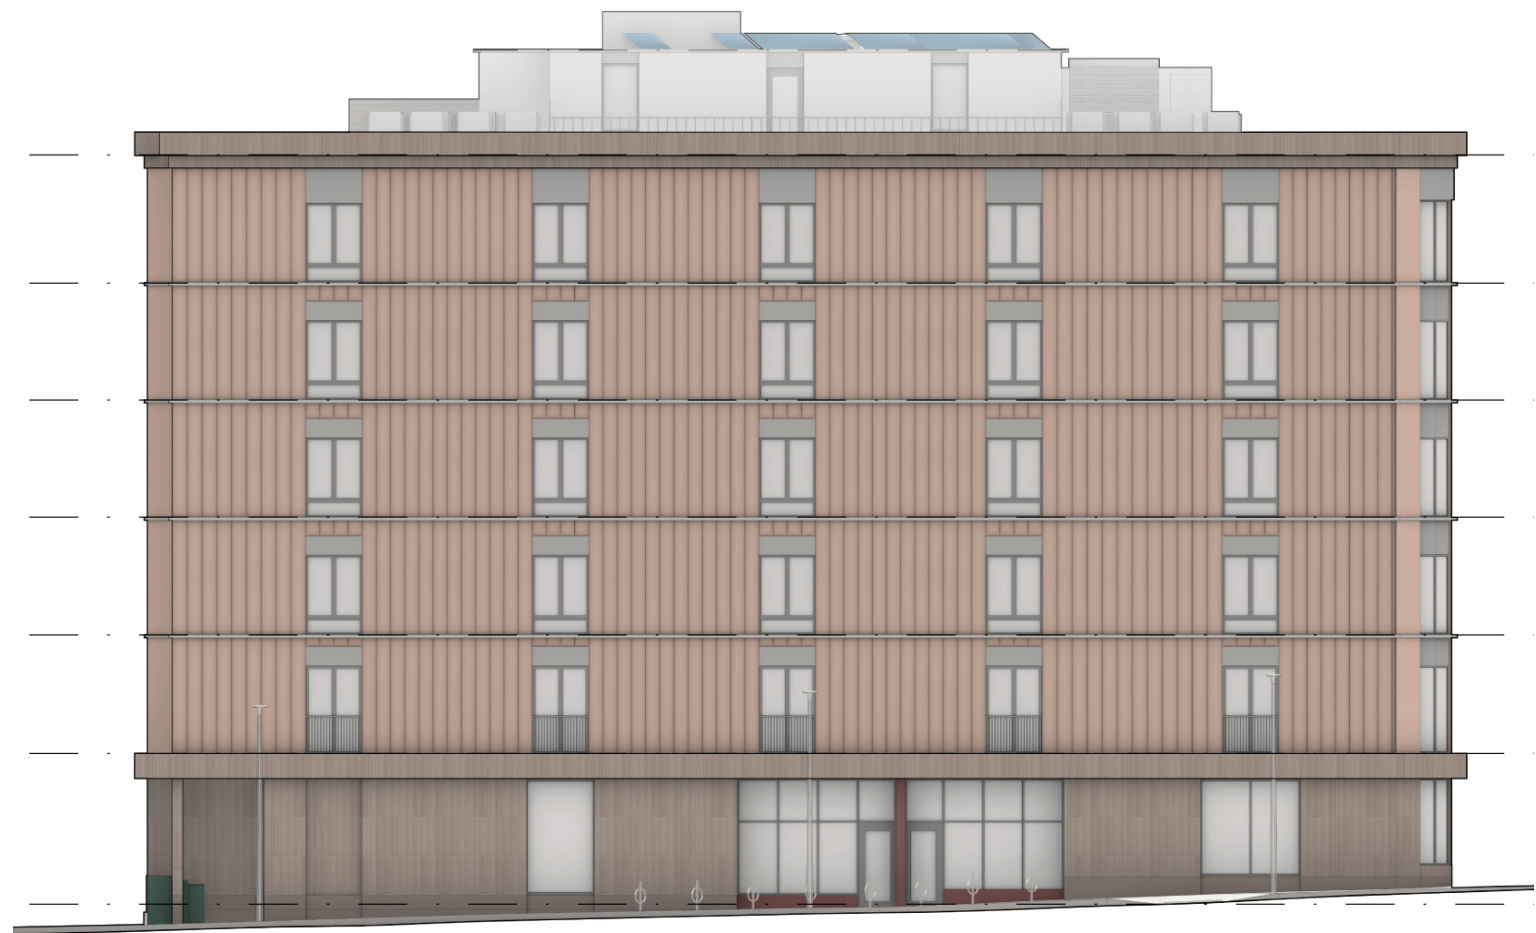
2 EAST ELEVATION

ELMWOOD STREET

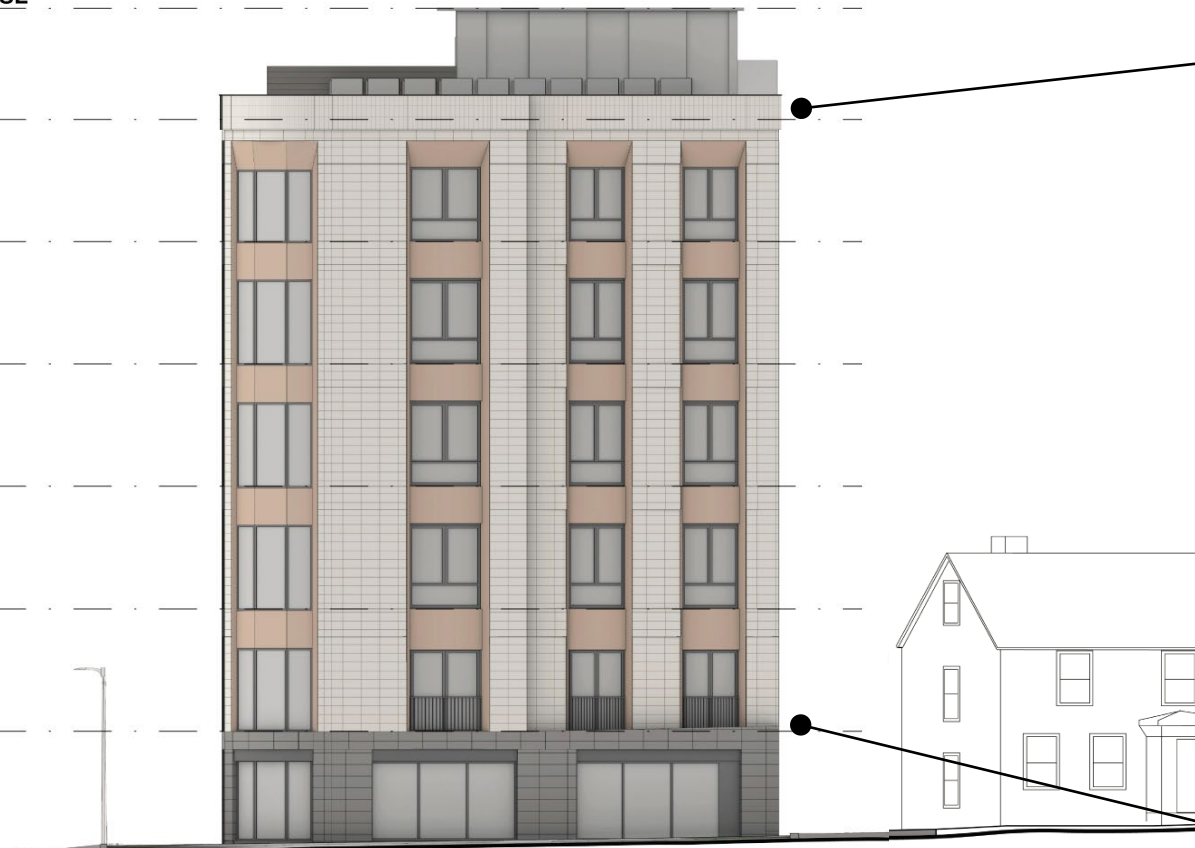
1 NORTH ELEVATION

UPPER
TERRA
COTTA

BASE
PRECAST/
BRICK

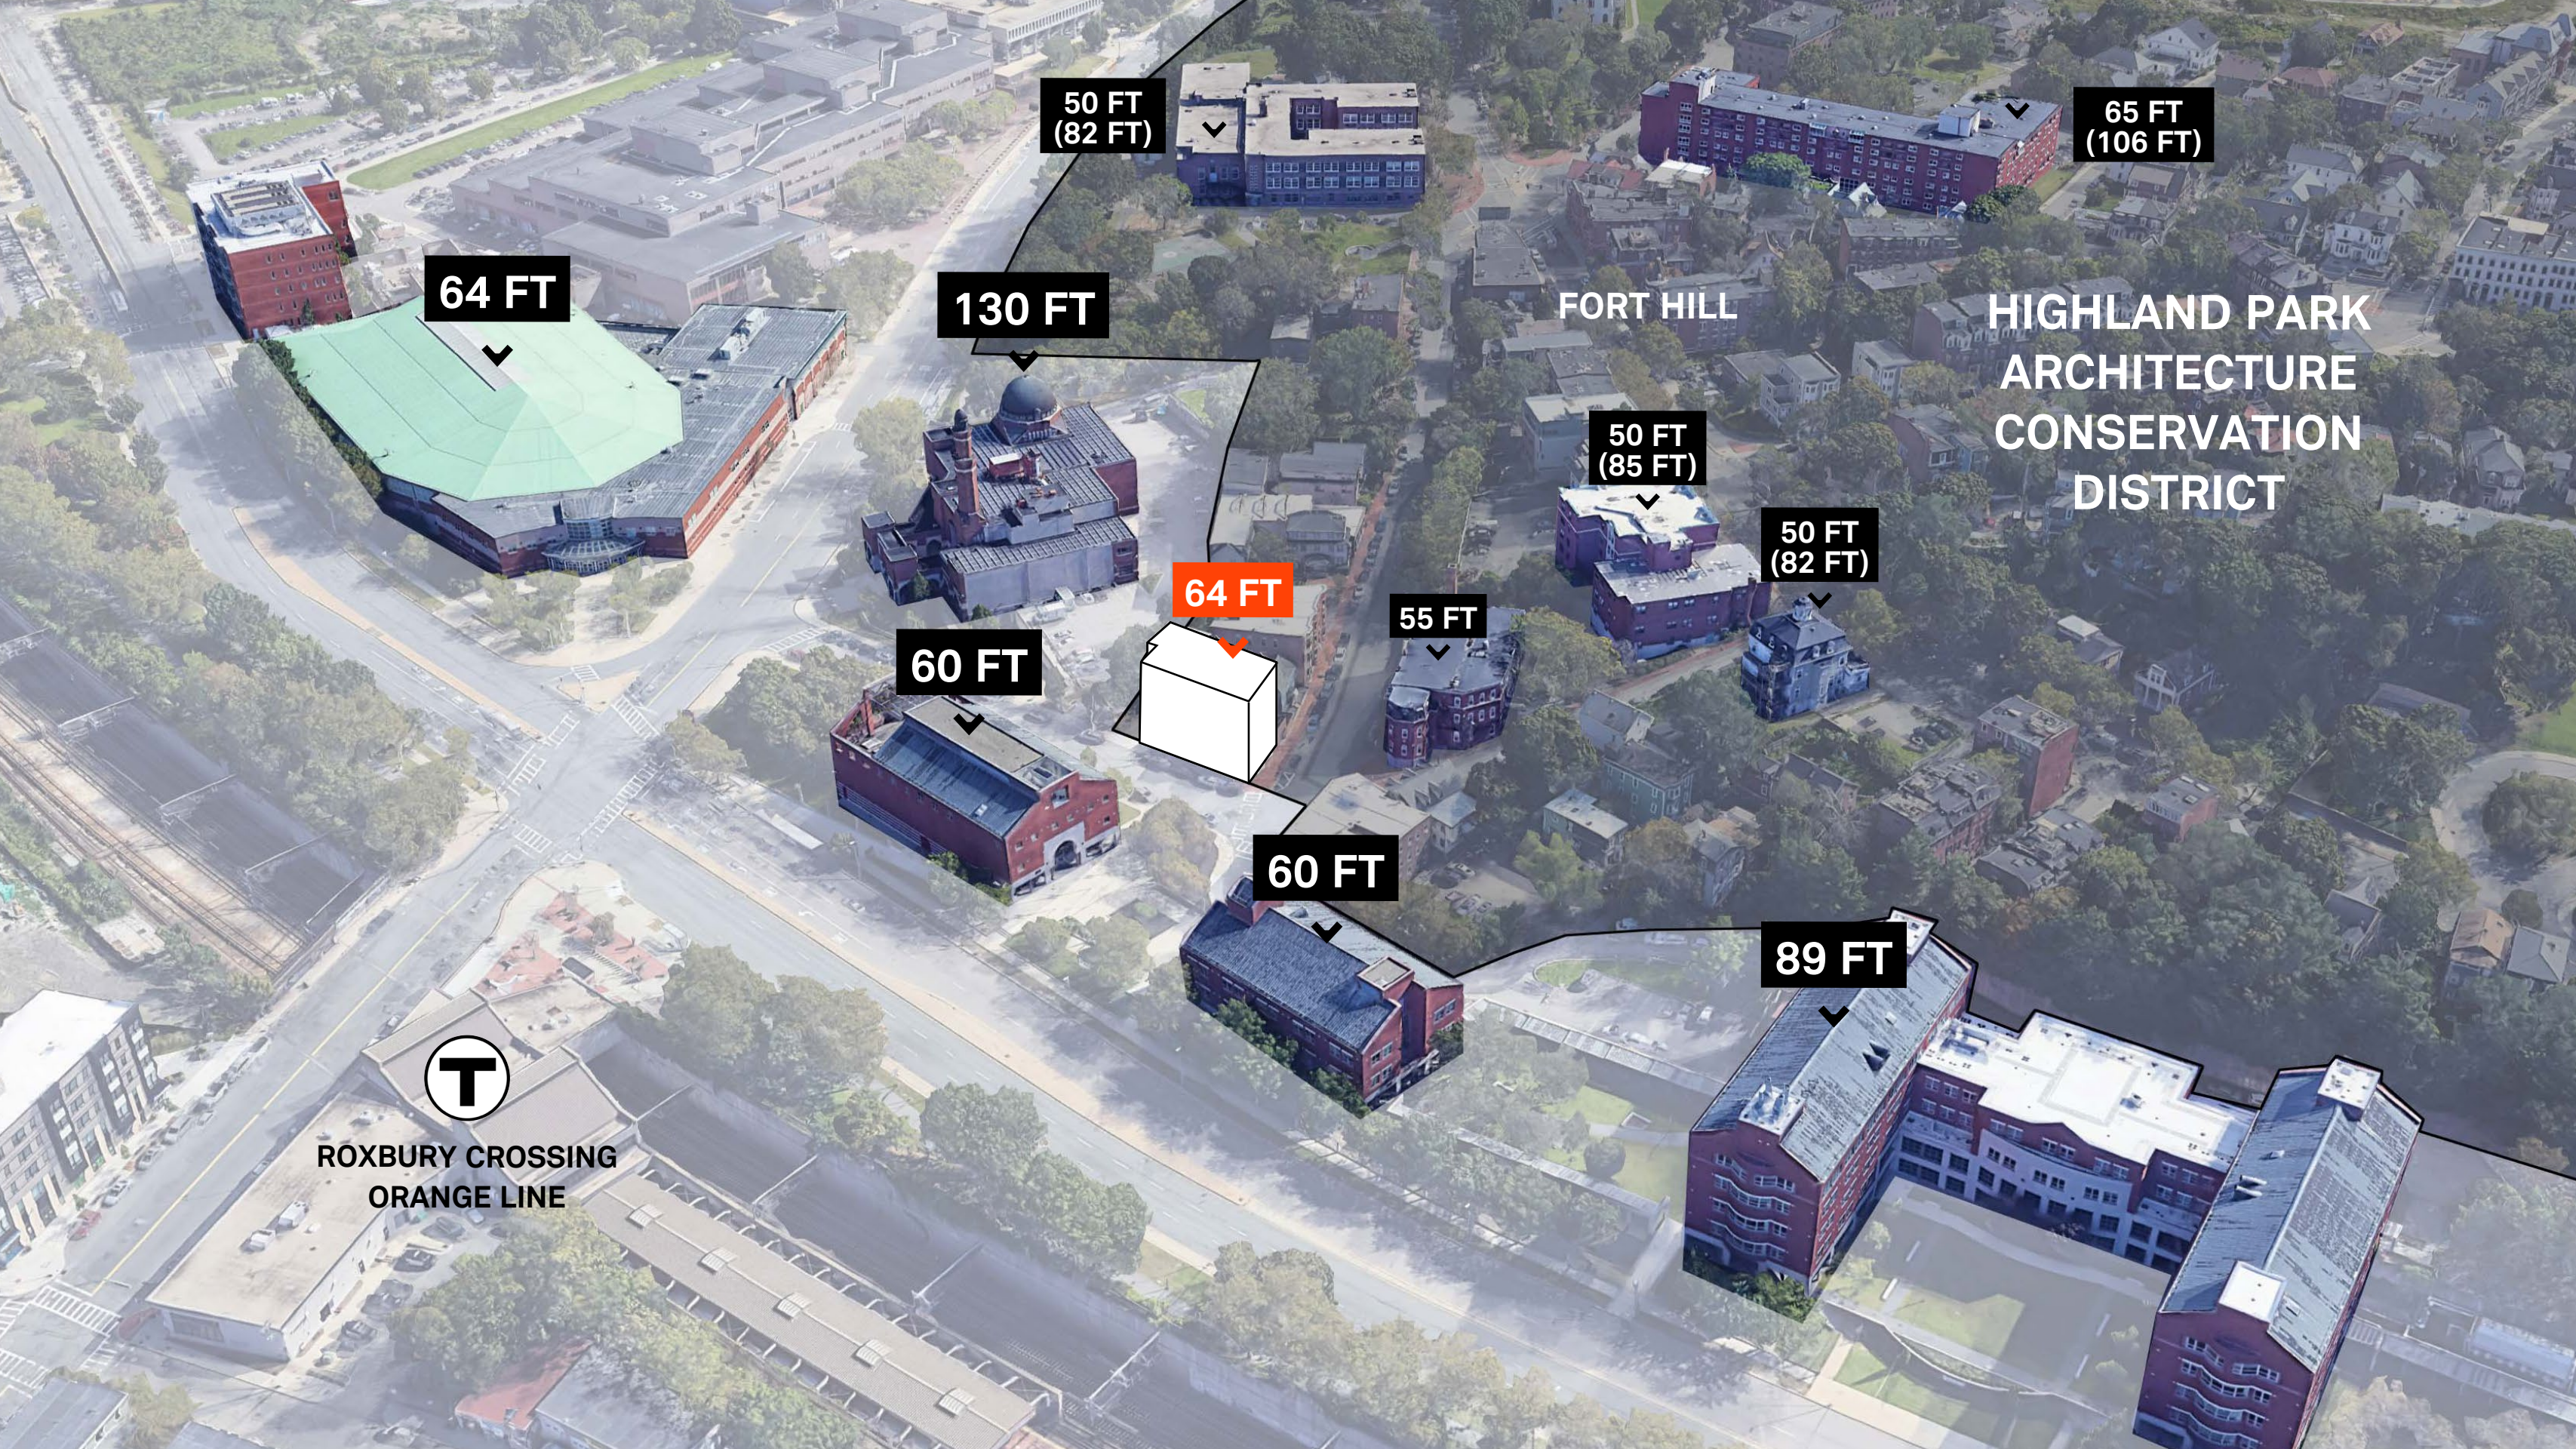
HIGHLAND PARK
ARCHITECTURE
CONSERVATION
DISTRICT
