STUDY REPORT

Isabella H. Fox House; Barbara A. Carroll House

318 Metropolitan Avenue, Roslindale, MA 02131

Petition # 293.24
Boston Landmarks Commission | Office of Historic Preservation
City of Boston

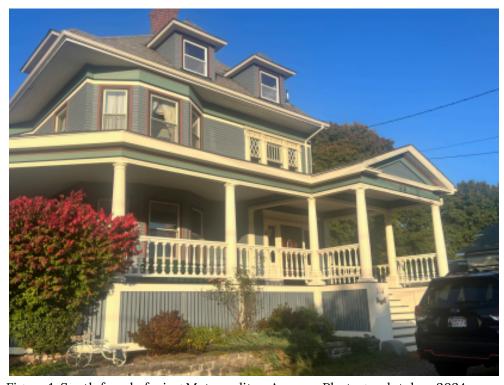
Figure 1. South façade facing Metropolitan Avenue. Photograph taken 2024.

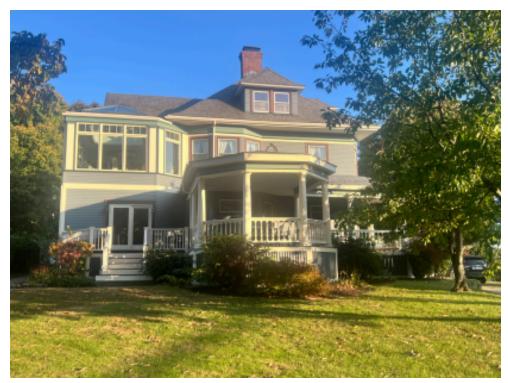
Figure 2. West façade facing Maynard Street. Photograph taken 2024.

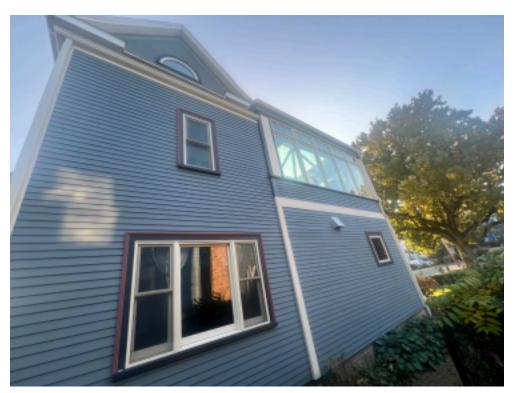
Figure 3. North façade facing 44 Maynard Street. Photograph taken 2024.

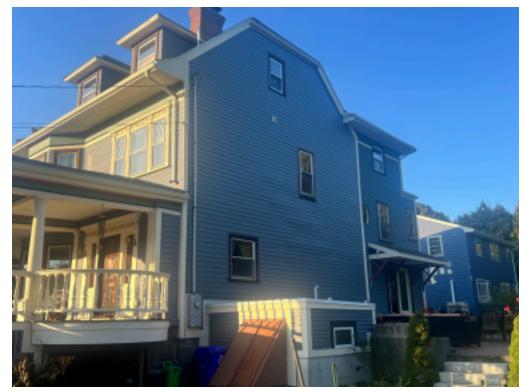
Figure 4. East facade where the house was cut. Photograph taken 2024.

One of the most interesting aspects of the home's history is that it was cut into two pieces in 1943<sup>48</sup>. The eastern portion was moved around the corner to 44 Maynard Street and the eastern side of the remaining portion was sheathed in clapboard. At the same time that the house was divided, its former stable was converted into a single-family home. A covered passageway that once led from the east side of the house to the stable is no longer extant. The plans for this operation can be found in the Boston City Archives. The house as it stands today is thus a fascinating record of the neighborhood's development from a sparsely populated rural area to an increasingly suburban community. With the increased local demand for homes, it was possible to profit by dividing a preexisting house into two smaller ones.

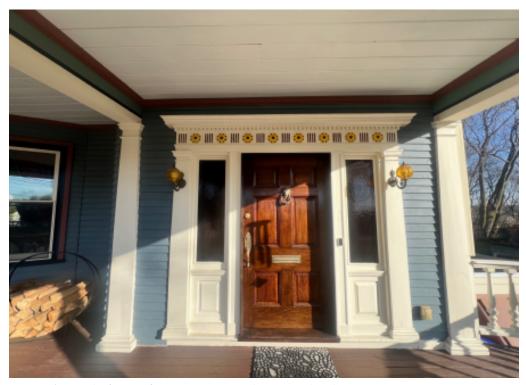
Figure 5. South-facing front entrance. Photograph taken in 2024.

The front door and front vestibule retain their original layout as described in the 1899 plans, and open into the entrance hall. This entrance hall contains the original oak panelling on the walls, and around the original fireplace, featuring the Scottish motto 'East, West, Hame's Best', (this motto, can also be found, for example, written on the Leith Tower of Castle Fyvie in Aberdeen, Scotland built by Lord Leith in 1900). This panelling hides original gas piping and electrical connection points for lights on either side of the fireplace which are no longer extant. The brick work inside the fireplace is original, although the exterior apron brick work has been replaced. The flooring, radiators and ceiling beams are original. Functioning original pocket sliding doors, surrounded by their original

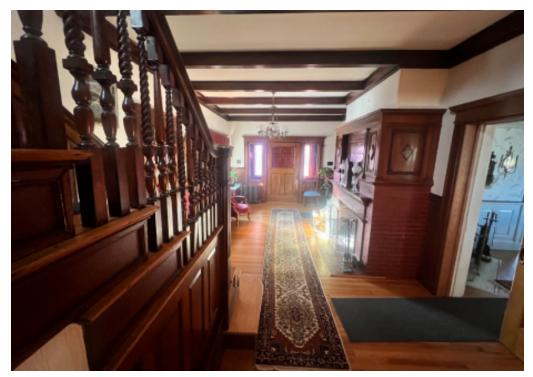
Figure 6. The entrance hall facing south and the front entrance. Photograph taken in 2024.

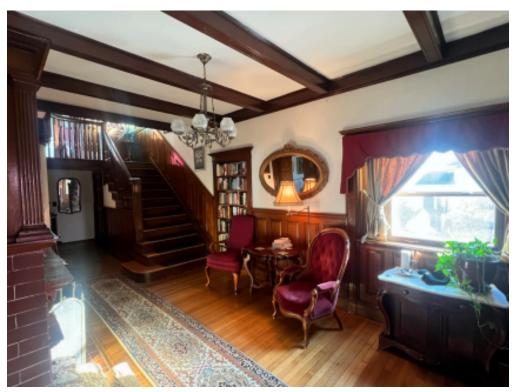
Figure 7. Entrance hall facing northeast. Photograph taken in 2024.

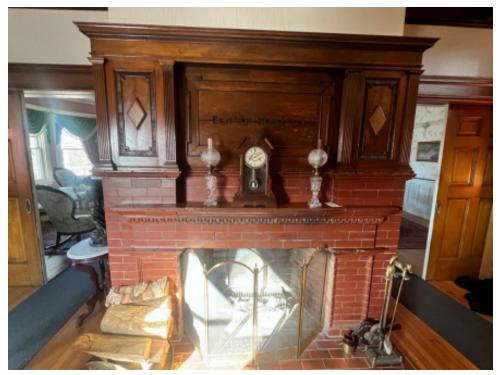
Figure 8. Entrance hall facing west toward main fireplace. Photograph taken in 2024.

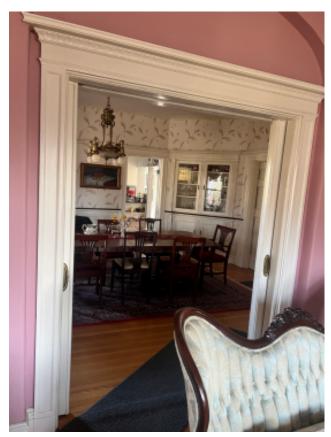
Figure 10. Looking north from parlour into dining room, and kitchen beyond. Photograph taken in 2022.

The music/dining room contains the same original baseboard, window, and pocket door framing, and also has original wood panelling (although now painted) around the border of the room. The original plans for the house indicate that there was once an organ below the extant original stained glass window in the bay on the west side of the room. The wood panelling is missing on the sides of the bay, where original plans indicate 'seats' next to the organ, suggesting that at some point the seats were removed. This bay is divided from the rest of the room by a colonnade – not shown in the original house plans – that is composed of a semi-elliptical arch springing from freestanding columns on either side. The columns sit atop bookcase pedestals with glass doors and musical motifs matching those of the room's fireplace. Likewise, a large built-in cabinet has been expanded from the original plans, and displays the repeated musical motifs. The original fireplace has an original tiled apron, flanking music-themed pillars and decorated mantle, including a mirror with original glass. The hammered metal back and side interior of the fireplace contain motifs matching the built-in cabinet and colonnade. A new door in the north wall replaces an original window, and leads through to the new kitchen and family room addition.

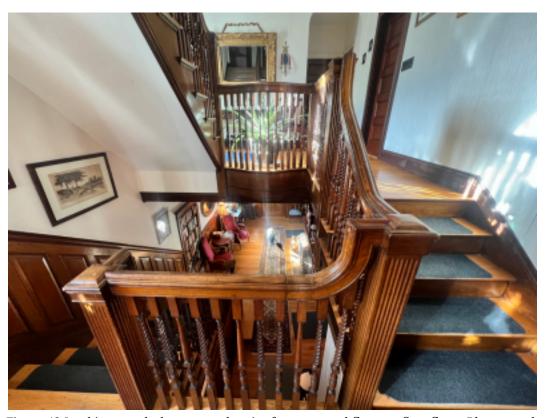
Figure 13.Looking south down grand stairs from second floor to first floor. Photograph taken in 2024.

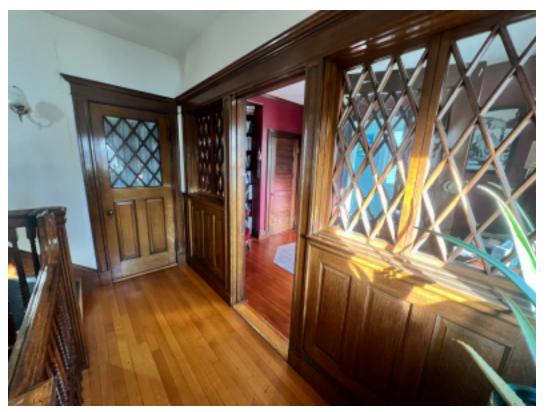
Figure 14. Looking west at sewing room entrance. Photograph taken in 2024.

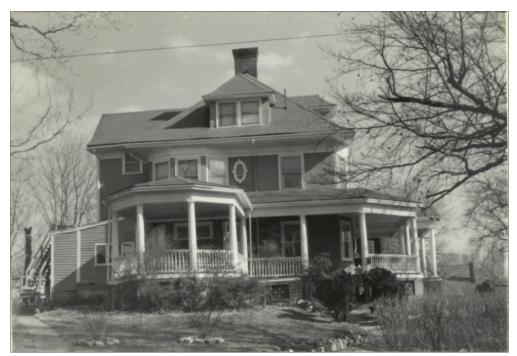
Figure 19. West façade facing Maynard Street. Photograph taken in 1980, from Massachusetts Cultural Resource Information System, 1980 survey of Hyde Park Form No. HP2, area Roslindale

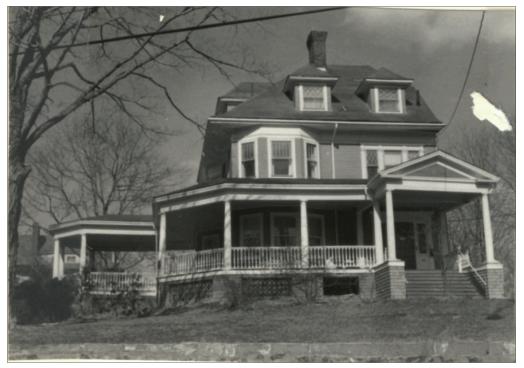
Figure 20. South façade facing Metropolitan Avenue. Photograph taken in 1980, from Massachusetts Cultural Resource Information System, 1980 survey of Hyde Park Form No. HP2, area Roslindale.

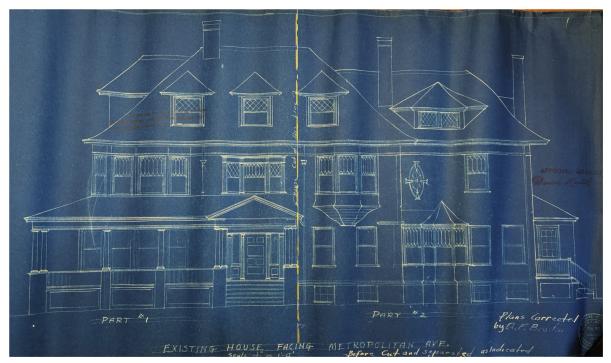
Figure 22. 1943 blueprints showing position of cut on house. City of Boston Archives.
