41 BERKELEY STREET

SOUTH END, BOSTON

41 BERKELEY STREET | SOUTH END LANDMARKS HEARING | 7 FEBRUARY 2023

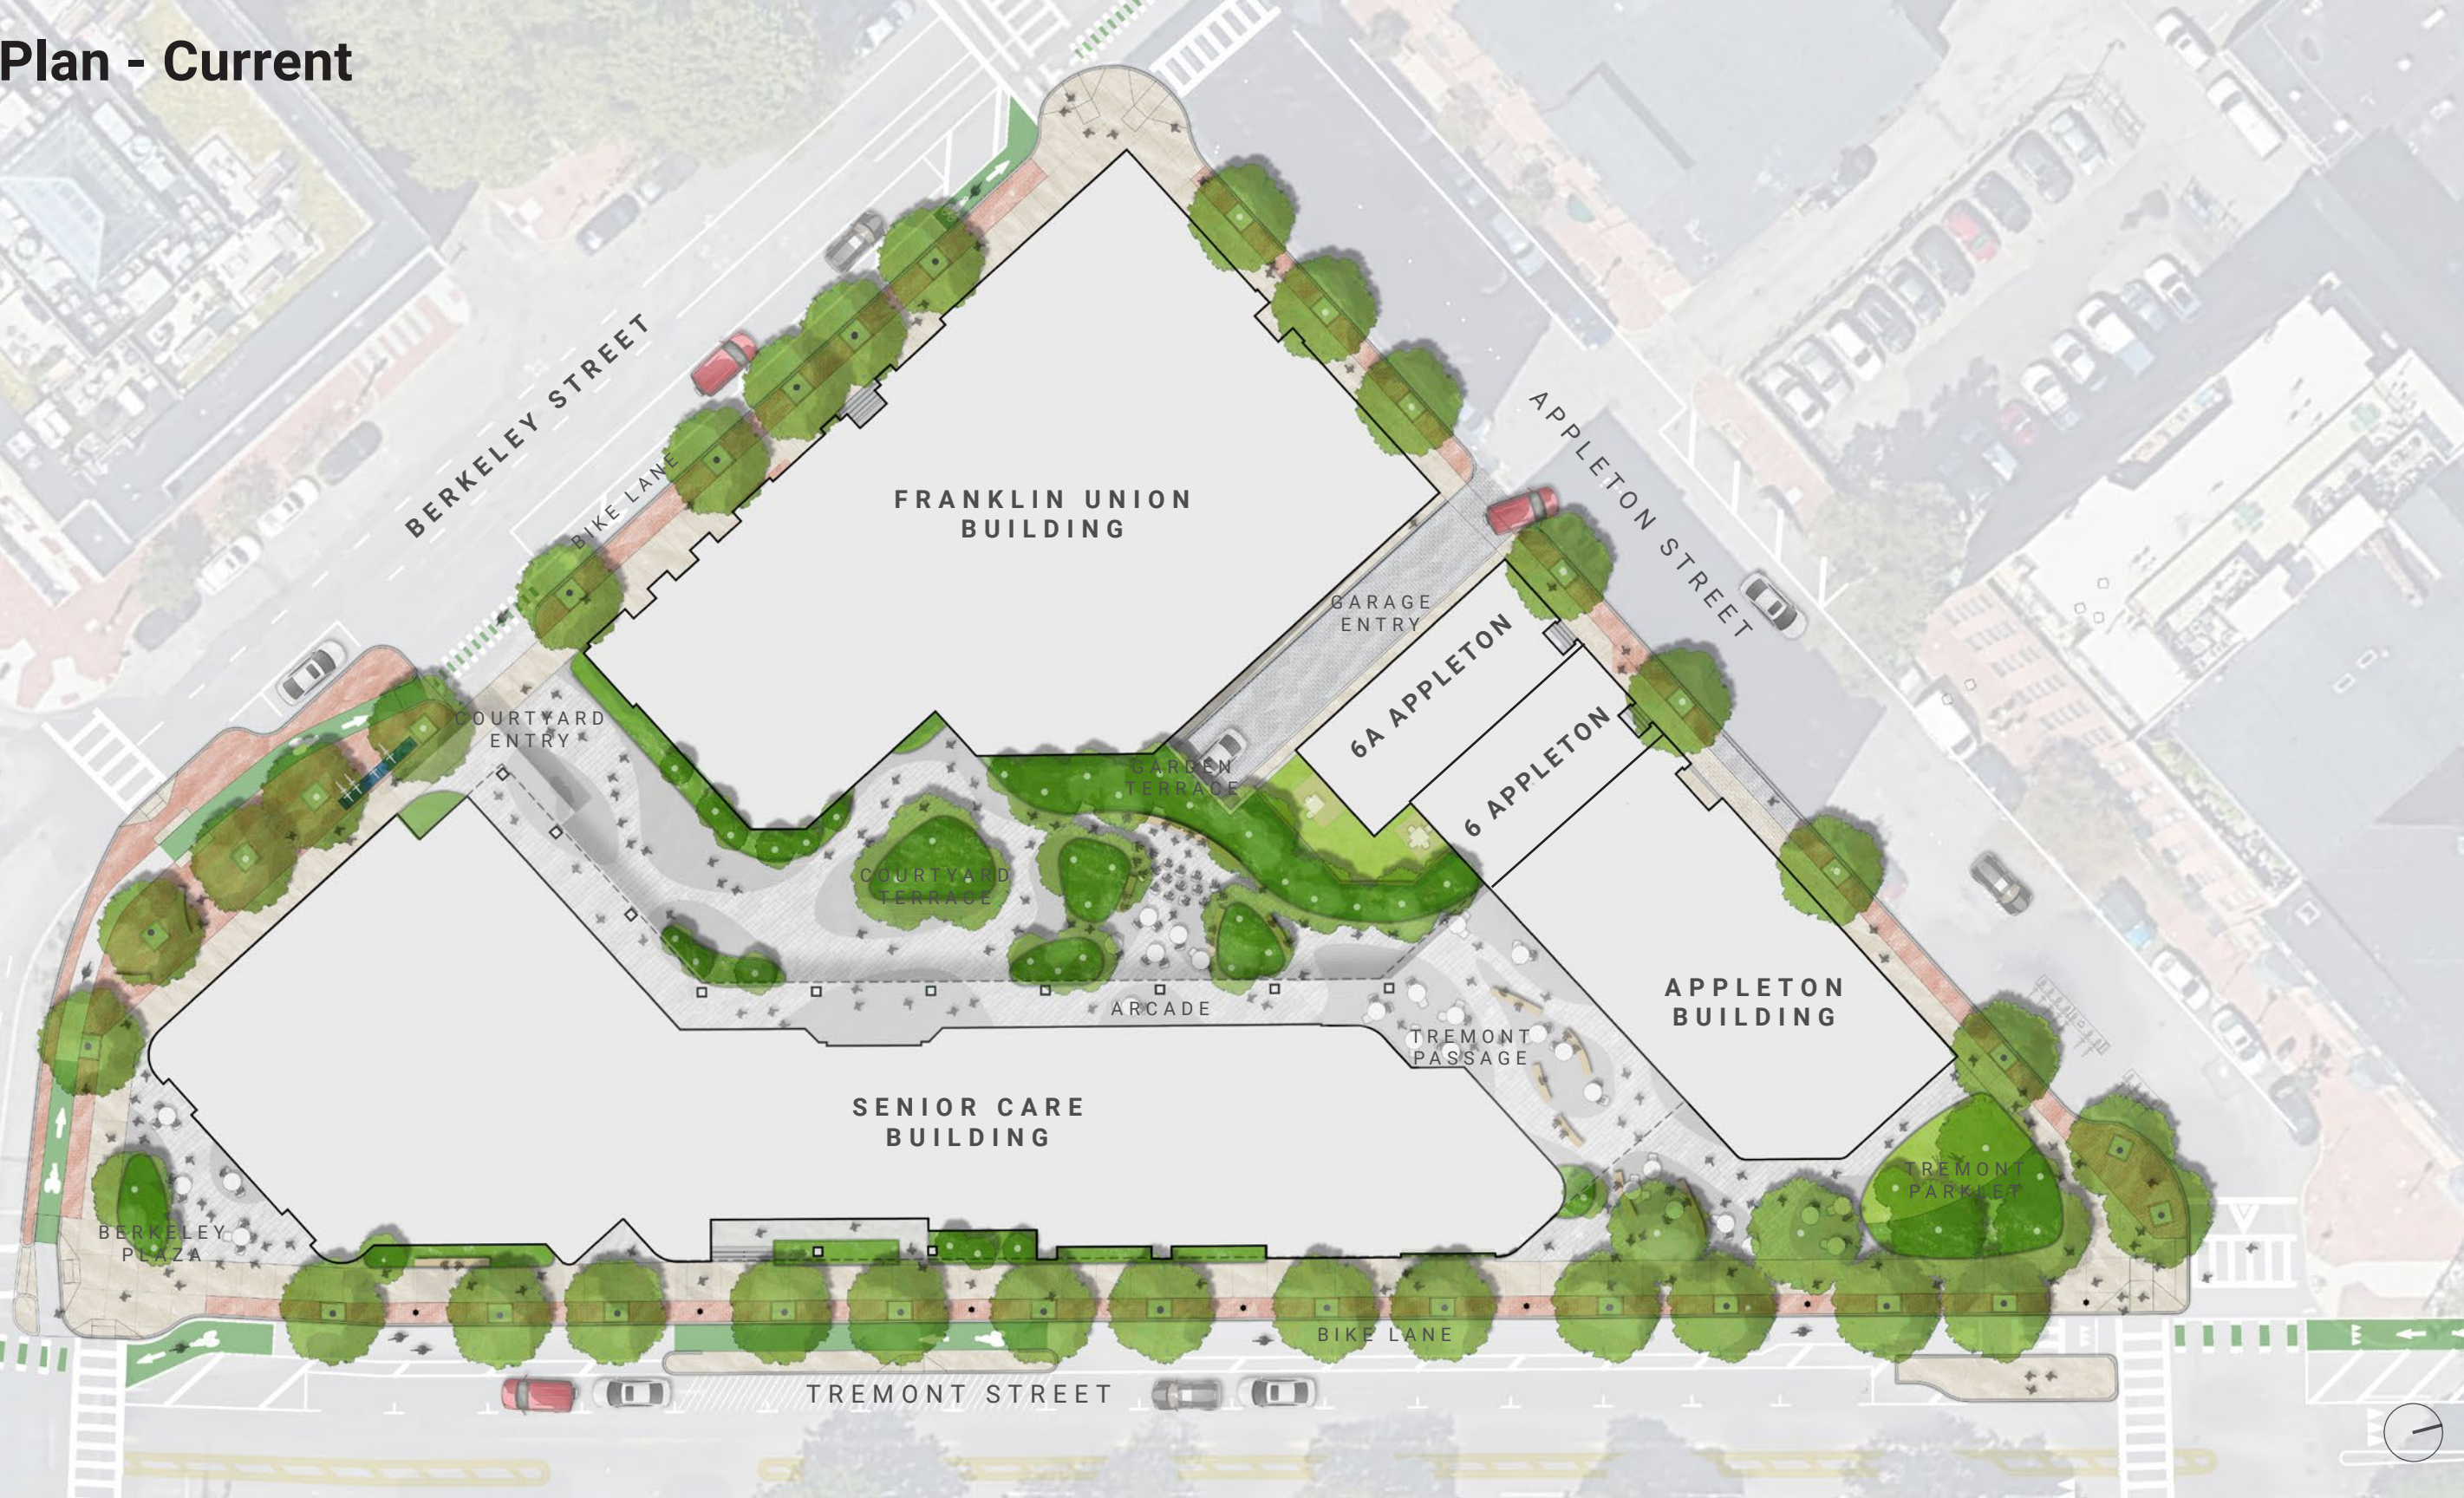
Site Plan - Current

BERKELEY STREET
BIKE LANE

FRANKLIN UNION
BUILDING

APPLETON STREET

SENIOR CARE
BUILDING

BERKELEY
PLAZA

TREMONT STREET

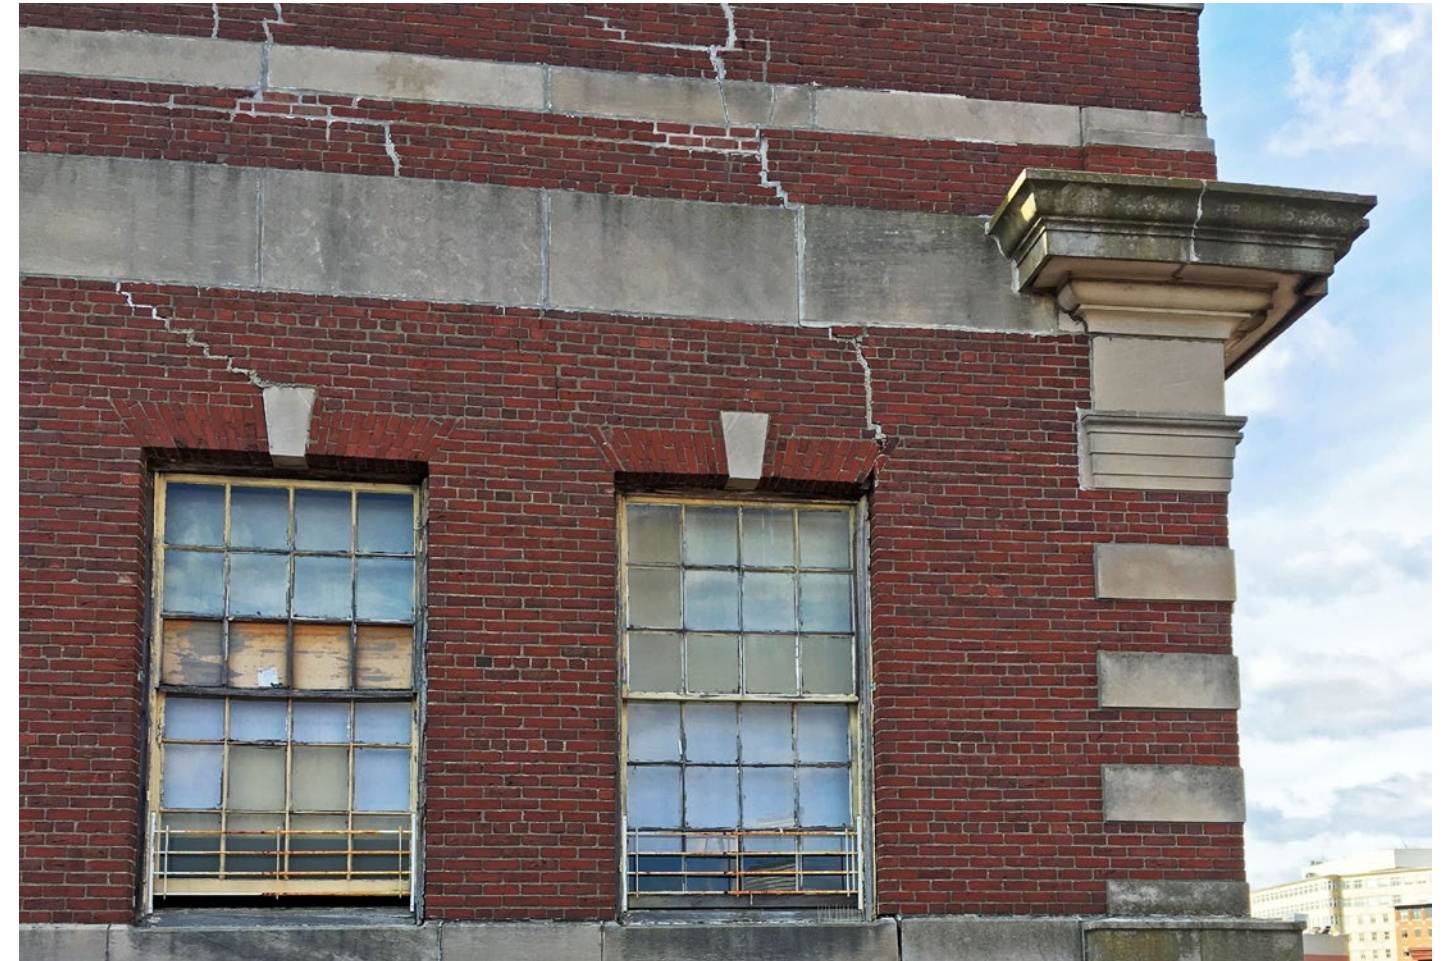
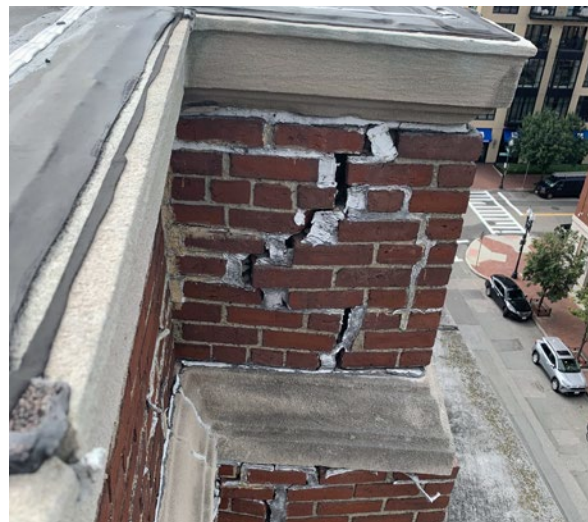
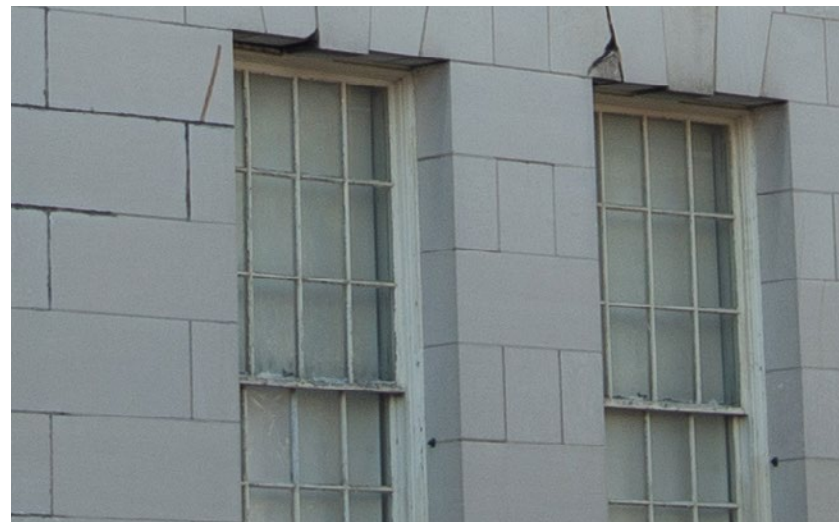
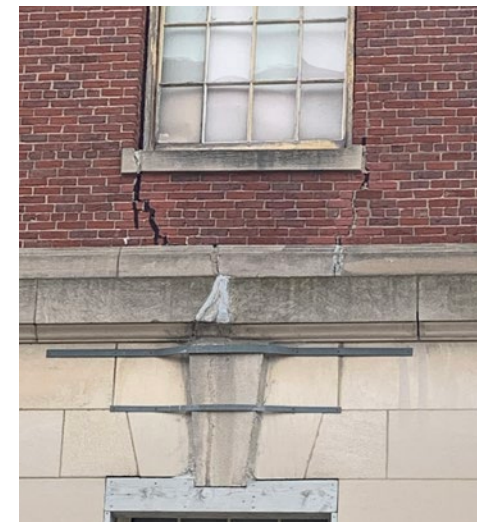
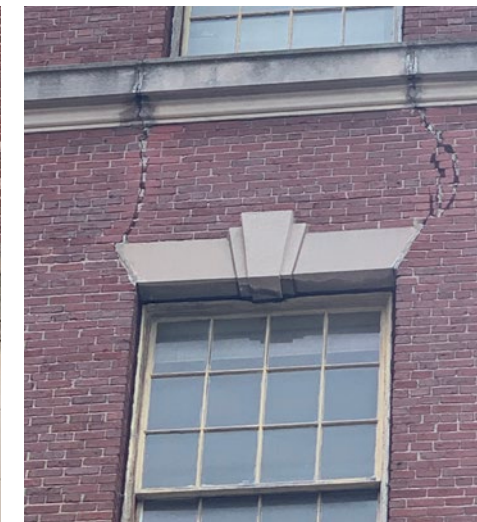
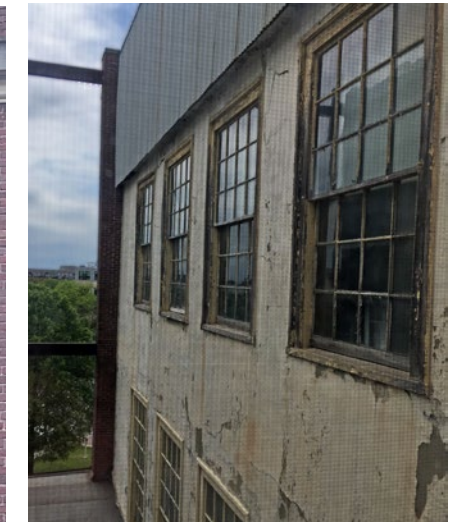
Preservation Challenges - Franklin Union Building

PILES

- Concrete pile caps supported by wood piles.
- Wood piles in average conditions with light soft rotting occurring, cracking at concrete pile caps.
- Supplemental piles and underpinning required to maintain existing loads.

FACADES

- Load-bearing mass masonry supporting interior floors and roof and providing weather resistance.
- Deferred maintenance + deterioration requires full masonry repair, steel corrosion occurring on structural elements from failed weatherproofing.
- Repoint 100% of Brick Façade + 50% of Stone Masonry
- At all masonry repairs, assume the inner wythe will require rebuilding

WINDOWS

- Wood framed with monolithic glazing and paint finish at window exteriors.
- Severely deteriorated, sills, jambs, sashes and perimeter blocking are checked, perimeter sealant joints fail. Replacement recommended.
- All windows are beyond their useful life, need full overhaul or replacement

MEP SYSTEMS

- No life safety sprinkler system.
- Steam heating system, no HVAC or fresh air.

RESTORATION NEEDS

- Roof needs replacement
- Slab underside concrete repairs at roof
- Rebuild spalled brick at all interior basement walls

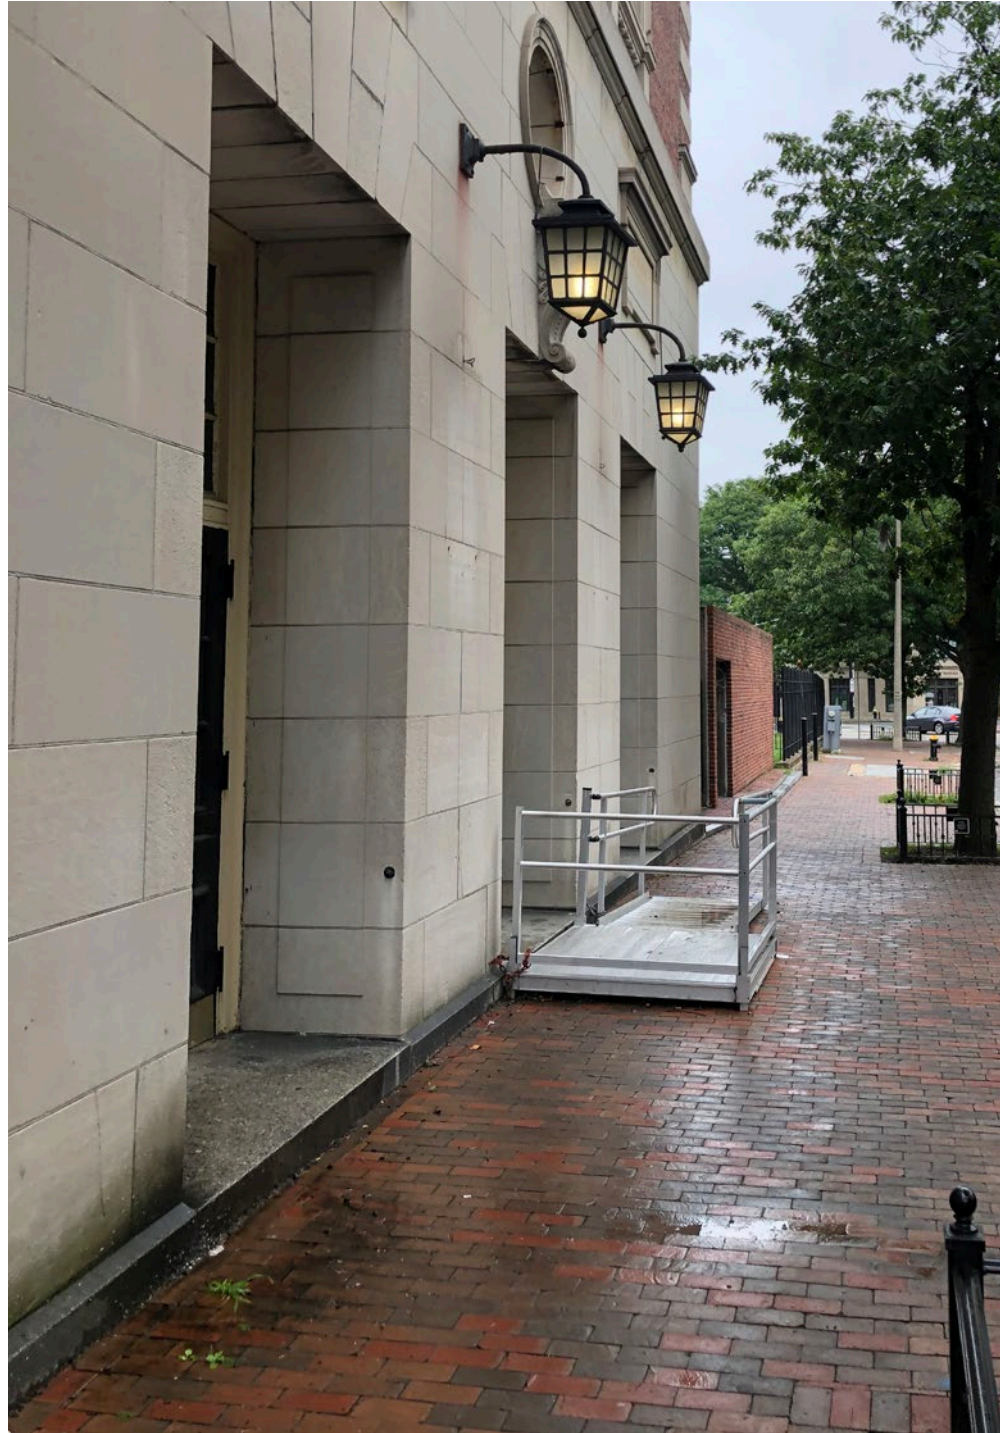
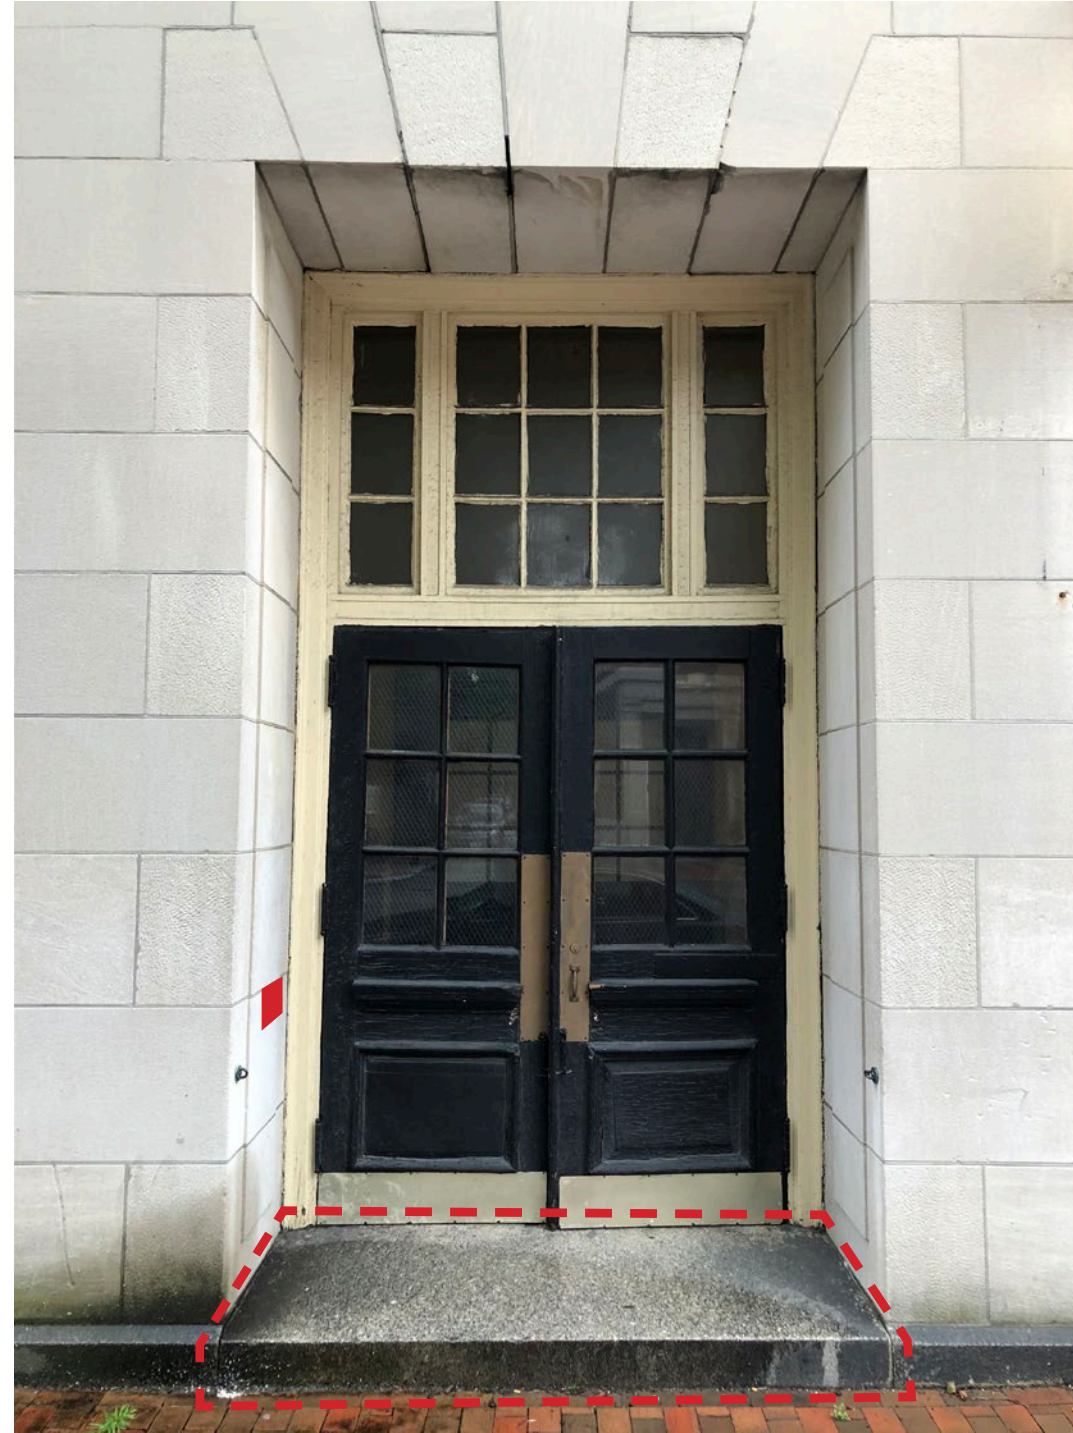
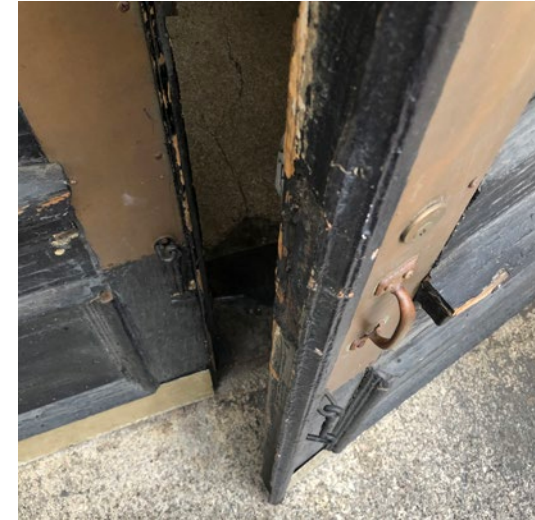
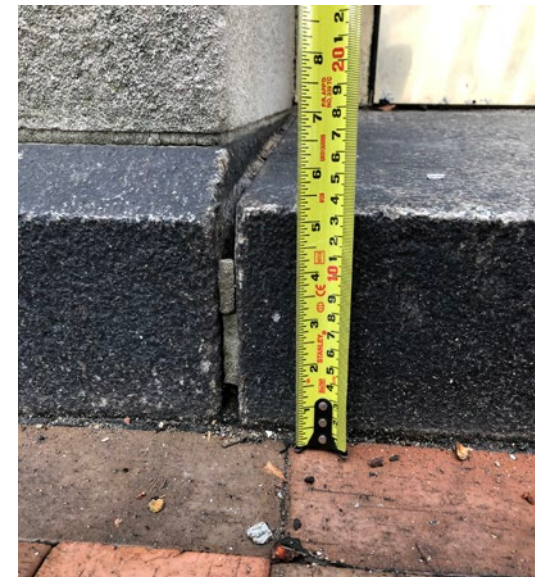
Accessible Entrance - Franklin Union Building

REVISED ENTRIES AND DOORS

- Remove existing granite raised thresholds, reinstall or replace in kind flush with sidewalk
- Replace failing single glazed doors with historic replica doors at revised height.
- Provide ADA door operators, paddles mounted in sidewall adjacent to doors.

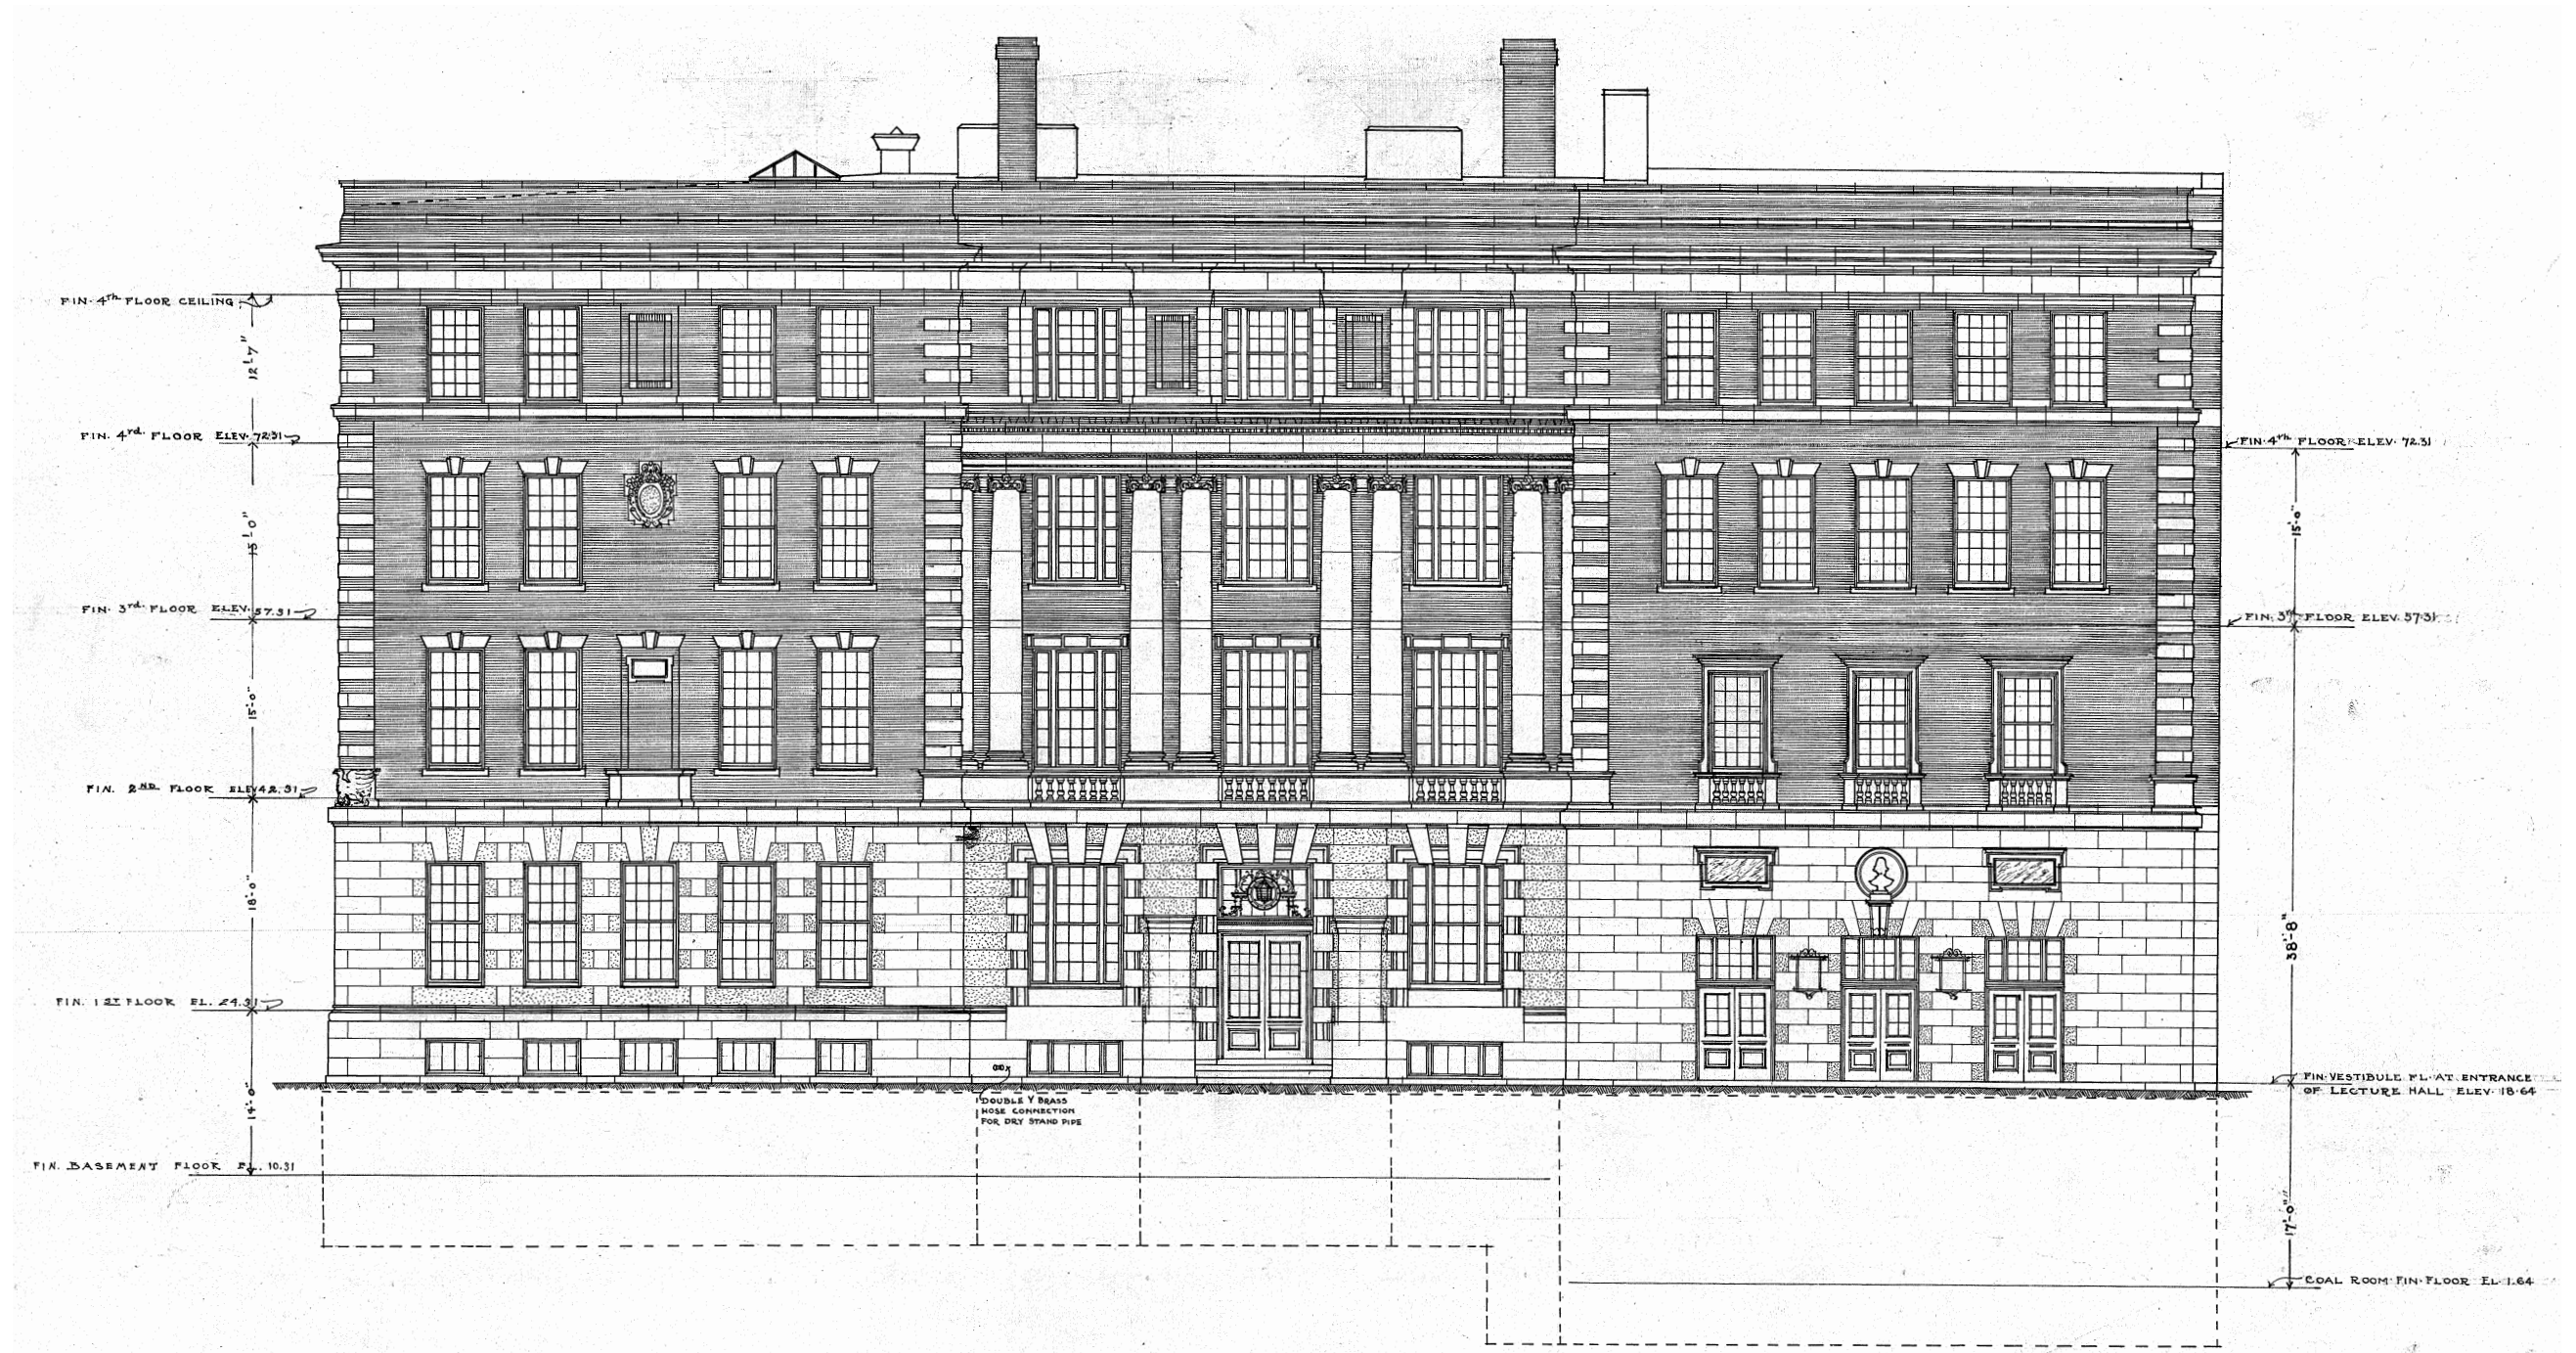
Union Building Berkeley Facade

Existing - Historic Drawing

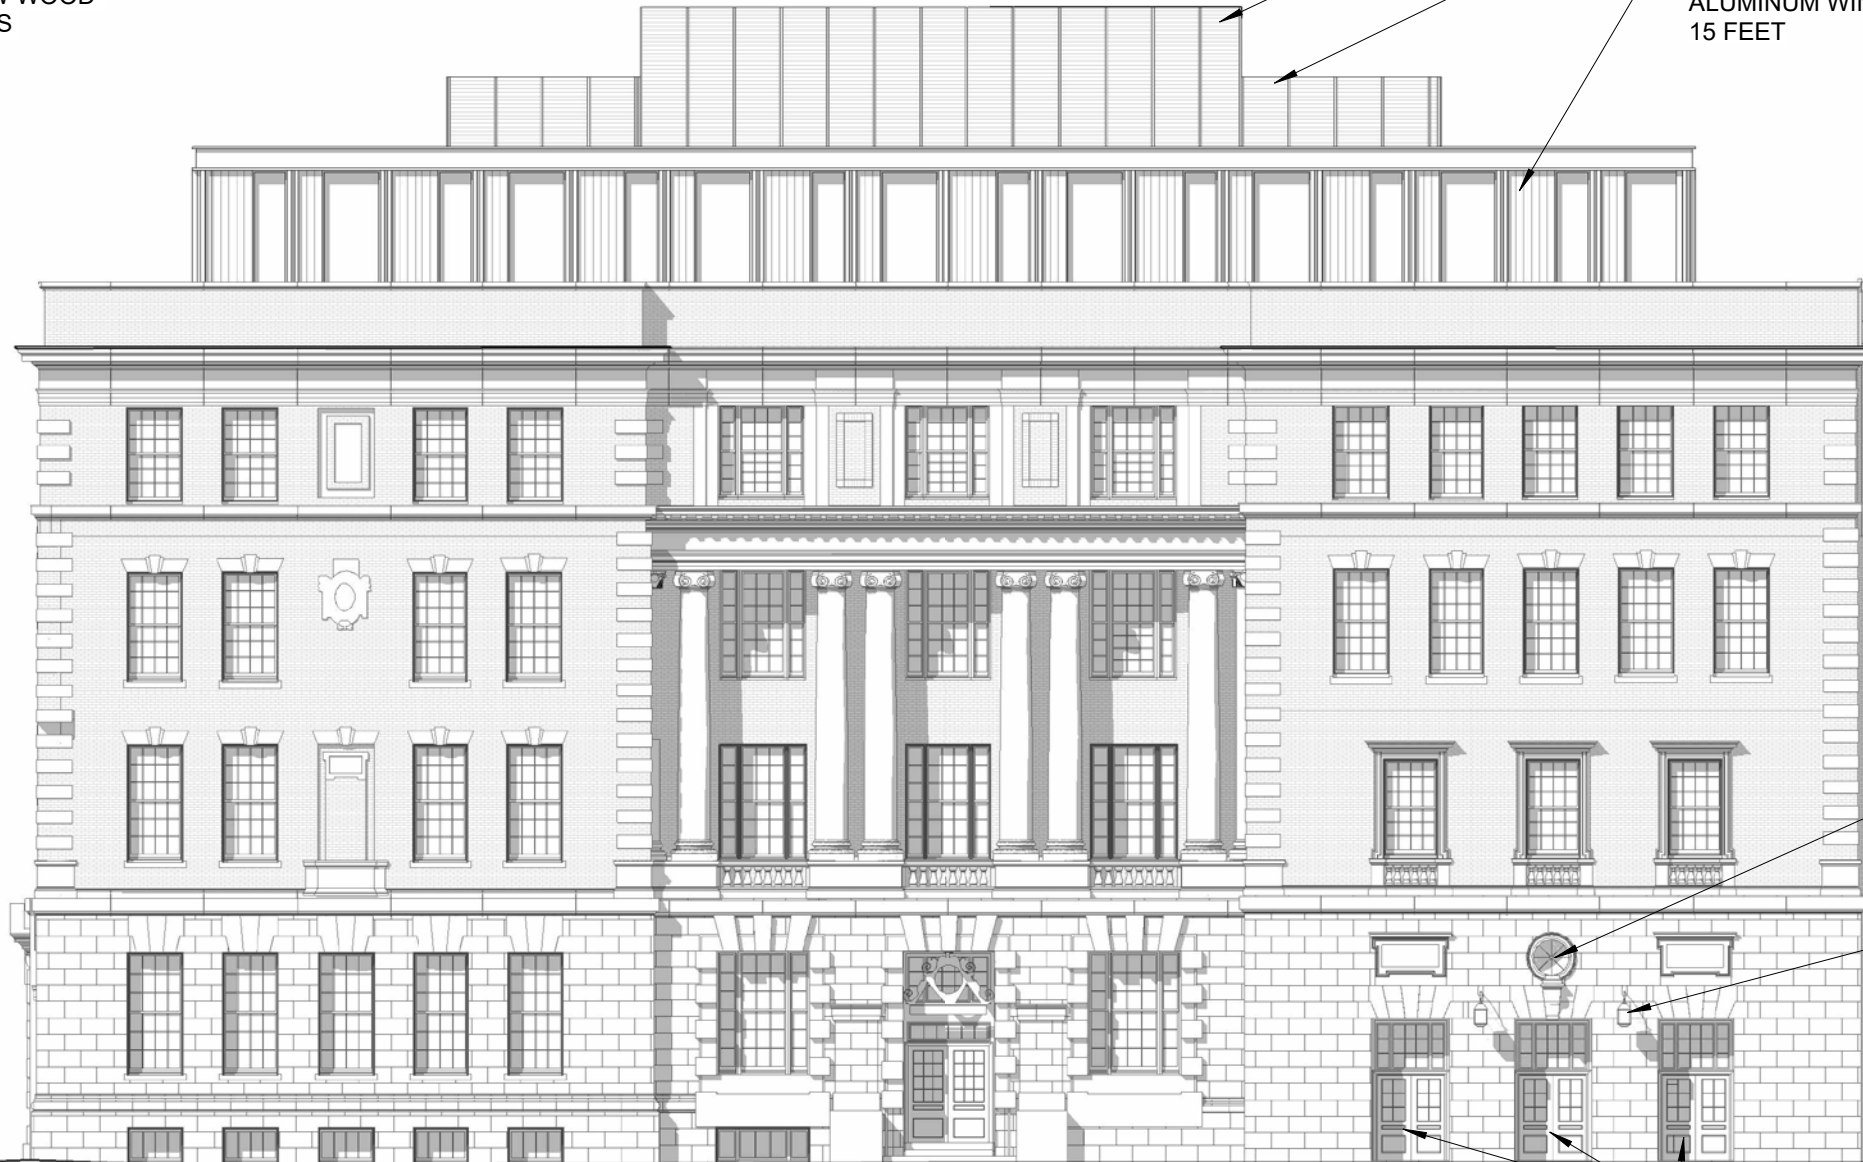
Union Building Berkeley Facade

Proposed

EXISTING FACADE
RESTORATION - BRICK
RECONSTRUCTION AND
REPOINTING. NEW WOOD
INSULATED GLASS
WINDOWS.

12 FOOT HIGH MECHANICAL
SCREEN AT GENERATOR

6 FOOT METAL MECHANICAL
SCREEN, SET BACK 30 FEET

METAL CLAD ADDITION WITH
ALUMINUM WINDOWS, SET BACK
15 FEET

RELIEF FOR BUST
OF FRANKLIN;
FRANKLIN BUST
MISSING

LIGHTS NOT PART
OF HISTORIC
DRAWINGS BUT
PRESENT AT TIME
OF BUILDING
CONSTRUCTION

NEW WOOD ENTRY DOORS TO MATCH
HISTORIC, SILLS DROPPED 4" TO MEET
SIDEWALK

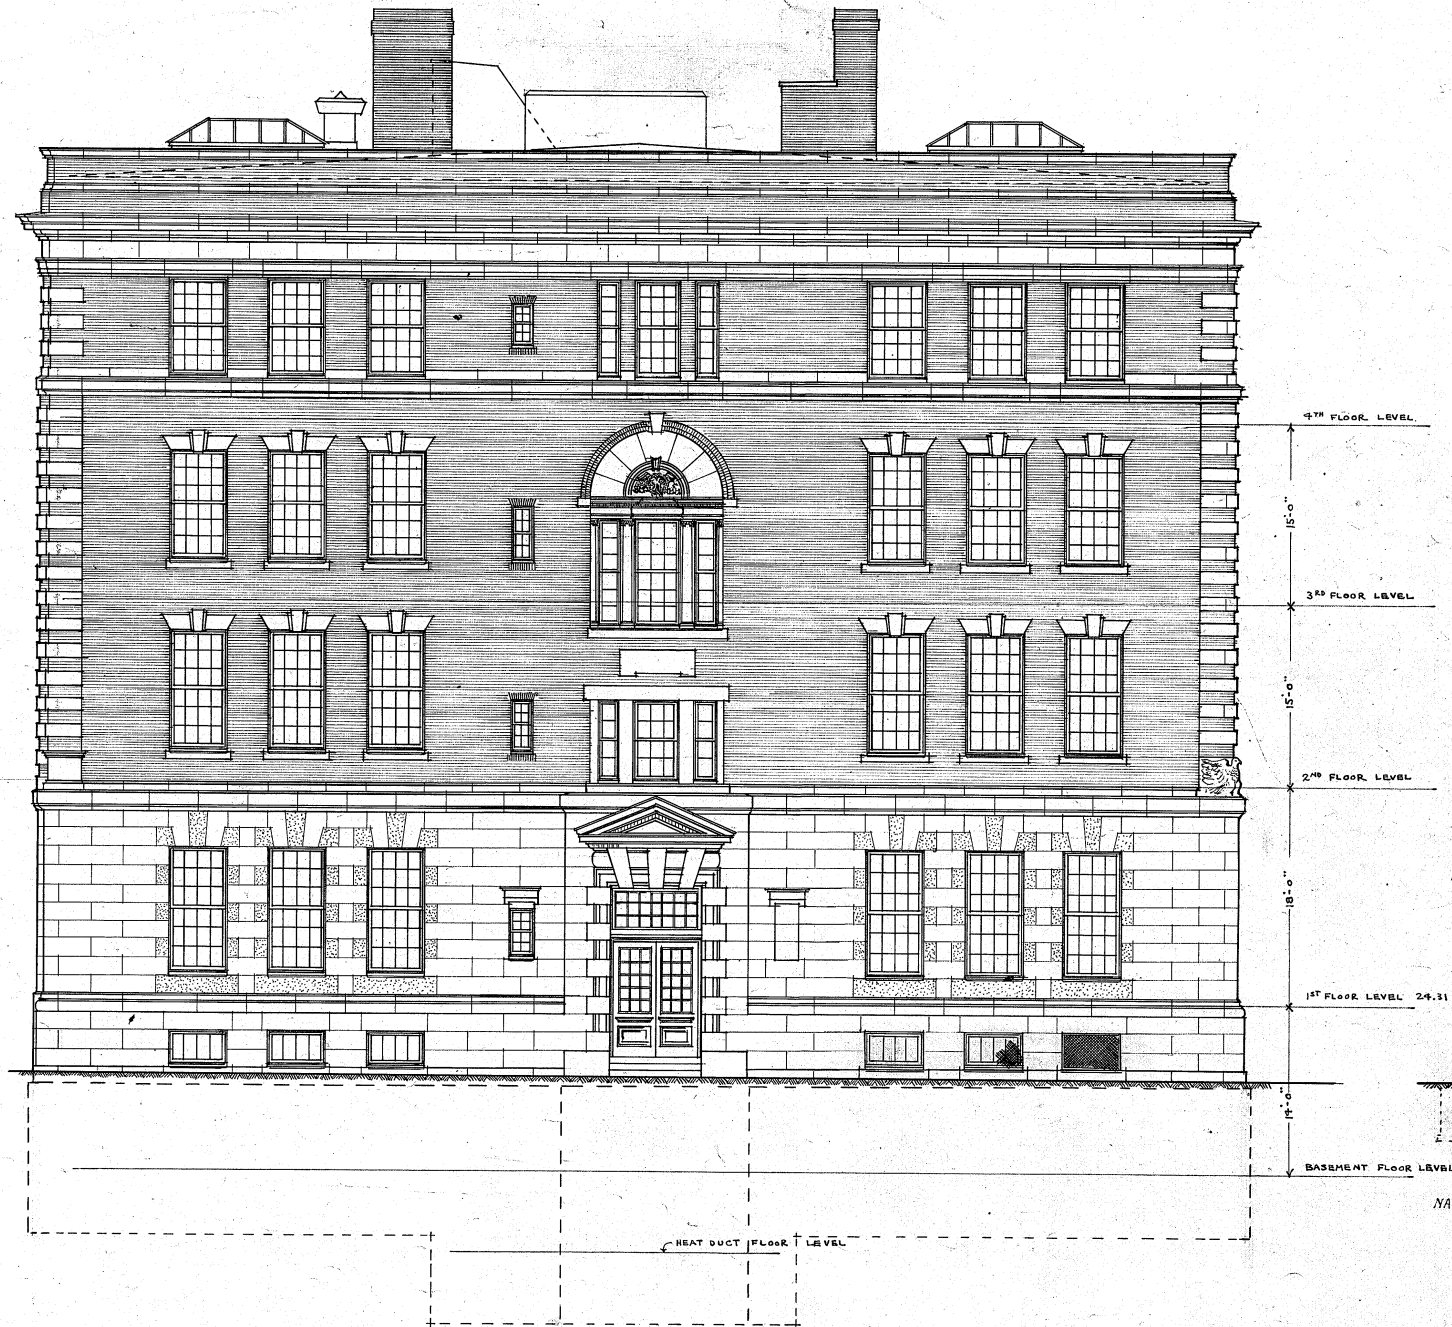
Union Building Appleton Facade

Existing - Historic Drawing

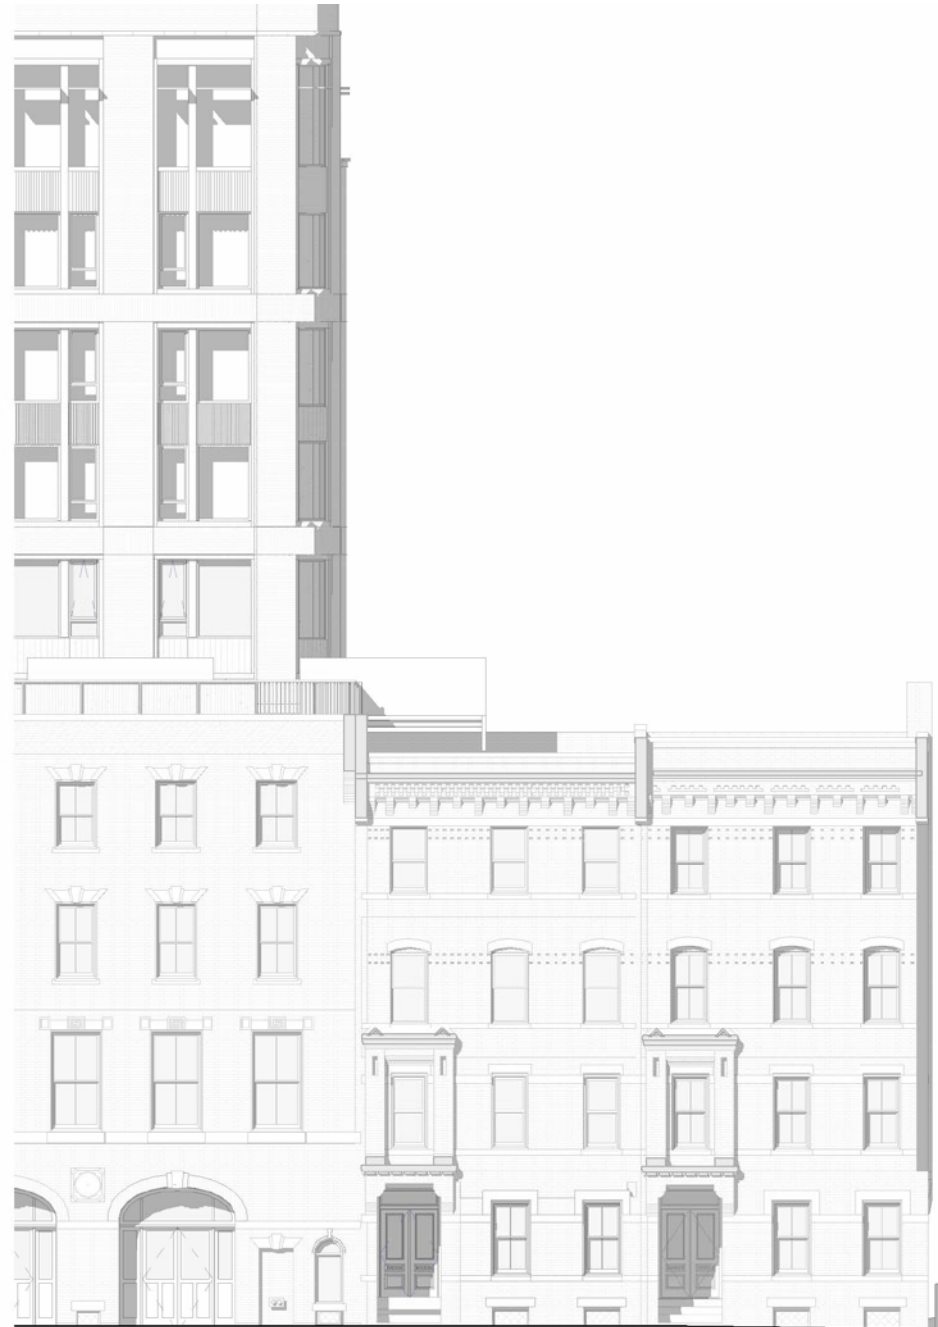
Union Building Appleton Facade

Proposed

EXISTING FACADE
RESTORATION - BRICK
RECONSTRUCTION AND
REPOINTING. NEW WOOD
INSULATED GLASS
WINDOWS.

6' METAL MECHANICAL SCREEN,
SET BACK 30 FEET

METAL CLAD ADDITION WITH
ALUMINUM WINDOWS, SET BACK
15 FEET

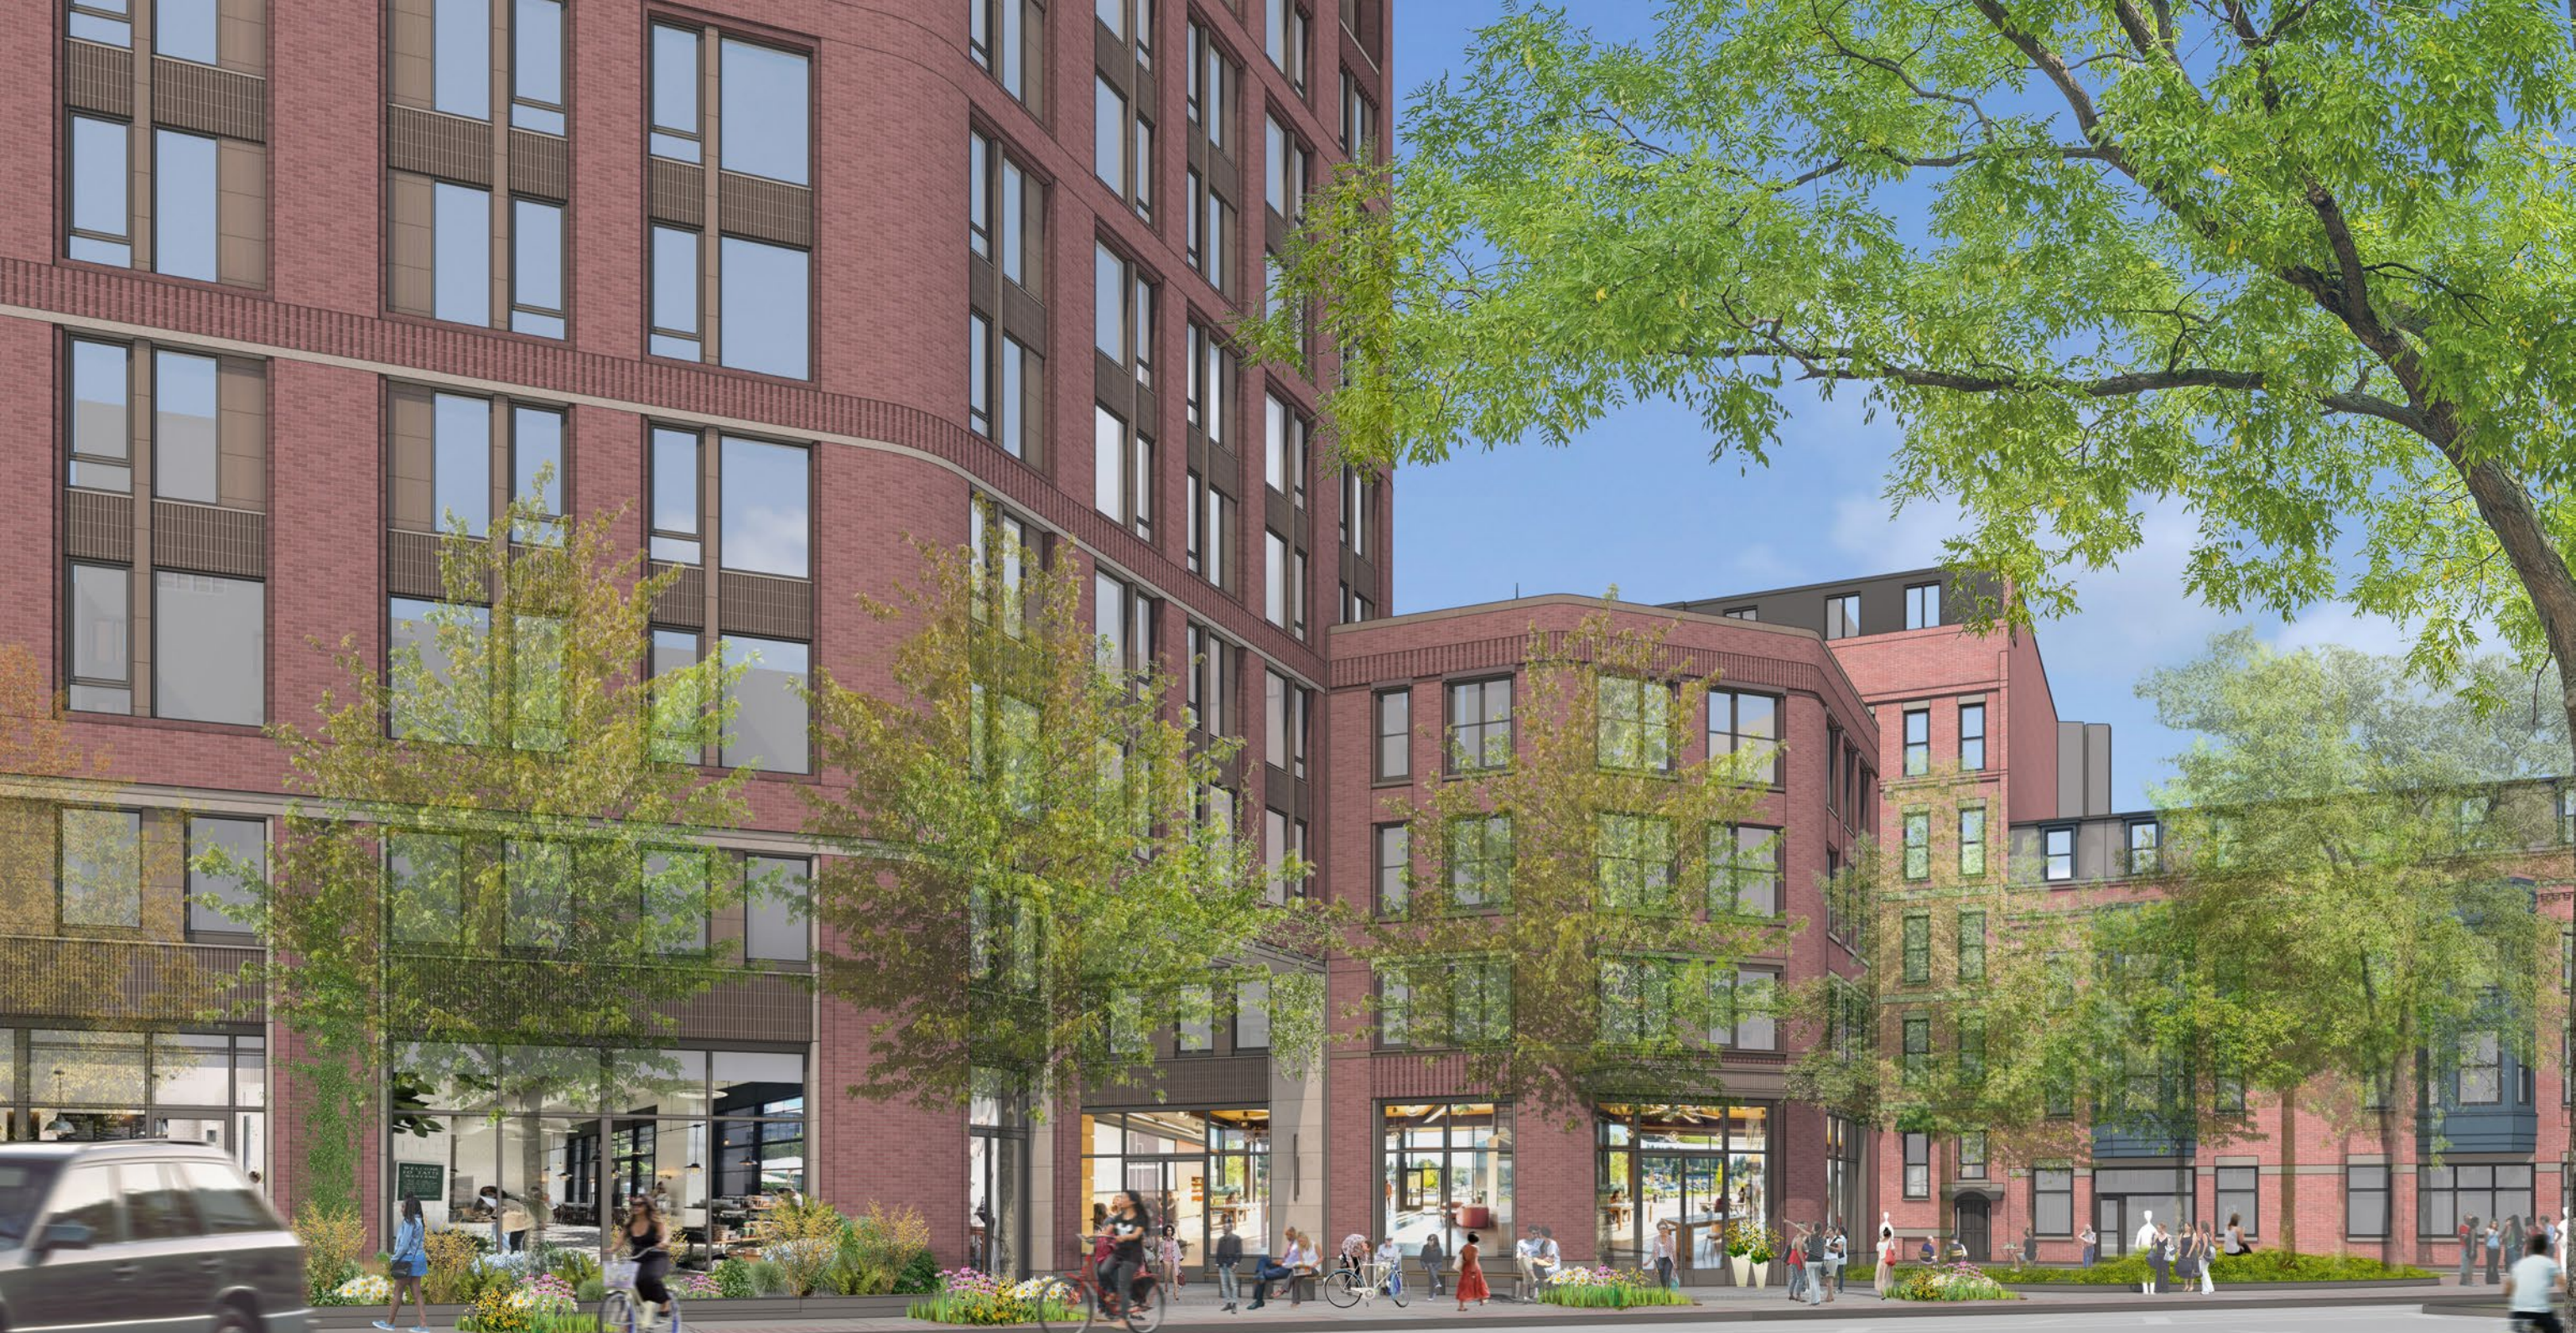
Appleton Corner at Tremont

TREMONT PLAZA - CURRENT DESIGN

PROVIDE PEDESTRIAN ACCESS ACROSS THE TREMONT - APPLETON CORNER

PEDESTRIAN ACCESS BETWEEN PARK AND BUILDING

COVERED OUTDOOR ACTIVITY SPACE

CONSIDER OTHER PLANTING BESIDES LAWN

NEW PARKLET WITH USABLE LAWN AND SHADE TREES

ACTIVATED COURTYARD PUBLIC SPACE

SIDEWALK BUILDING SETBACK WITH PLANTING

SENIOR CARE BUILDING (FIRST FLOOR RETAIL)
