41 BERKELEY STREET

SOUTH END, BOSTON

41 BERKELEY STREET | SOUTH END LANDMARKS HEARING | 7 FEBRUARY 2023

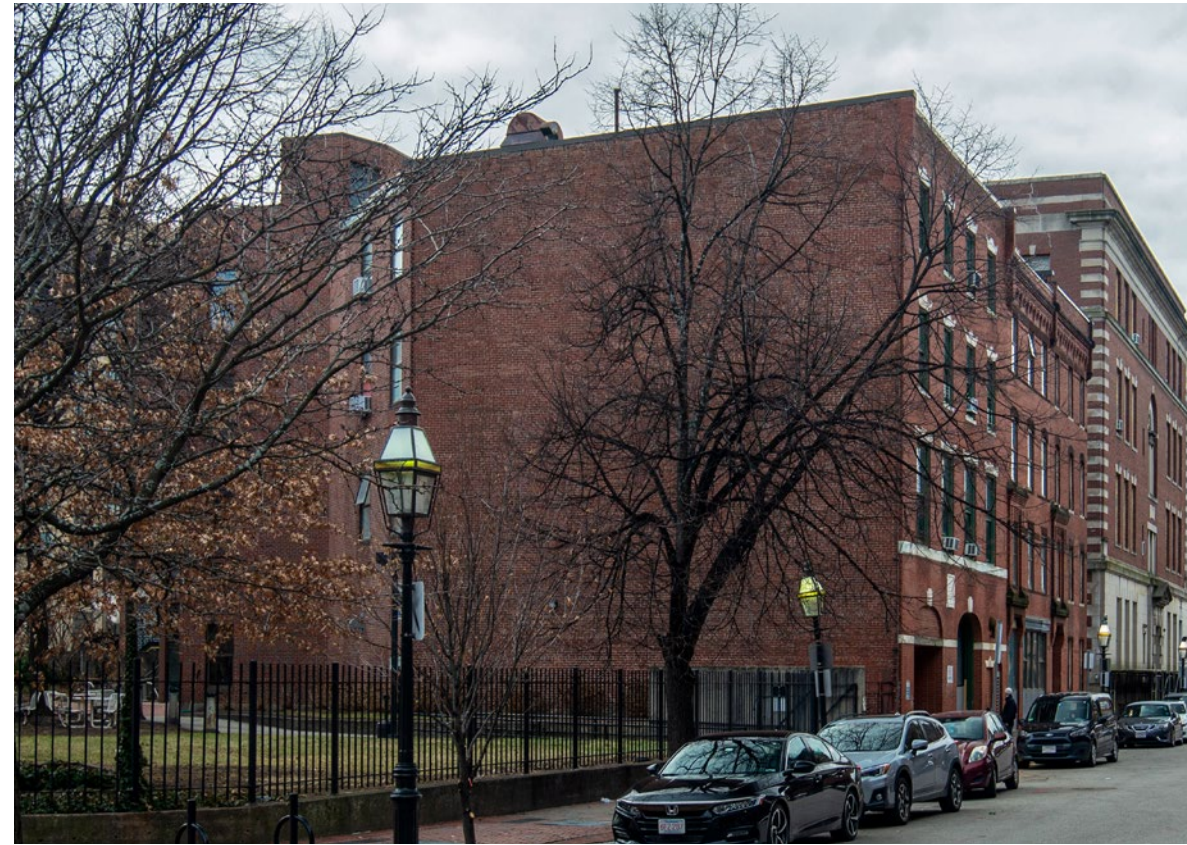
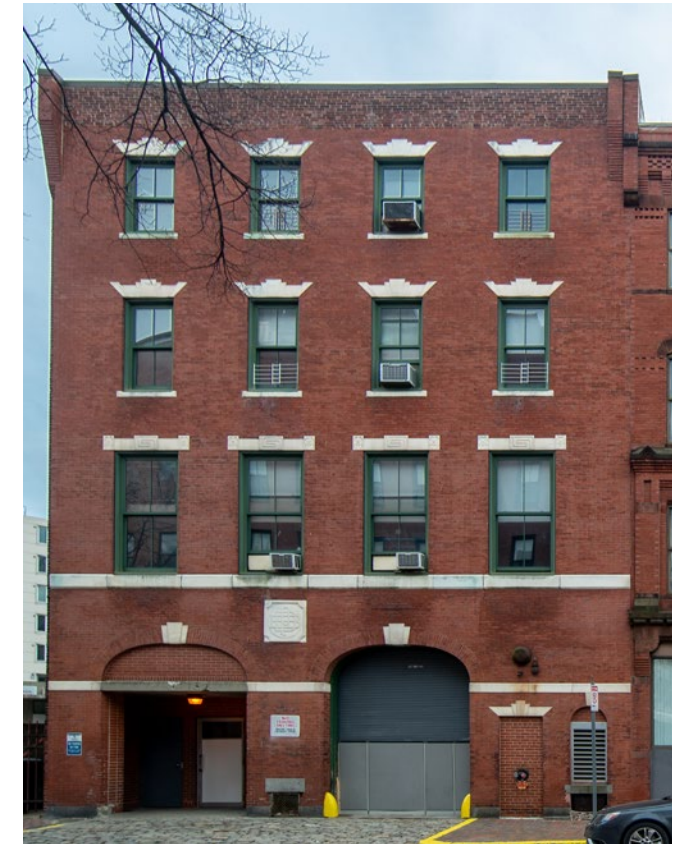
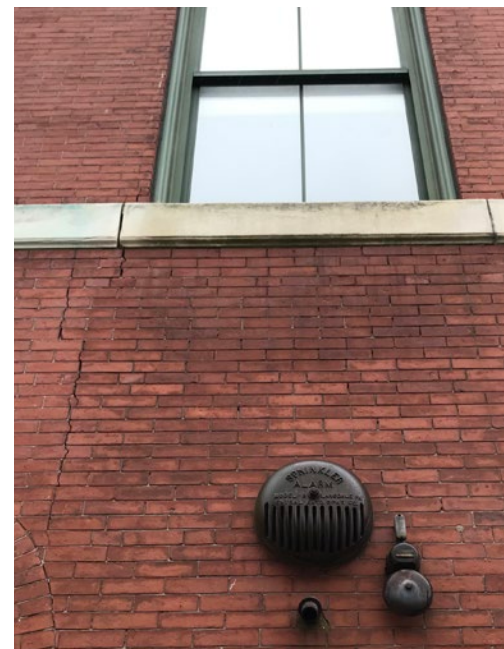
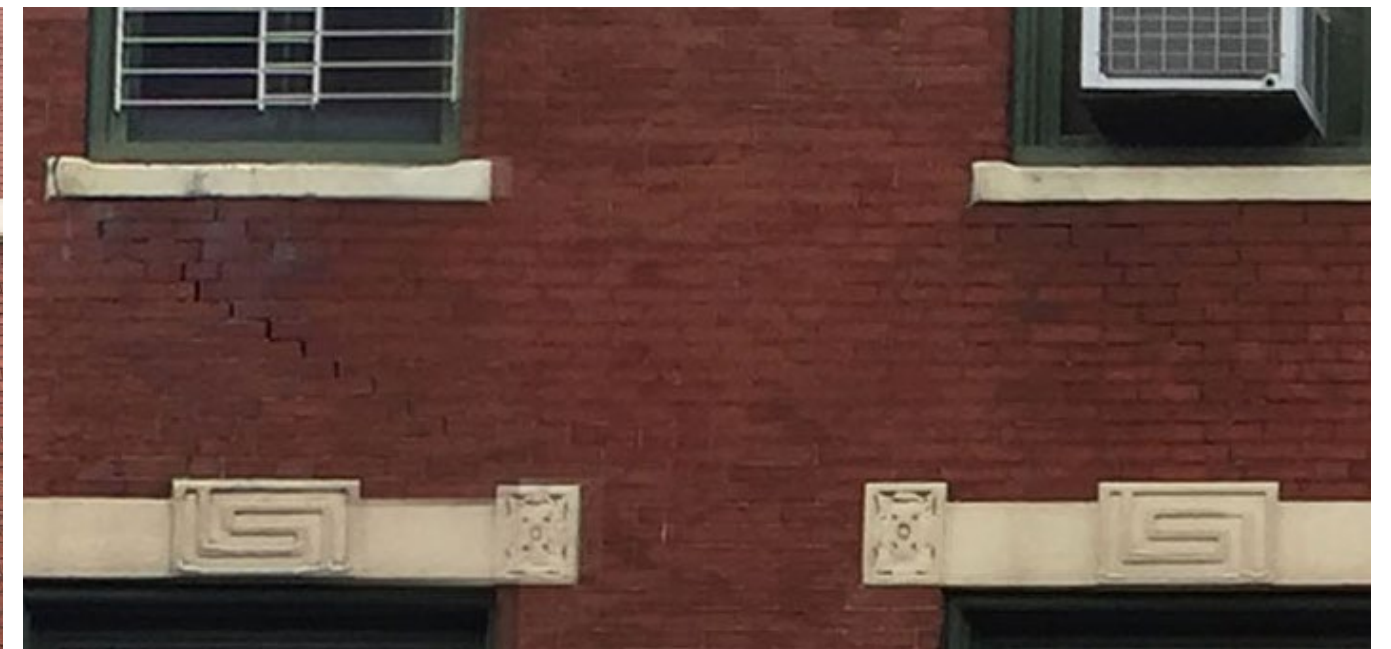
Preservation Challenges - 4 Appleton

- Load-bearing mass masonry
- Repoint 100% of brick facade + 50% of stone masonry
- Front facade window surrounds and arch expression remain, cornice is lost; no historic record found.
- Concrete fire stair infill at left arch with new infill brick
- Cracking due to settlement; may require localized reconstruction.
- Existing windows are metal replacements. To be replaced with wood windows, insulated glazing, true divided lights.
- Left side elevation is a blank party wall.
- Rear facade includes 1980's stair tower addition.
- Granite base repairs at sidewalk

- Interior existing wood structure has been significantly altered and does not meet fire resistance standards required by new Type 1 high-rise building.

- Stone pile caps supported by wood piles.
- Existing wood piles deteriorated, cracking visible on facade. Underpinning and resupport of facade is required.
- Basement and foundations of new senior care building require excavation of entire building footprint.

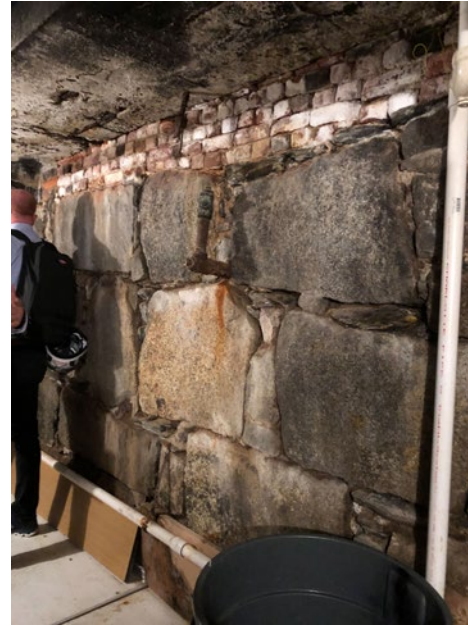
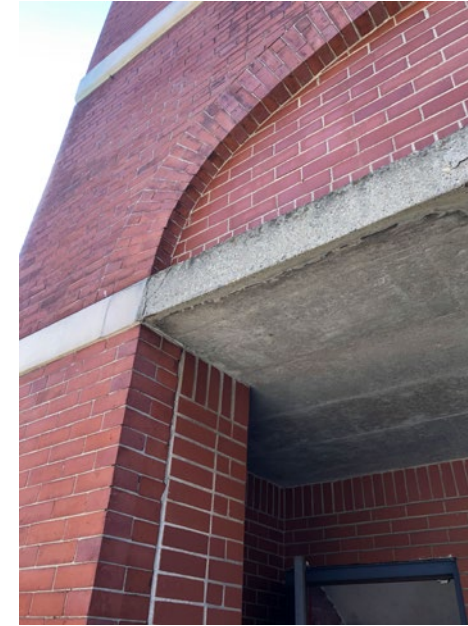
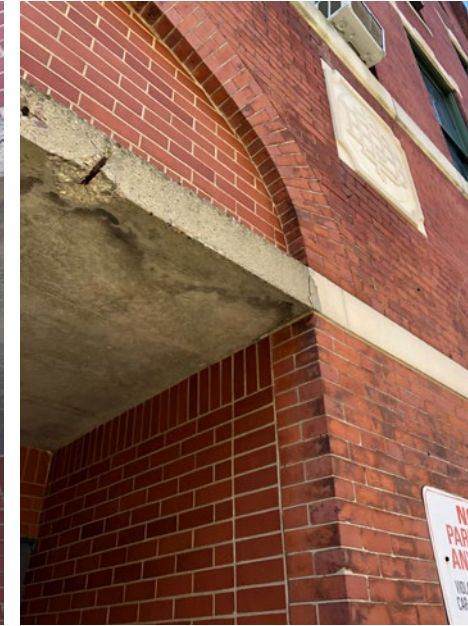
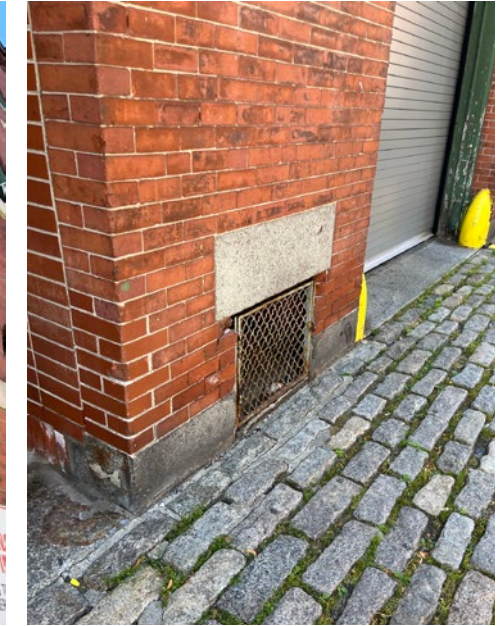
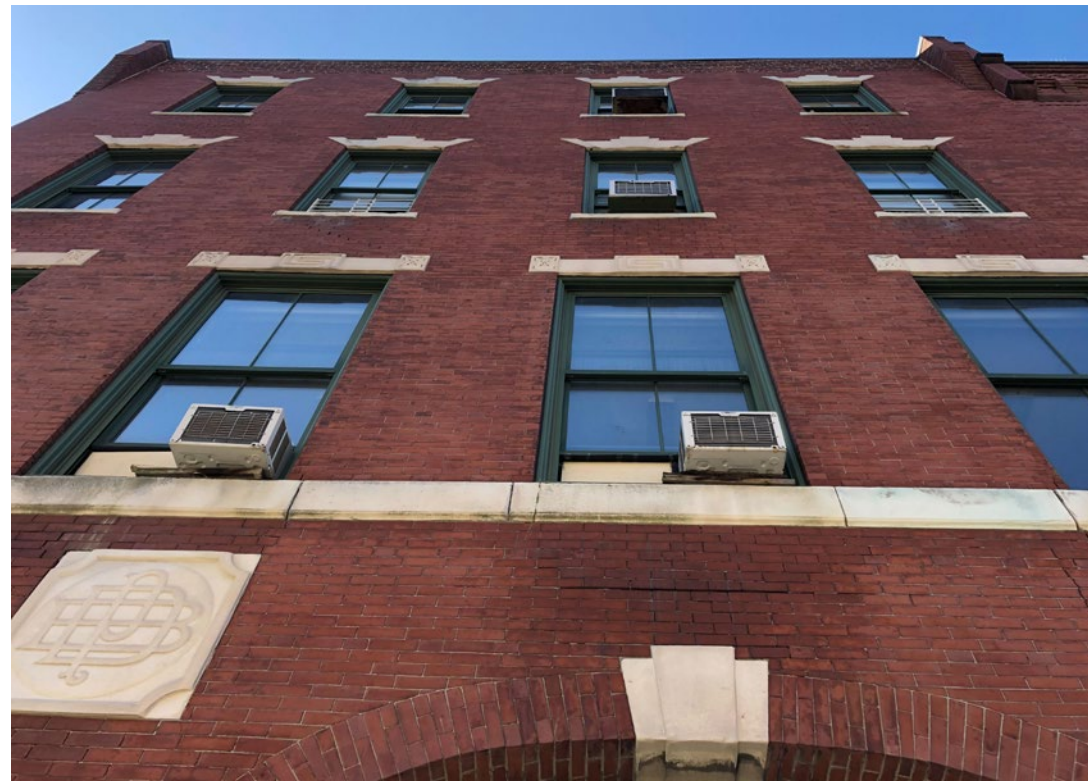
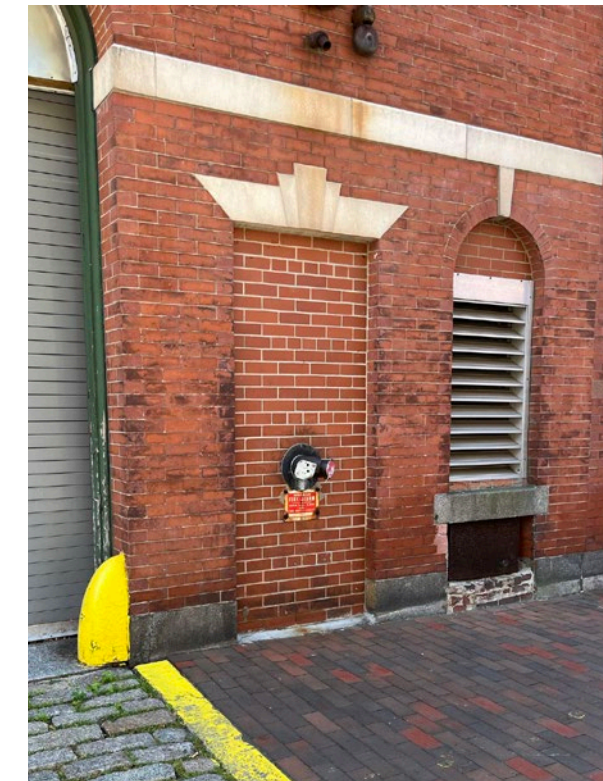
Preservation Challenges - 4 Appleton

- Load-bearing mass masonry
- Repoint 100% of brick facade + 50% of stone masonry
- Front facade window surrounds and arch expression remain, cornice is lost; no historic record found.
- Concrete fire stair infill at left arch with new infill brick
- Cracking due to settlement; may require localized reconstruction.
- Existing windows are metal replacements. To be replaced with wood windows, insulated glazing, true divided lights.
- Left side elevation is a blank party wall.
- Rear facade includes 1980's stair tower addition.
- Granite base repairs at sidewalk

- Interior existing wood structure has been significantly altered and does not meet fire resistance standards required by new Type 1 high-rise building.

- Stone pile caps supported by wood piles.
- Existing wood piles deteriorated, cracking visible on facade. Underpinning and resupport of facade is required.
- Basement and foundations of new senior care building require excavation of entire building footprint.

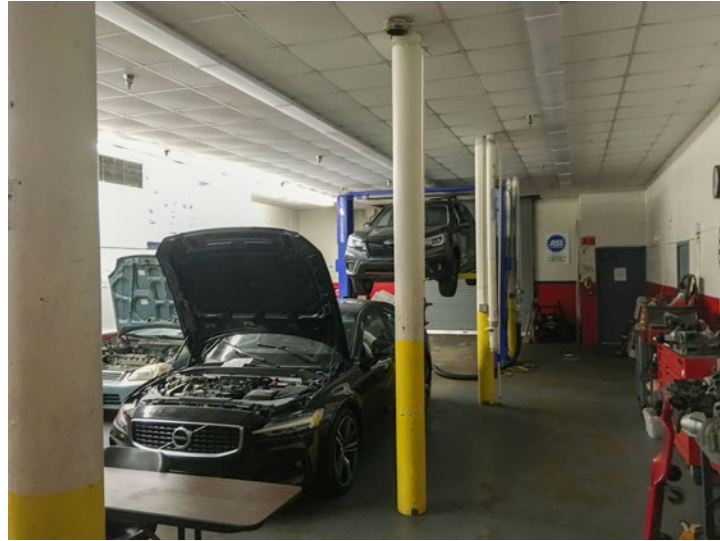
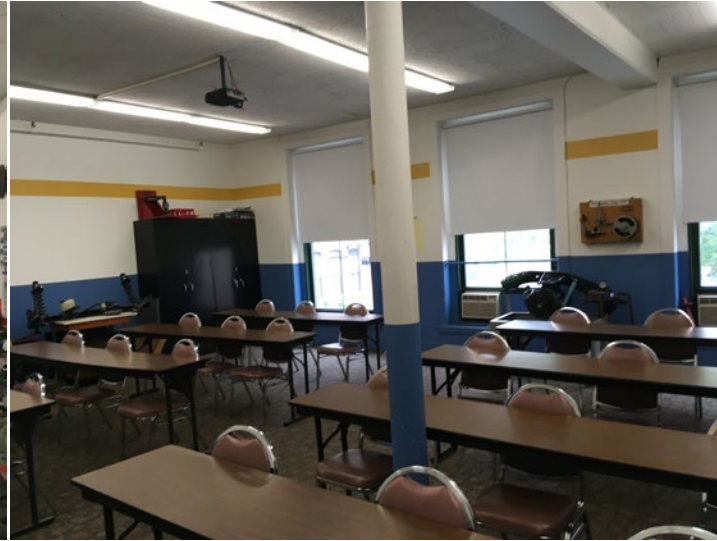
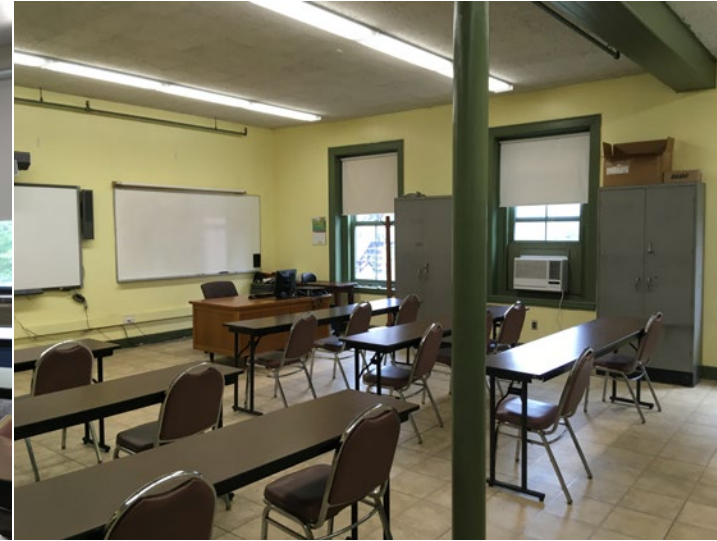
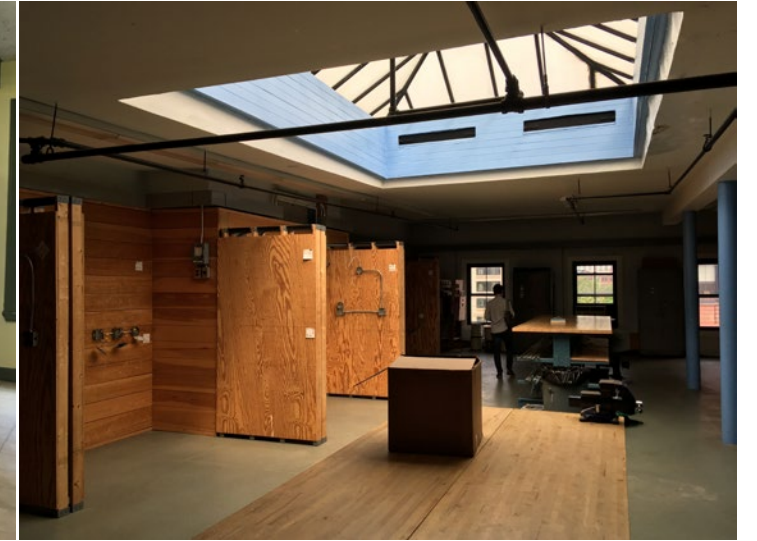
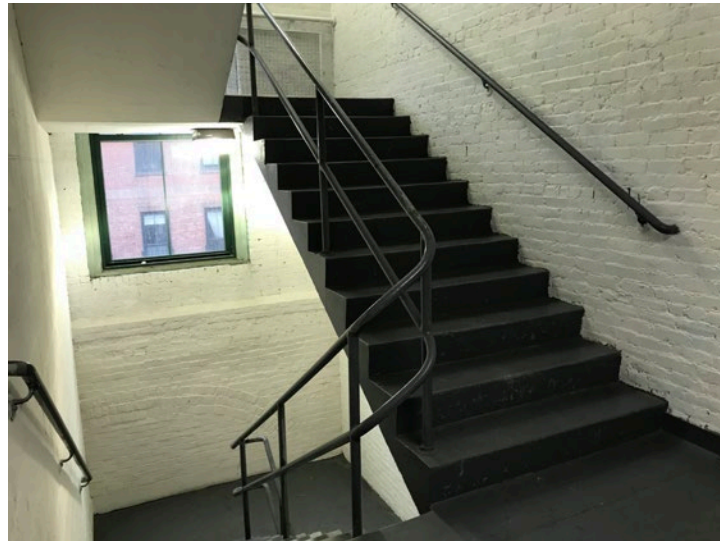
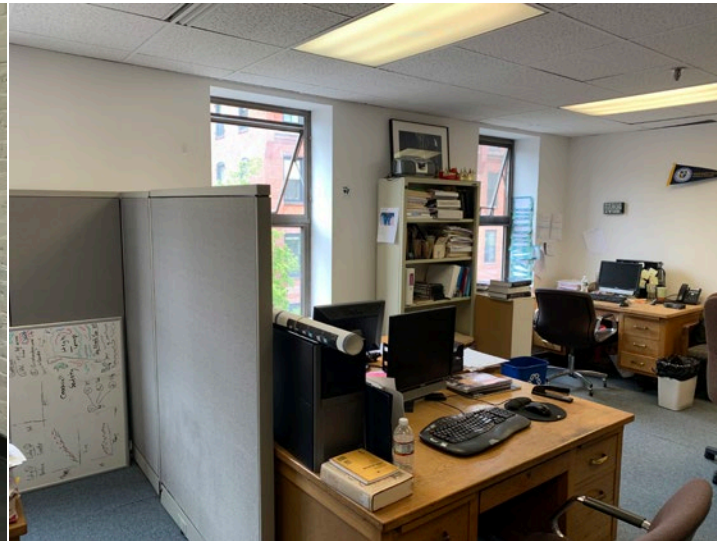
4 Appleton Existing Interiors

- Partial interior structure remains - wood floors, center beam and columns
- Almost no original interior finishes remain - some beam wraps, window trim on level 3

- Fire stair interrupts facade integrity but structurally supports a front section of floor - all requires infill and restructuring to restore facade
- Rear facade was removed when connected to 1980's addition; removal of this addition requires resupporting the building structure

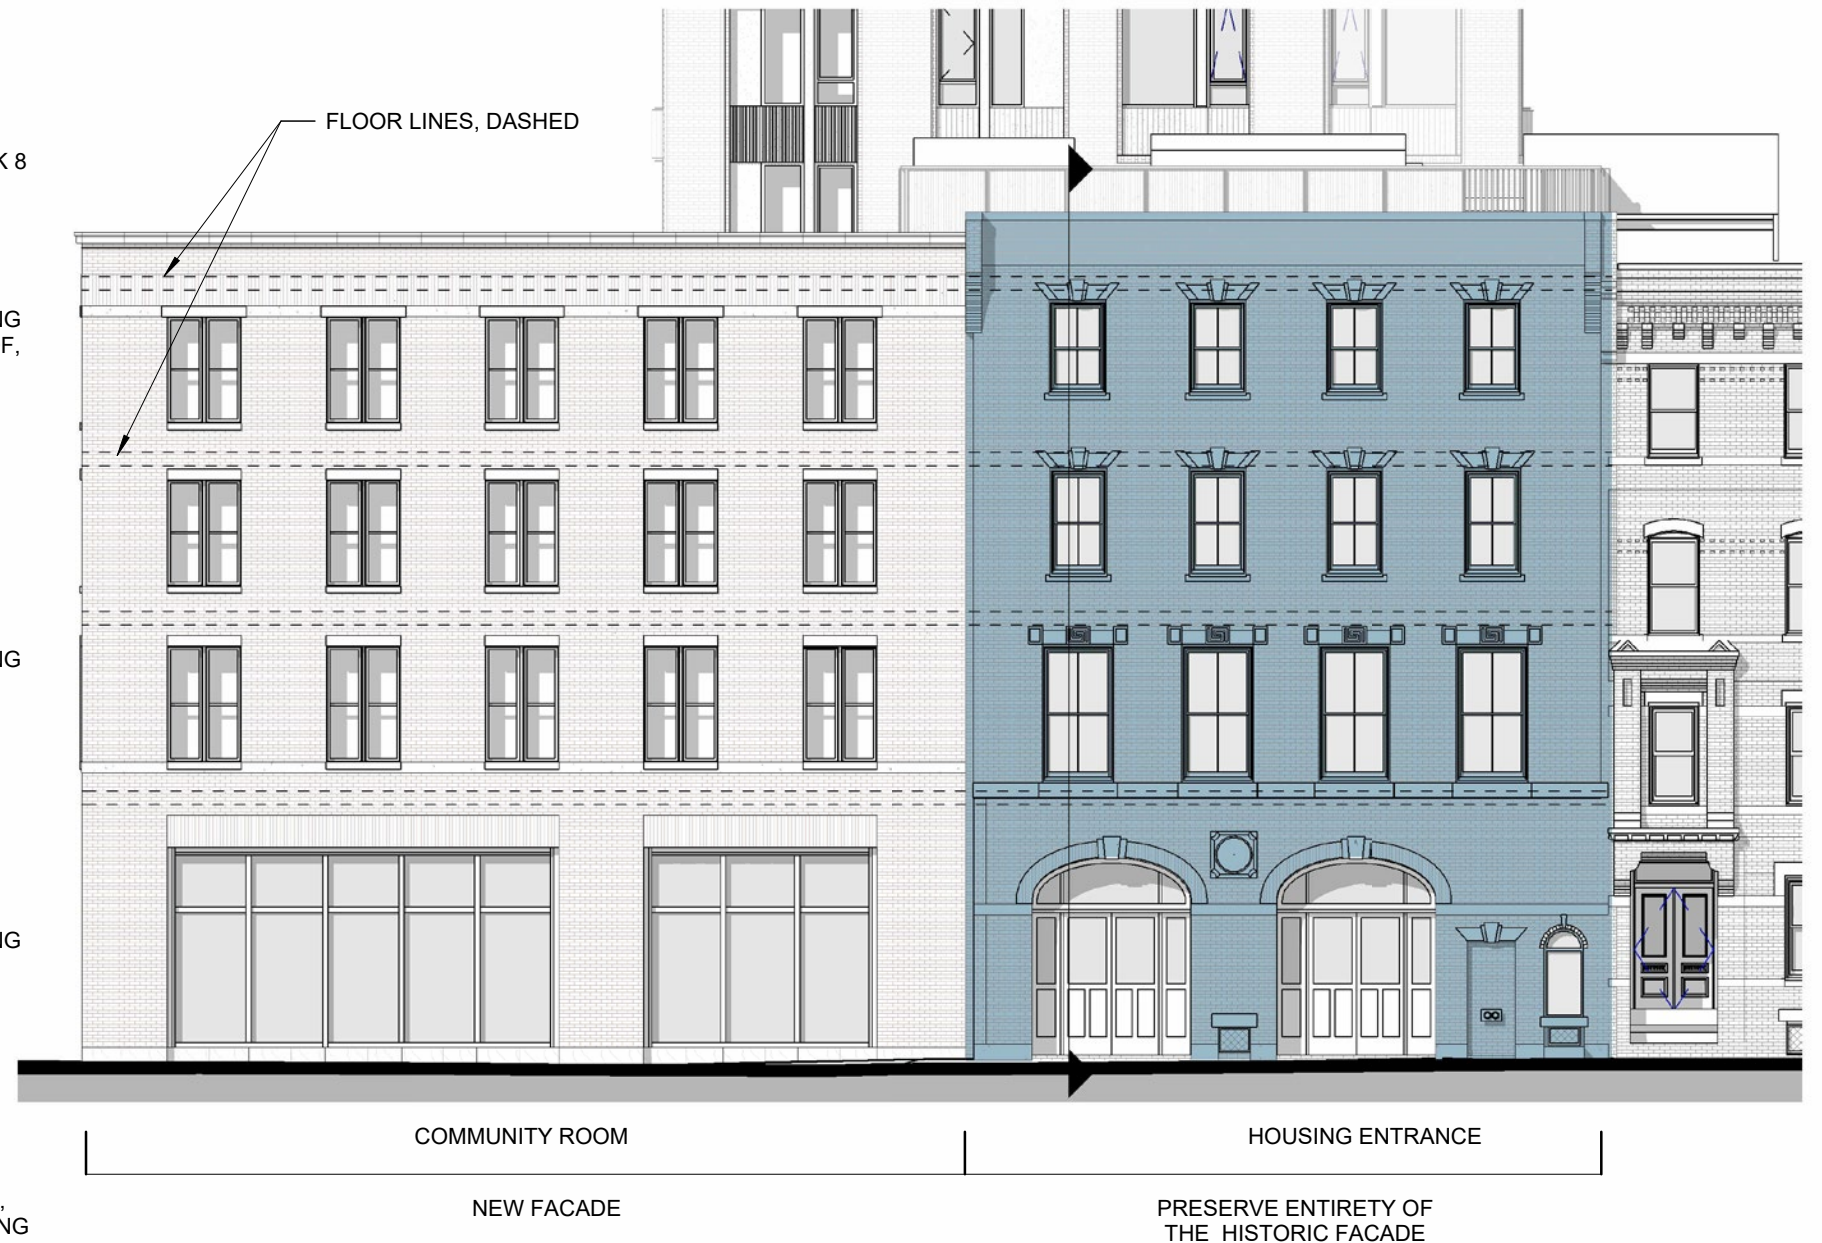
4 Appleton Section and Elevation

Historic Preservation of 6 Appleton with new Structural Components

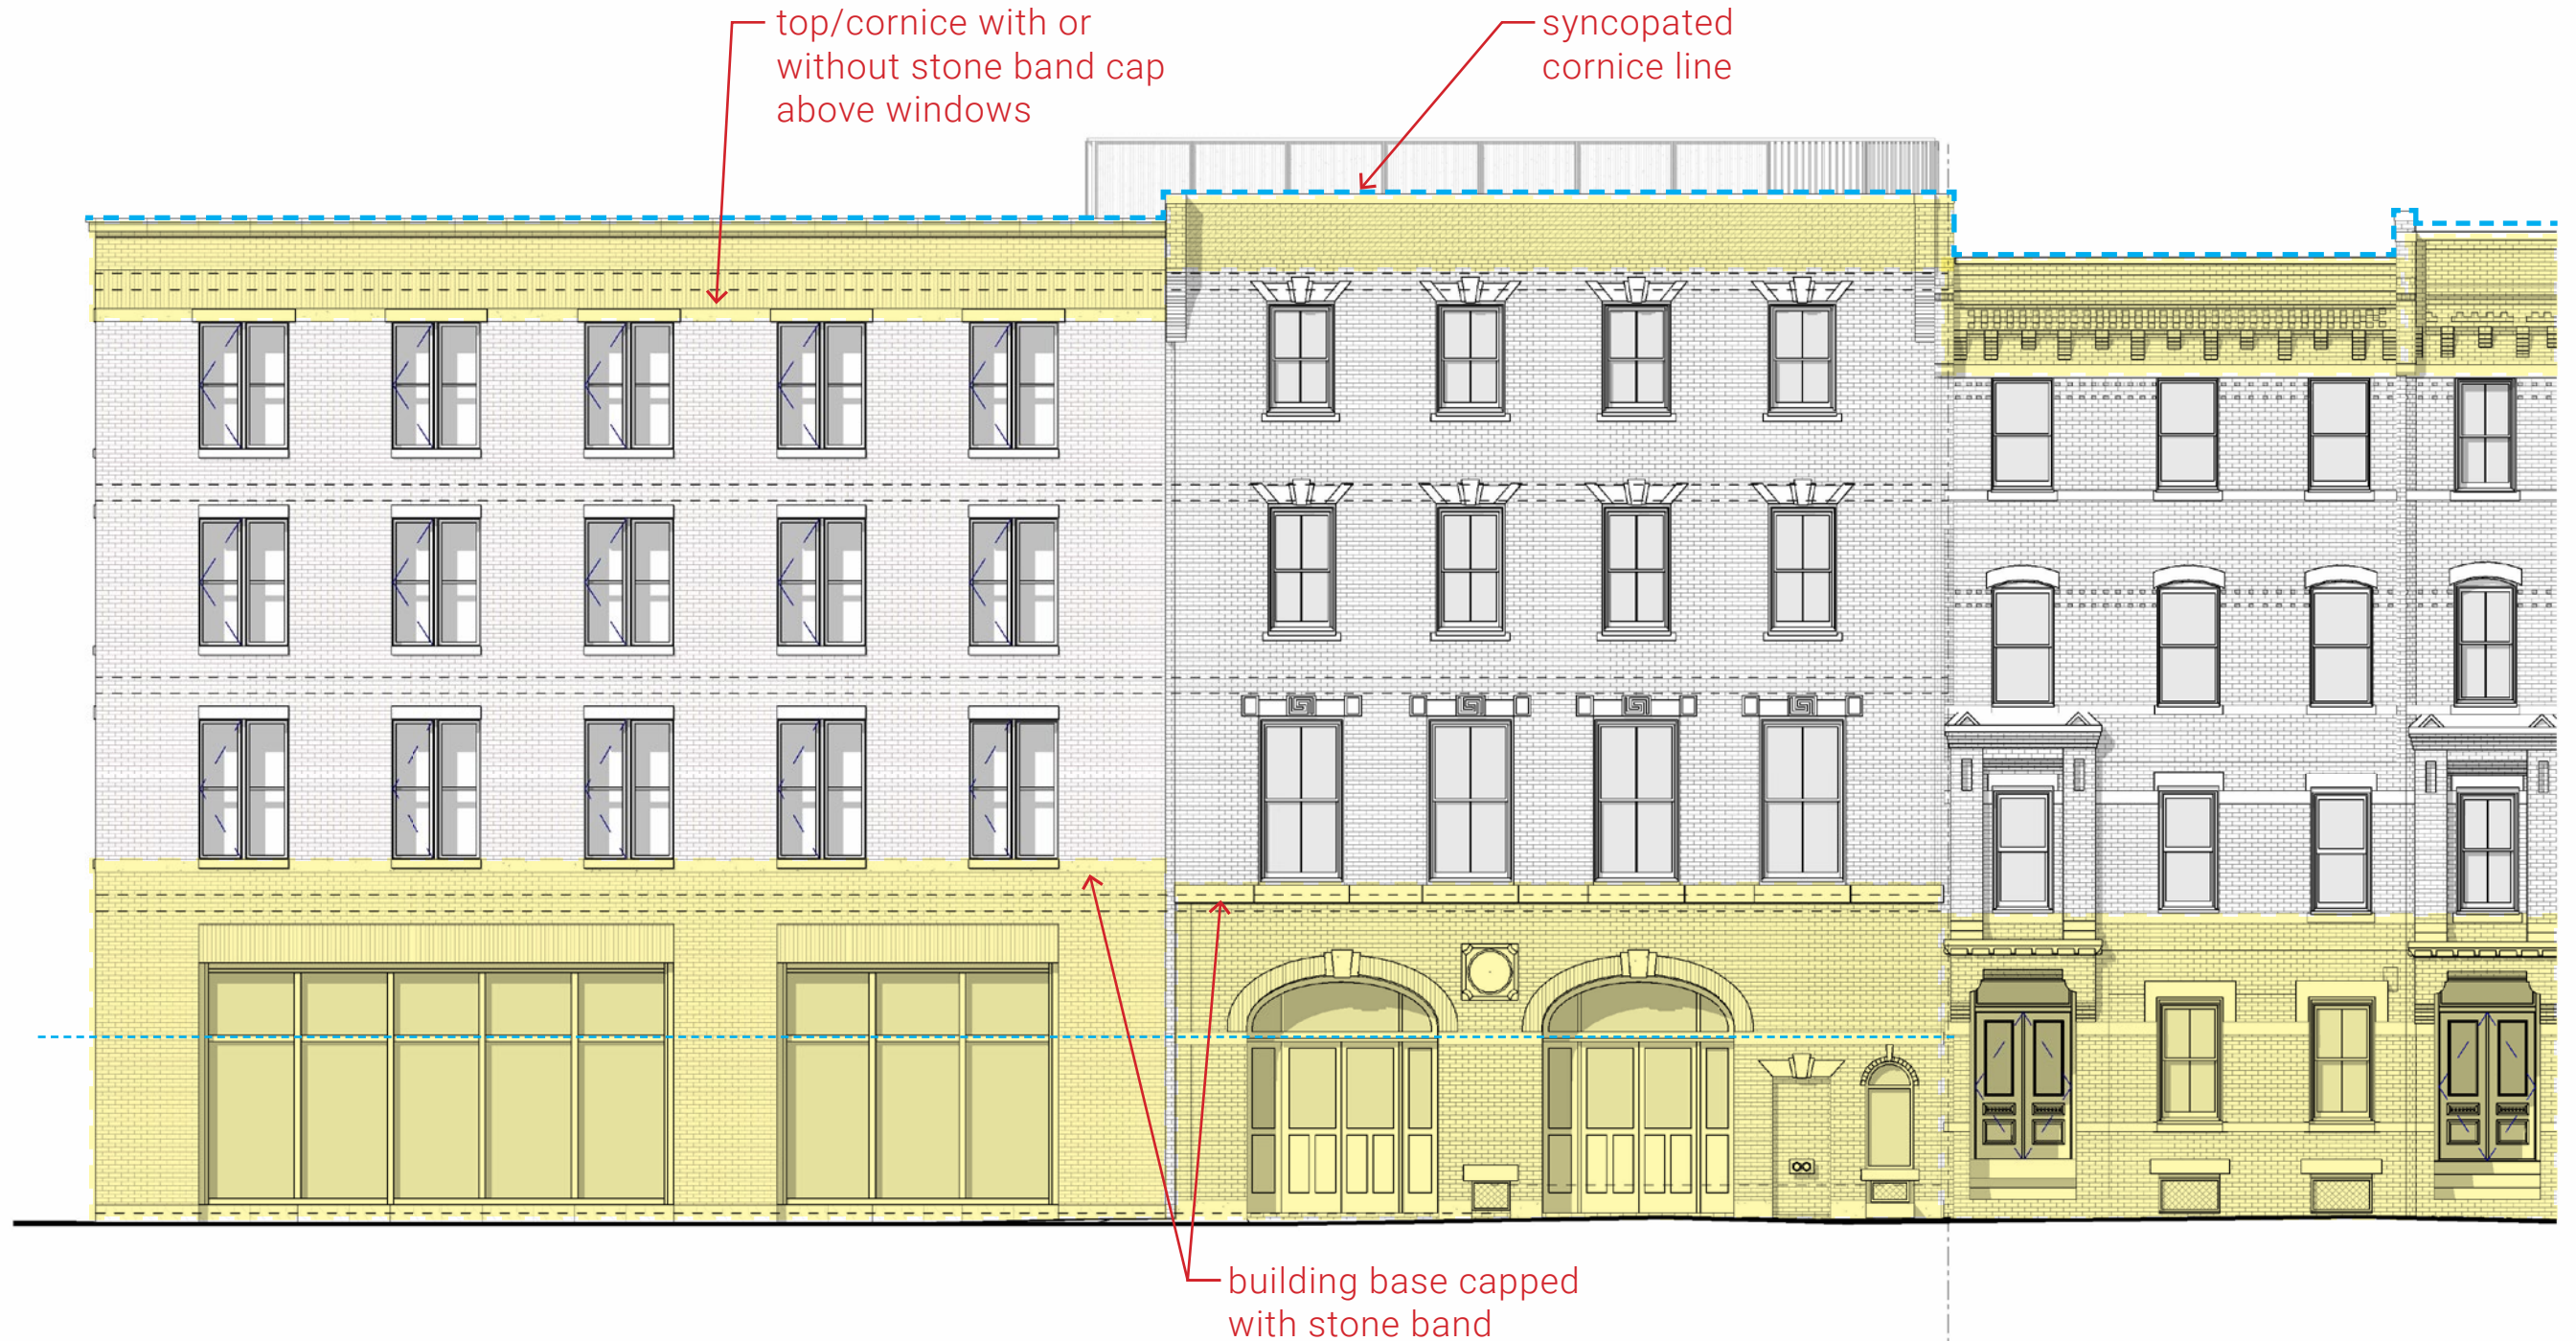
4 Appleton Facade

Design Elements

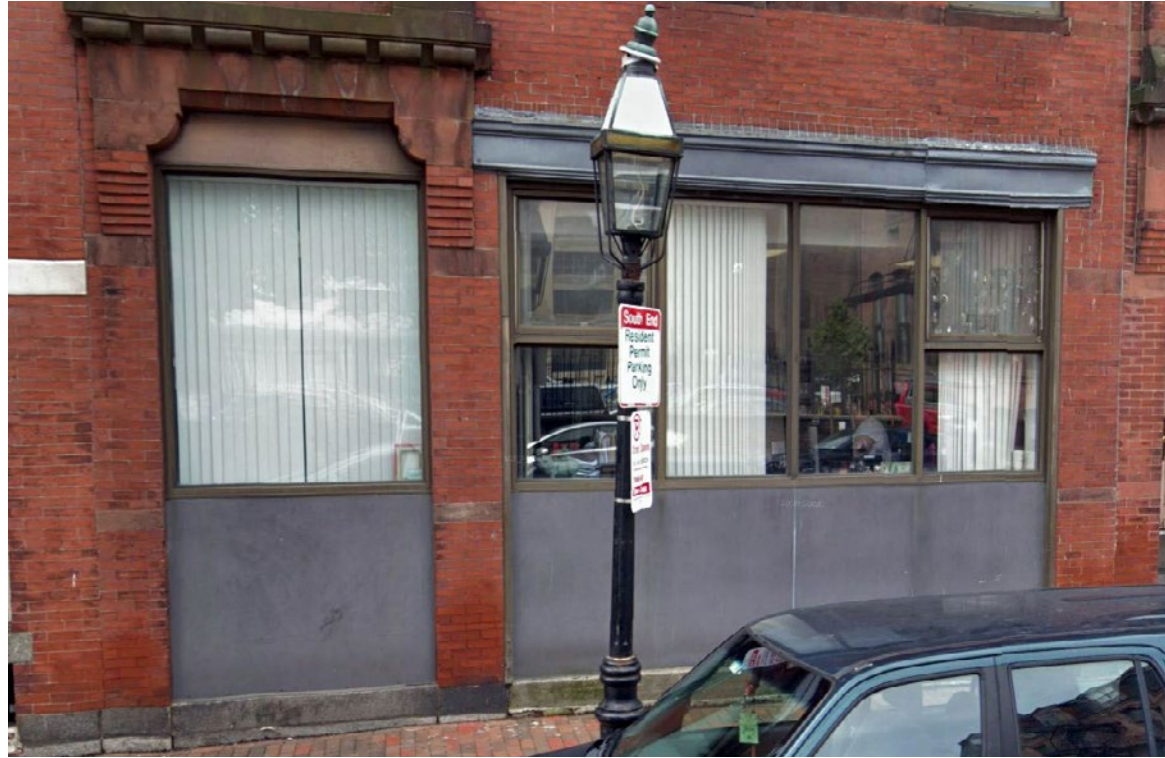
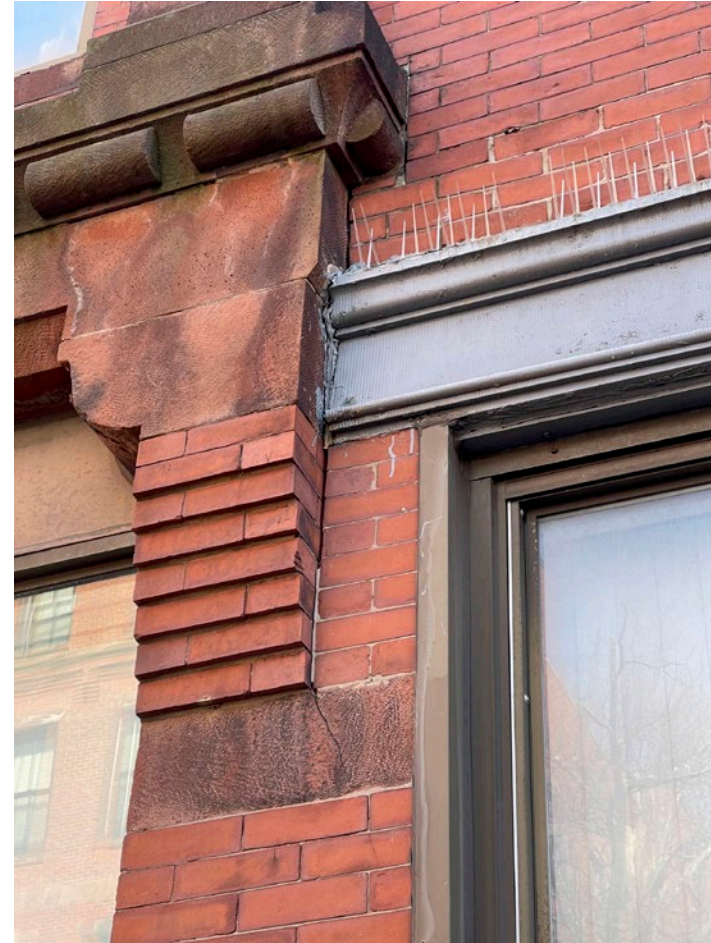
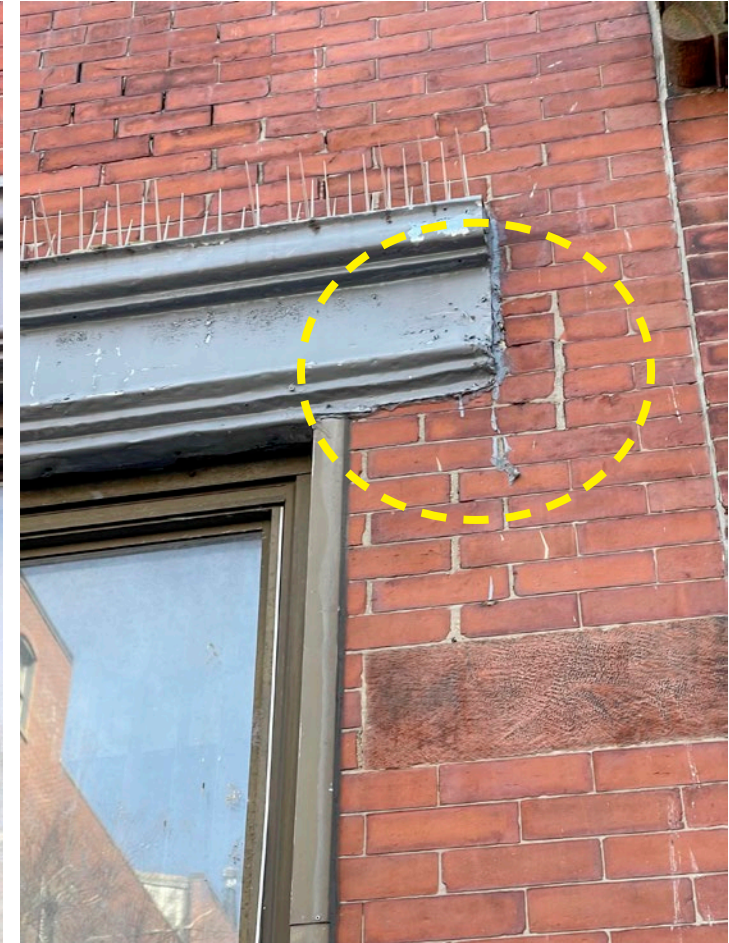
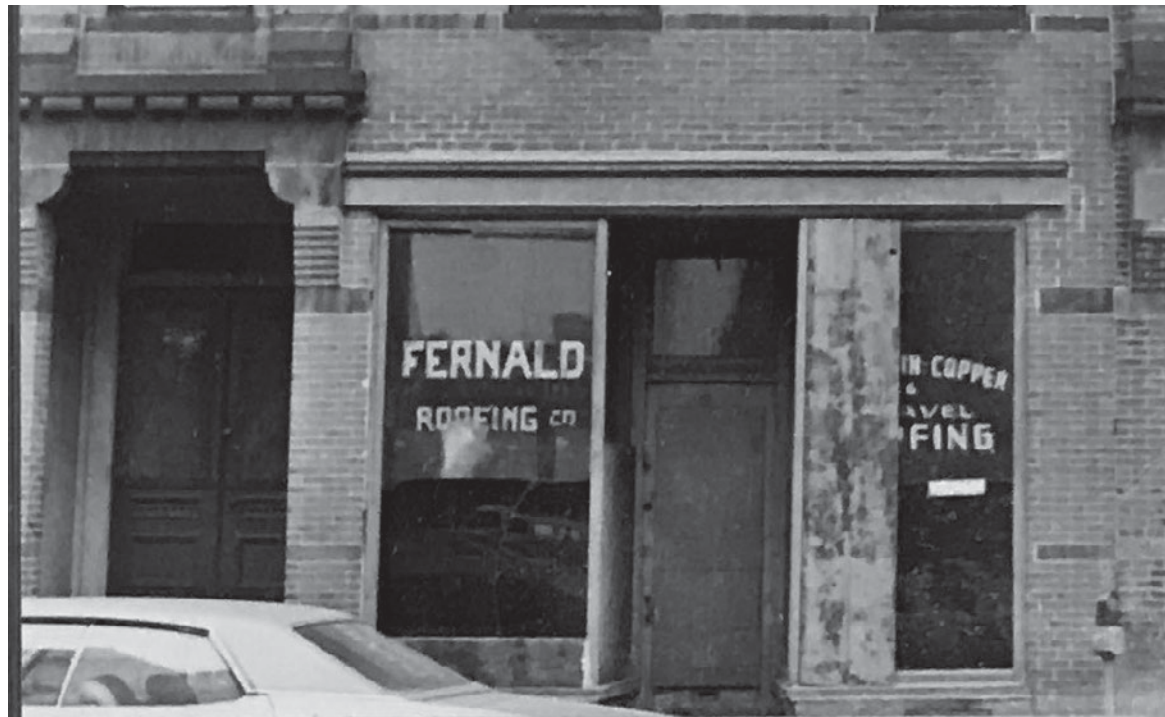
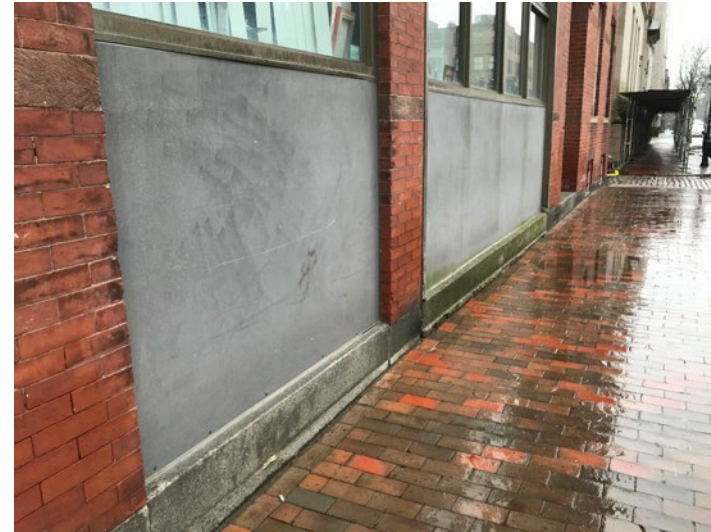
6 Appleton Street

Storefront configuration, visible in 1972, appears not to be the original configuration - brick infill appears where original stone window heads would have been. Proponent would be amenable to keeping a storefront reading if this is preferred as shown in the subsequent renderings.
