SCHEMATIC DESIGN
WASHINGTON IRVING MIDDLE SCHOOL
105 CUMMINS HIGHWAY
ROSLINDALE, MA

DRAFT REPORT
OCTOBER 14, 2022

BOSTON PUBLIC SCHOOLS
CITY OF BOSTON
WASHINGTON IRVING SCHOOL RENOVATION/ADDITION PROJECT
ROSLINDALE, MA.

SCHEMATIC DESIGN

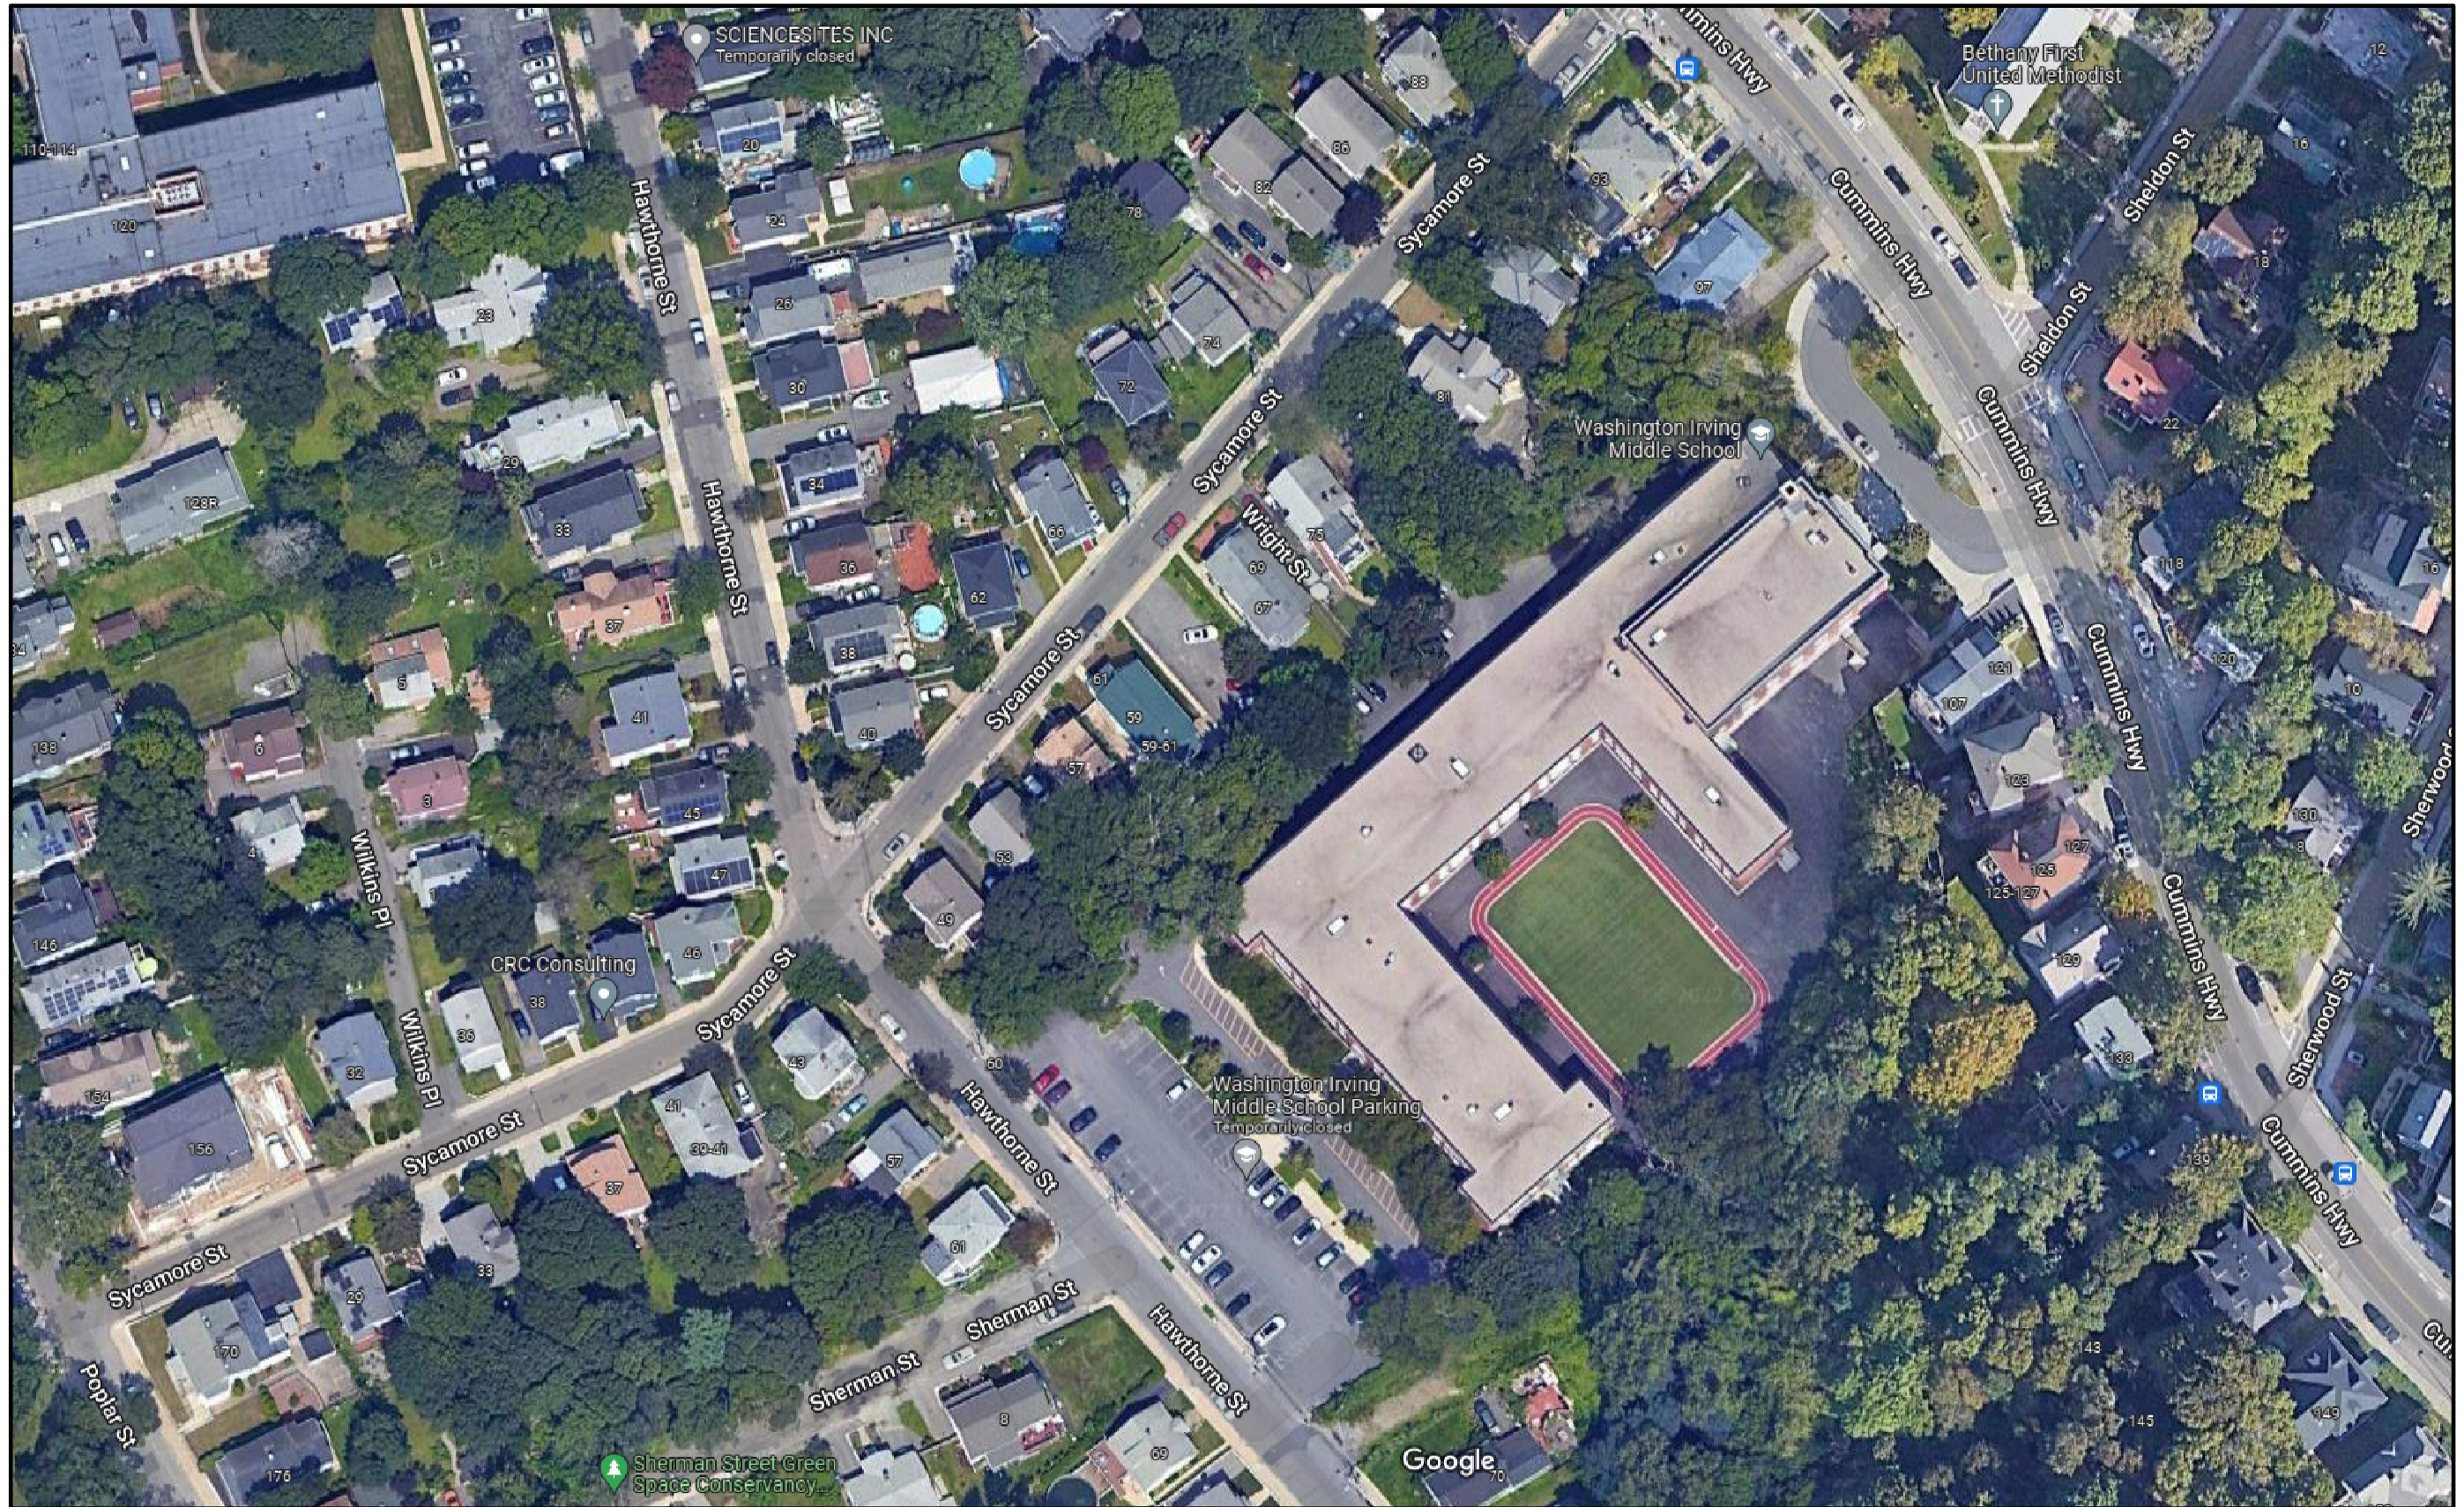
Washington Irving Elementary School Location
Alternative 1, Existing Aerial View
Gr. K-6, 700 Students
Renovation/Addition Construction
114,225 SF

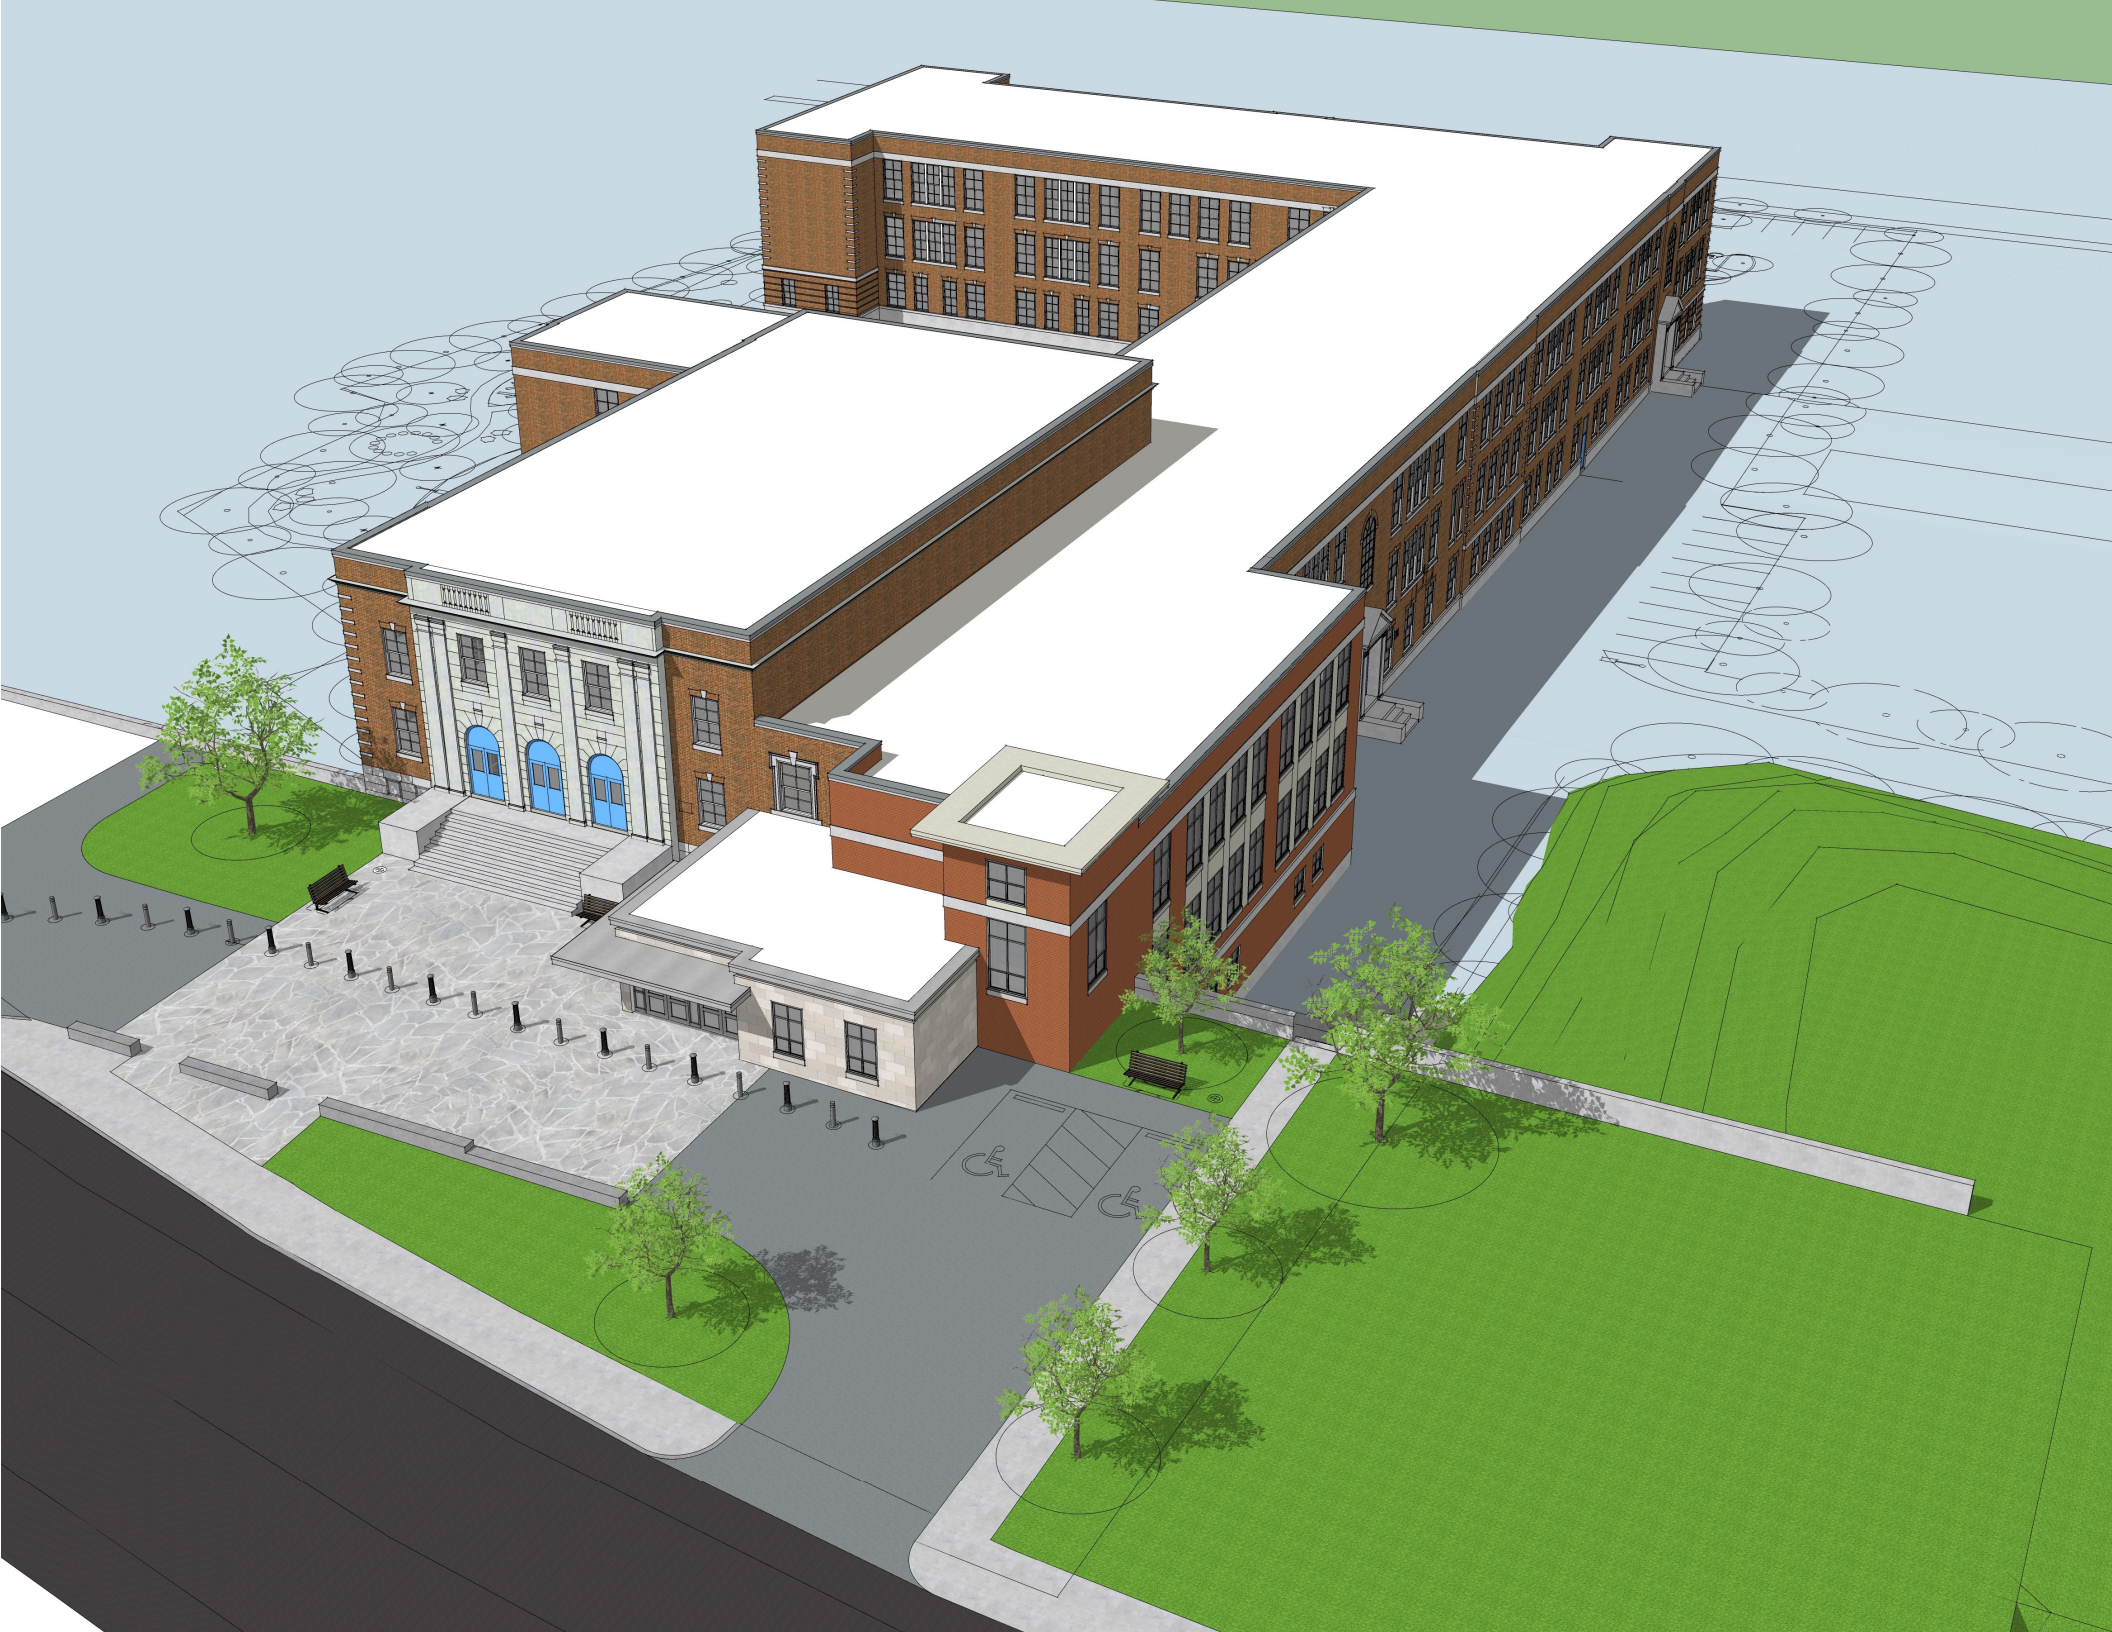
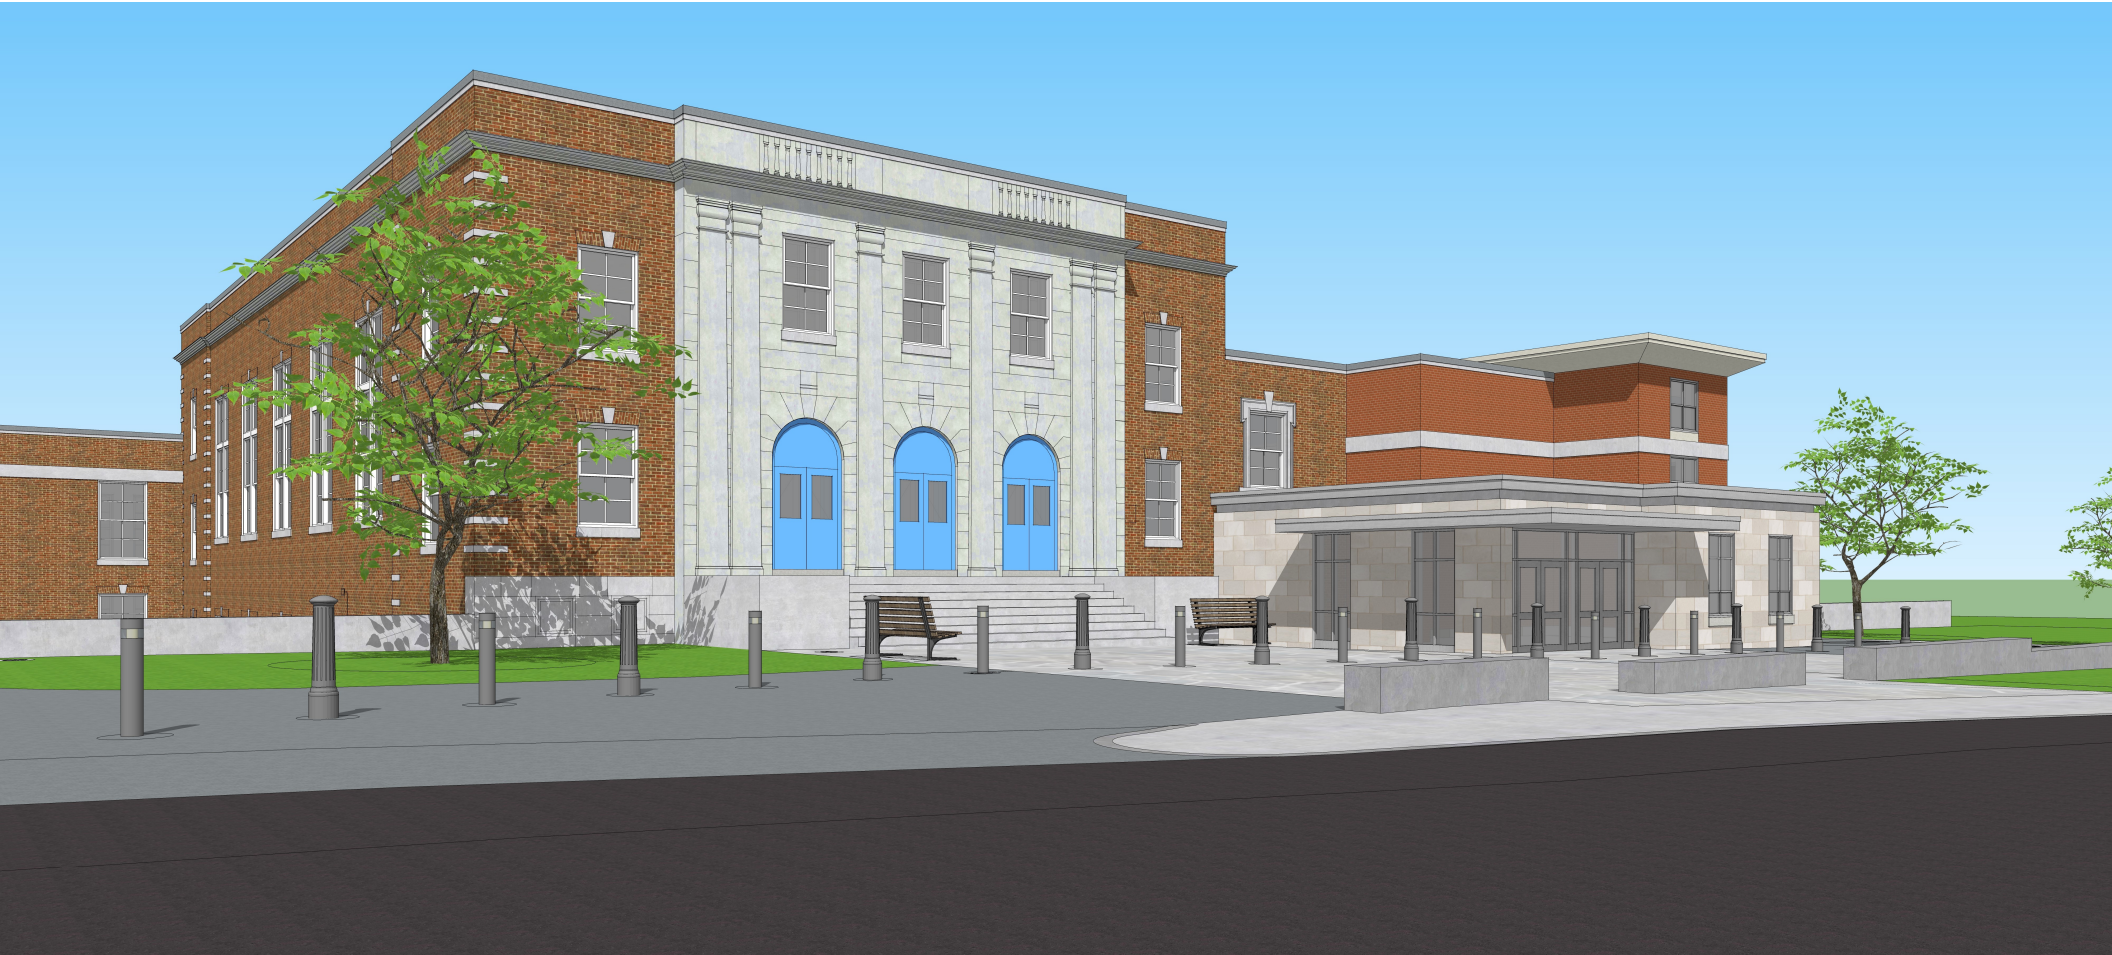
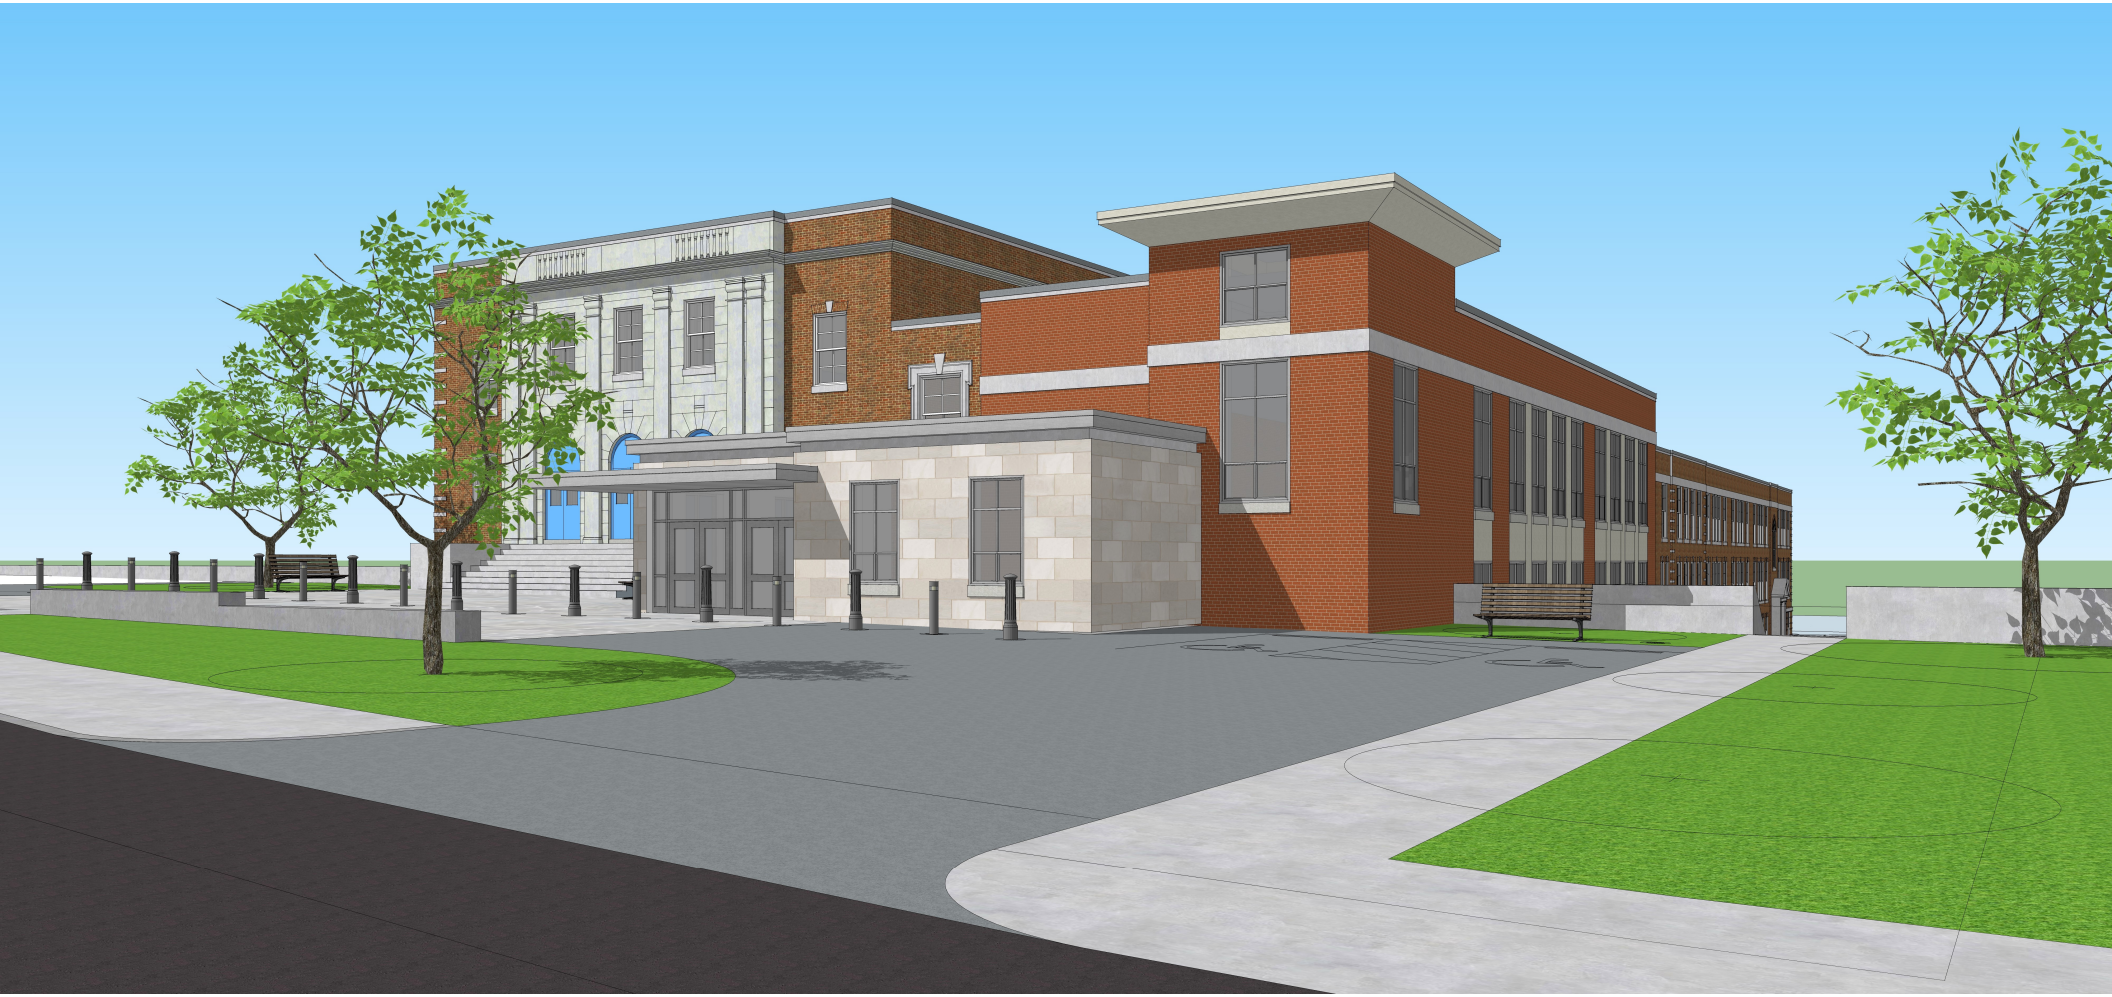
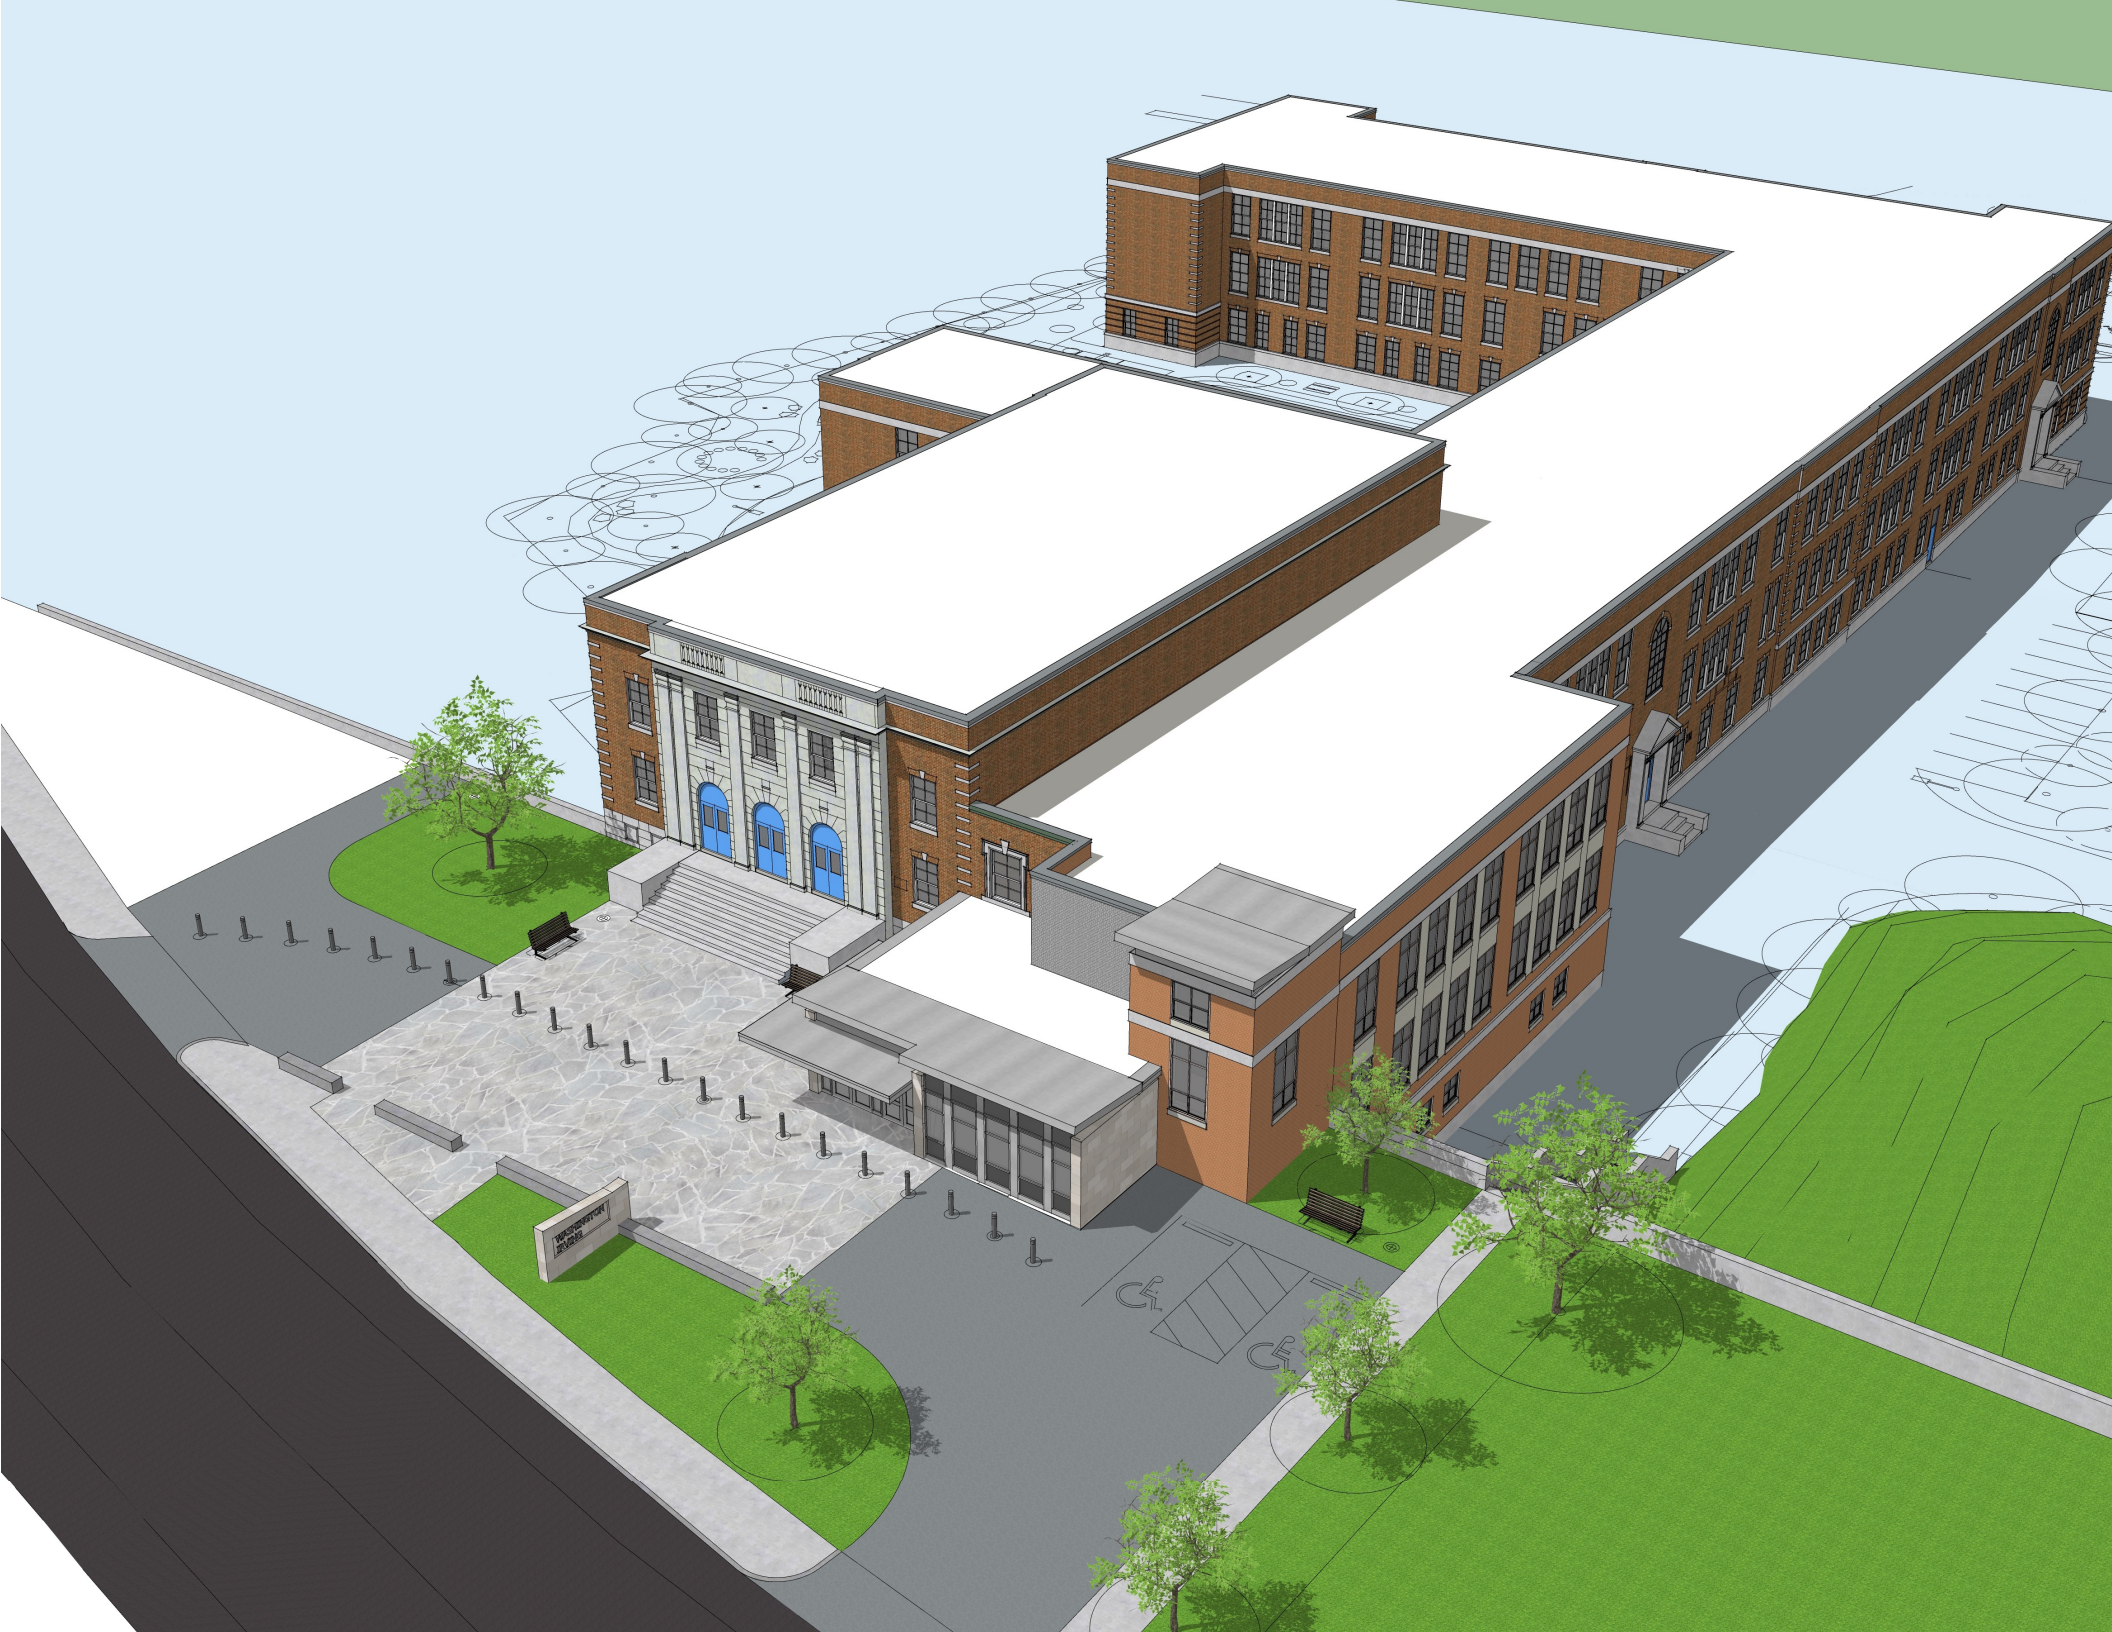
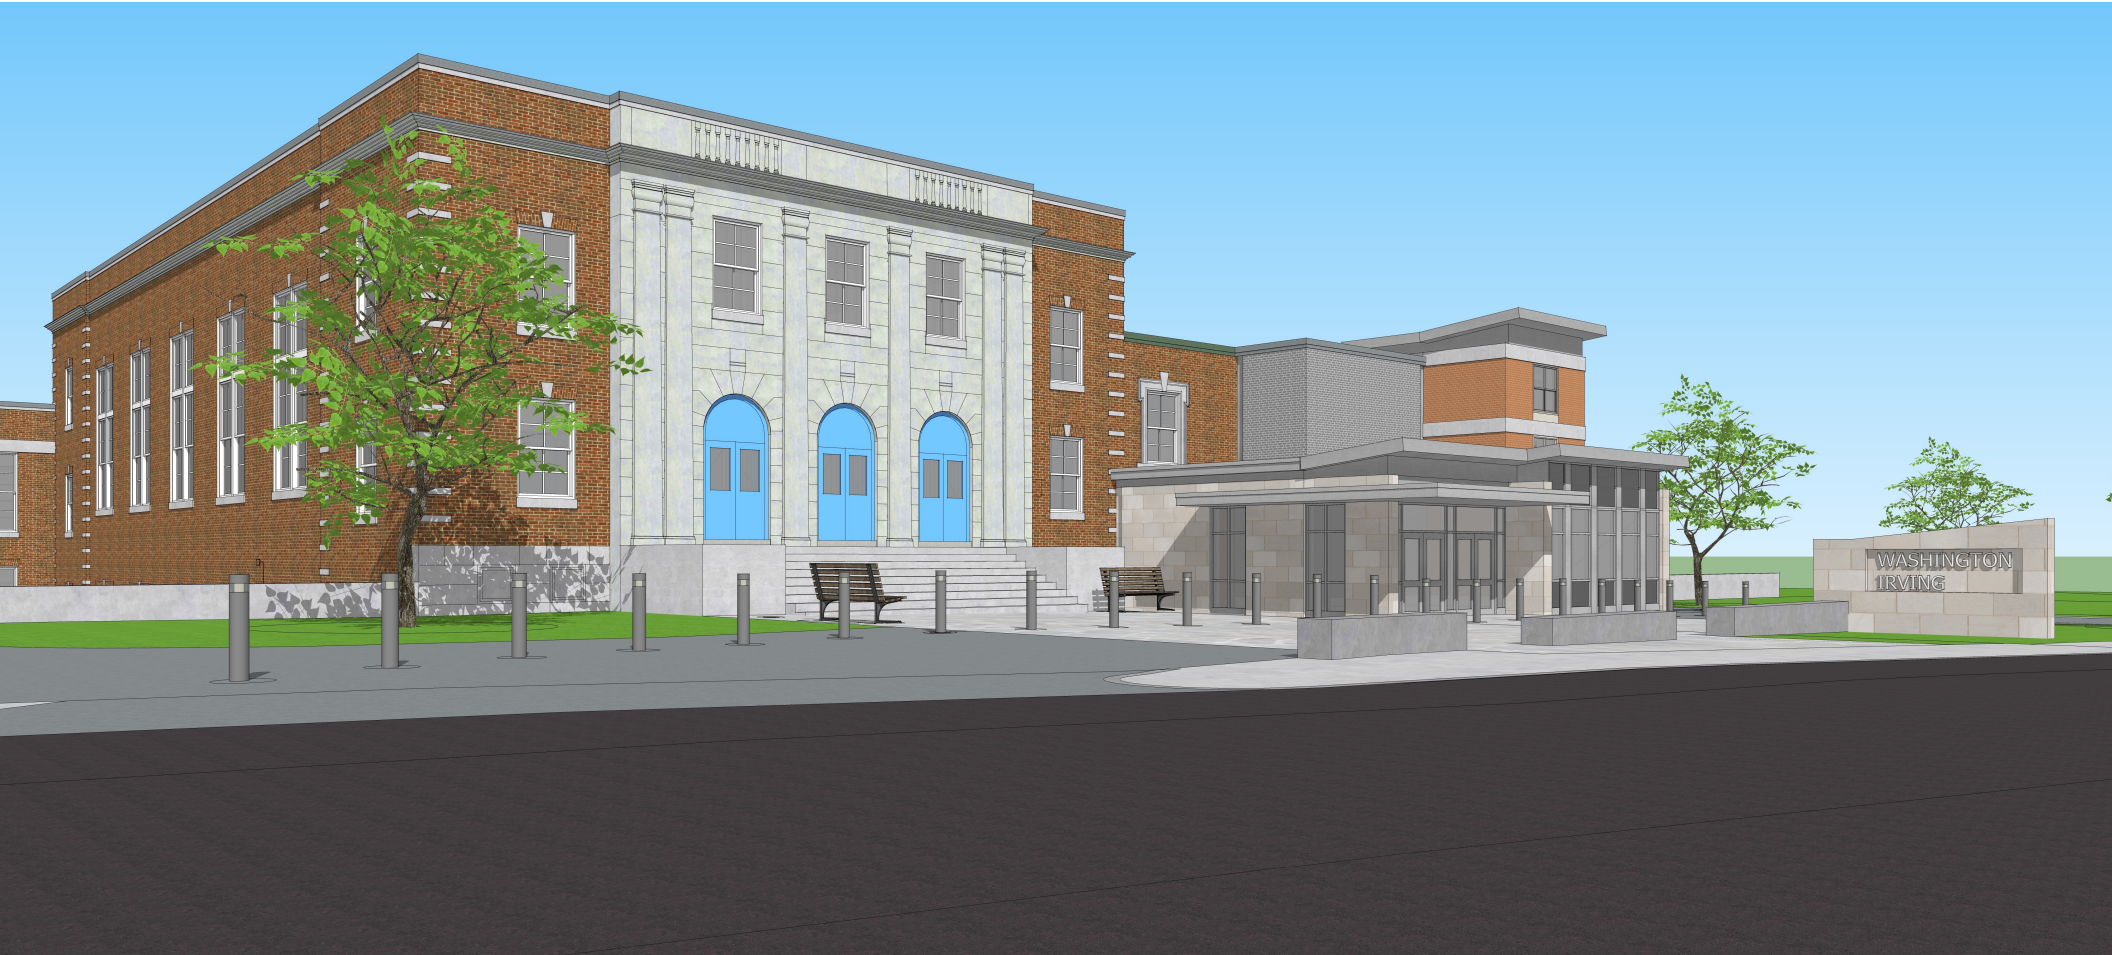
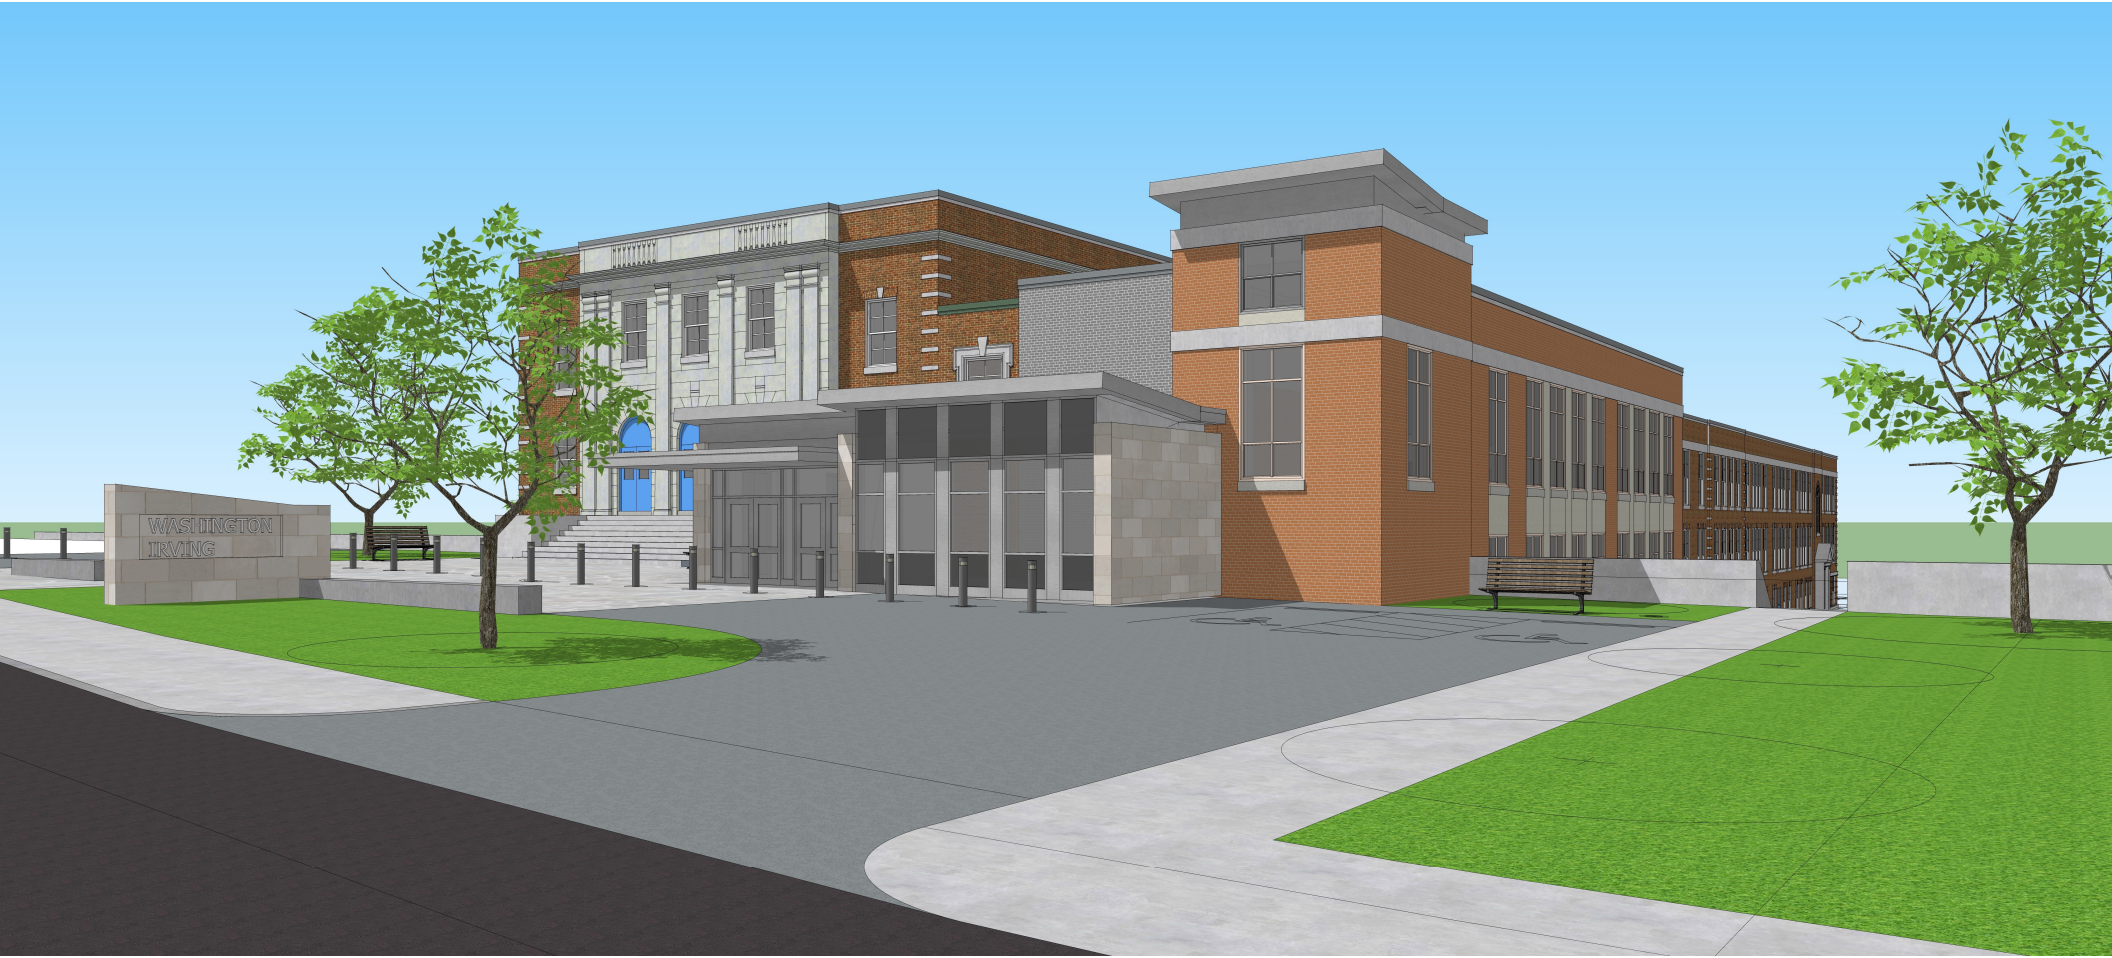
Washington Irving Elementary School Location
Alternative 1, East & South Exterior Elevations @ New Addition
Gr. K-6, 700 Students
Renovation/Addition Construction
114,225 SF

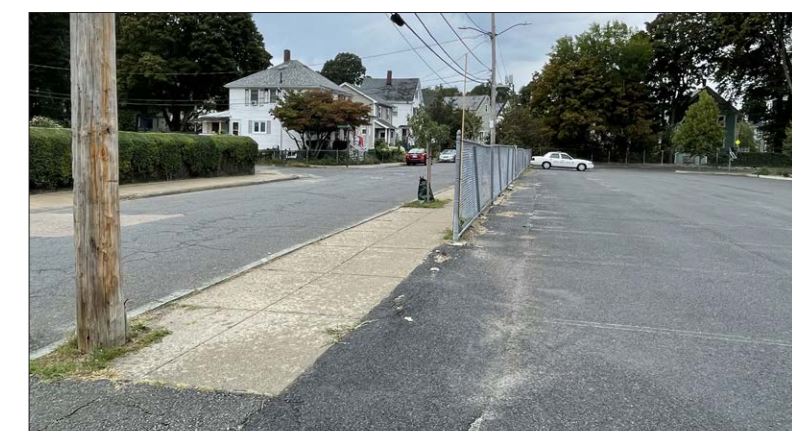
1 ASPHALT PARKING LOT
 all asphalt to get new top coat and parking to be re-stripped. Chainlink fence to be removed and replaced along Hawthorne sidewalk.

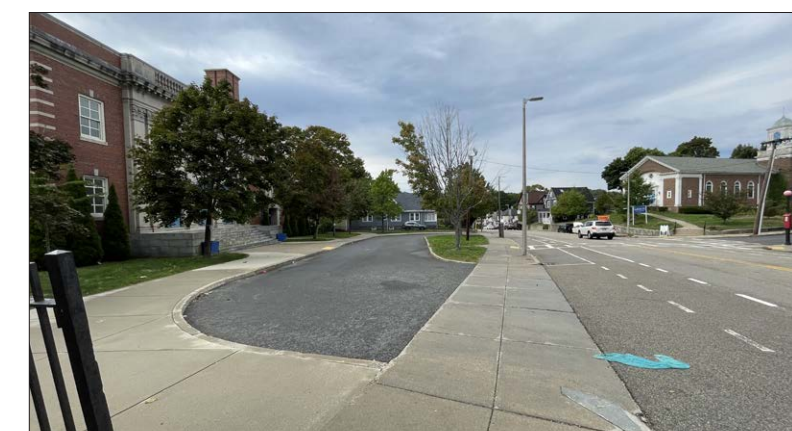
4 CUMMINS HIGHWAY ENTRY
 asphalt and concrete to be removed for accessible entry building addition and future plaza dropoff and parking

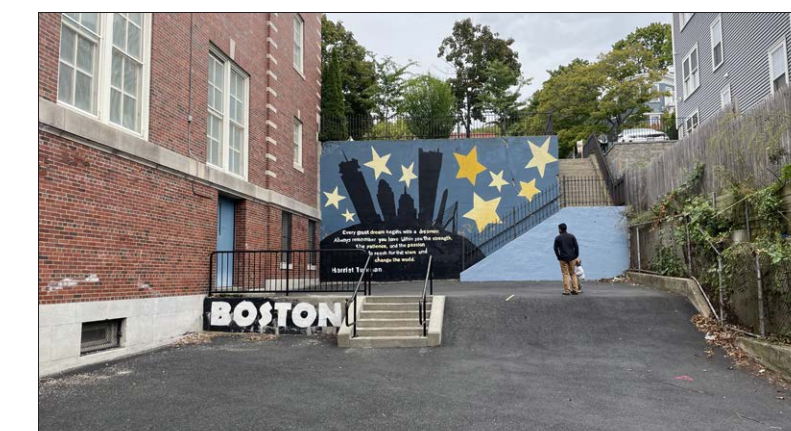
12 CONCRETE STAIRS AND ASPHALT RAMP
 stairs and ramp to be removed and replaced with sloped path through nature play. window well required at building.

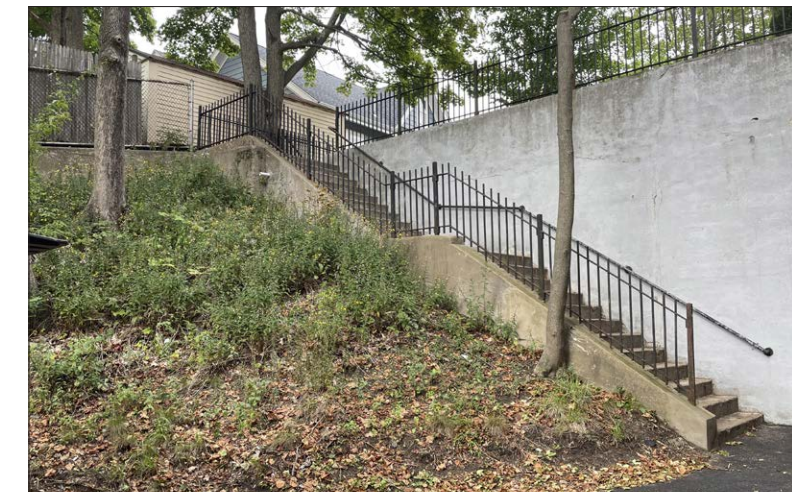
2 CONCRETE STAIRS
 stairs to be demolished and replaced to align parallel with the building. Slope to be removed and retained with a wall following the north property line.

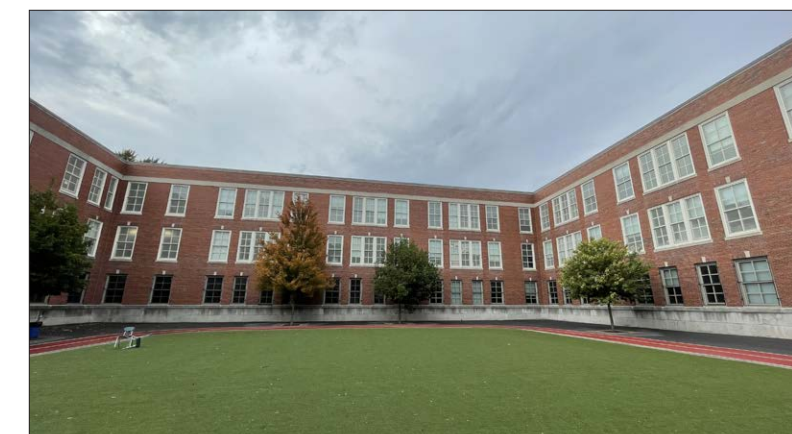
5 TURF FIELD AND RUBBER TRACK
 field and track to be removed and replaced with smaller grass field and playground structures

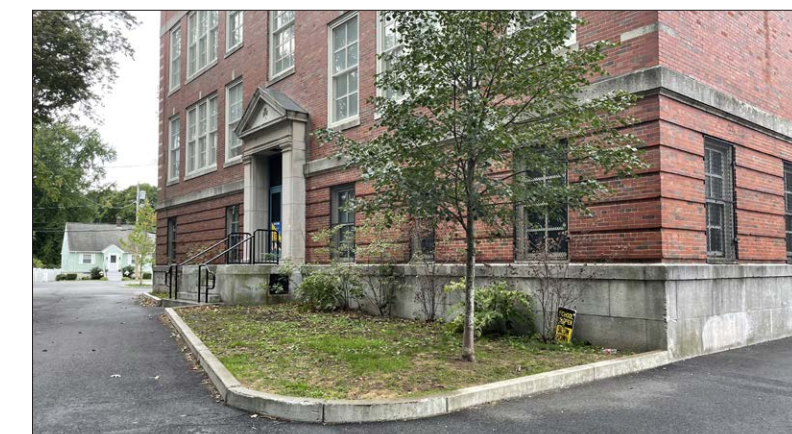
9 CURBED PLANTING
 curbed planter to be adjusted to improve fire access

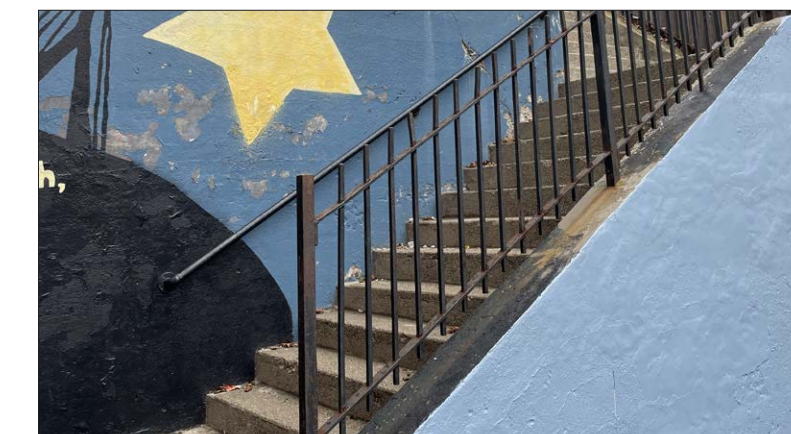
13 CONCRETE STAIRS AND WALLS
 stairs and walls to be structurally assessed and replaced in kind if deemed necessary

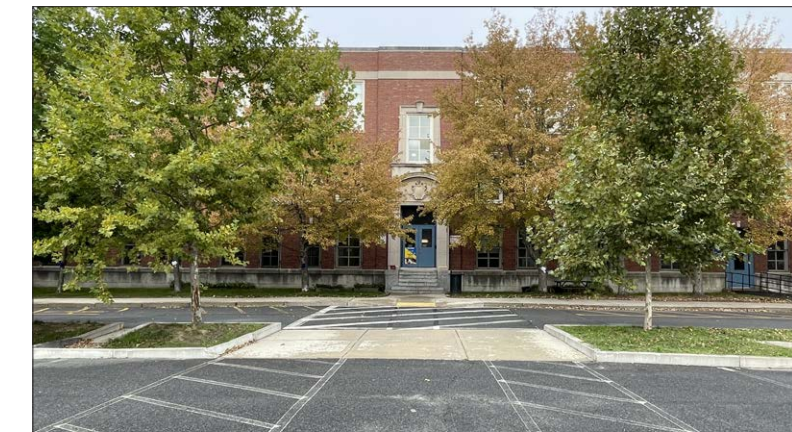
3 1ST FLOOR ENTRY
 concrete paving and accessible entry to be removed and reconfigured to meet new secure entry on NW corner

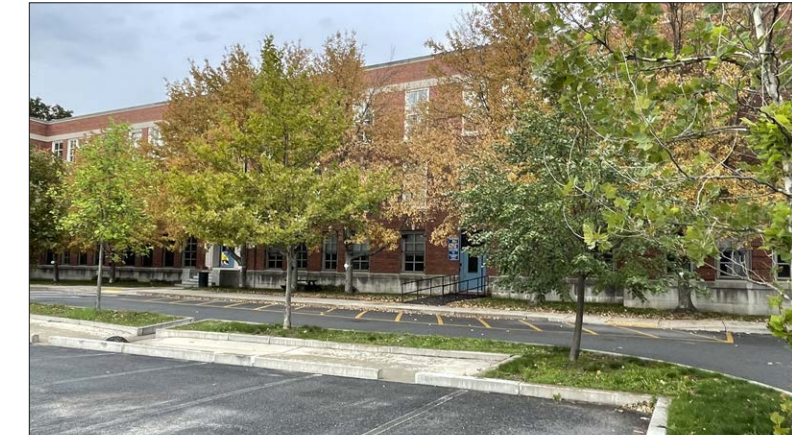
7 CONCRETE DRAINAGE BASIN
 concrete to be removed and replaced with extension of rain garden

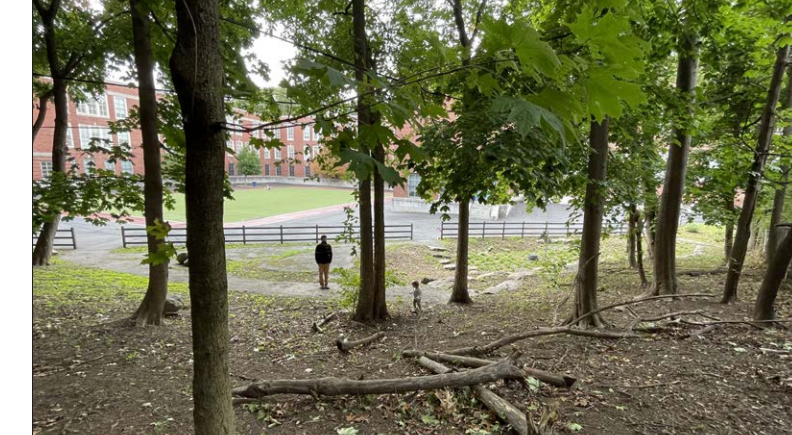
11 WOODED PLAY AREA
 canopy trees to remain and planting to be expanded as nature play area. Abandoned curbs and vinyl split rail fence at boundary to be removed.

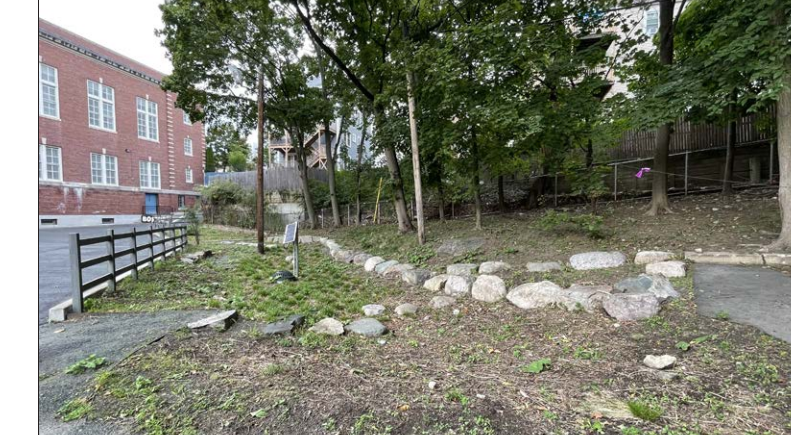
15 TELEPHONE POLES
 existing powerlines to be removed when possible. existing lights to be removed and replaced
