SOUTH END LANDMARKS COMMISSION

587 ALBANY STREET

- NEW CONSTRUCTION OF A SIX (6) STORY BUILDING WITH SIX (6) CONDOMINIUM UNITS. THE PROJECT WILL REPLACE IN KIND THE EXISTING EXTERIOR ALBANY STREET FACADE.

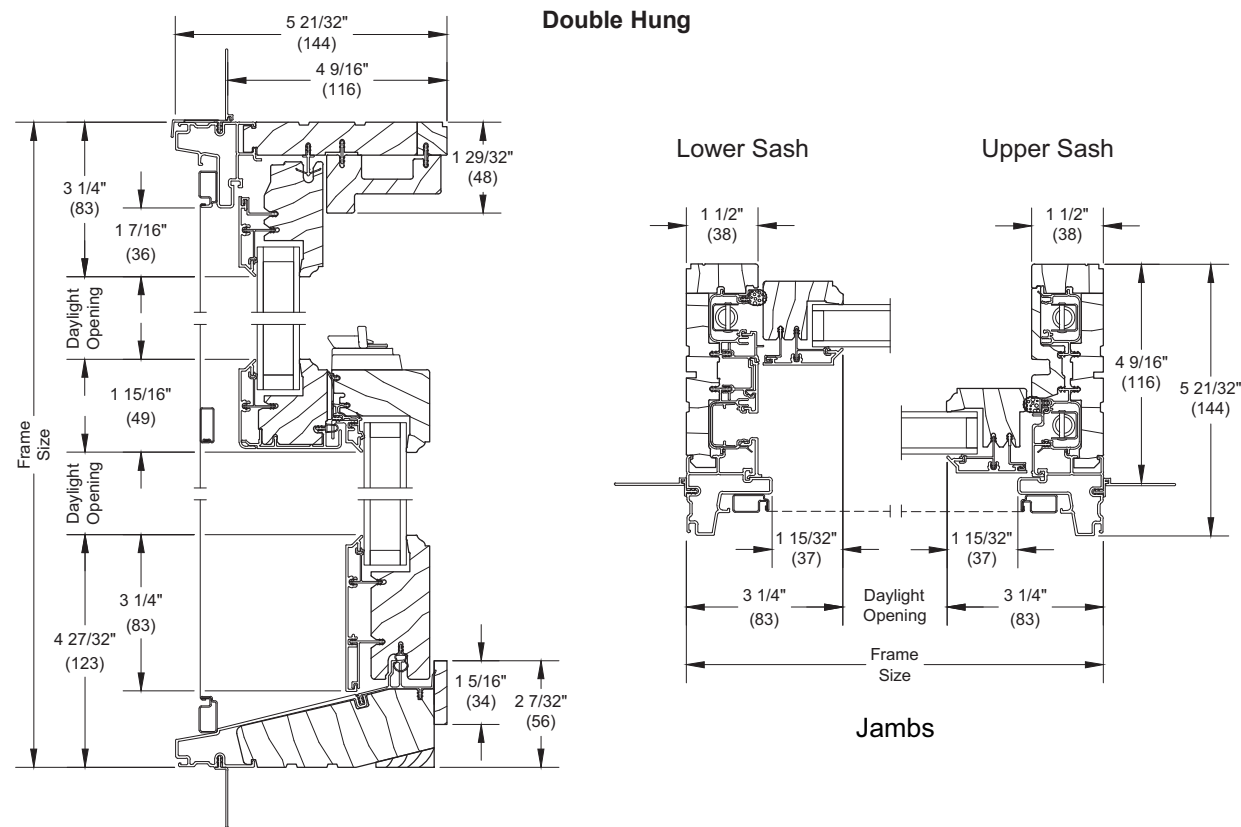
Section Details: Operating (with Lock Status Sensor)

Scale: 3" = 1' 0"

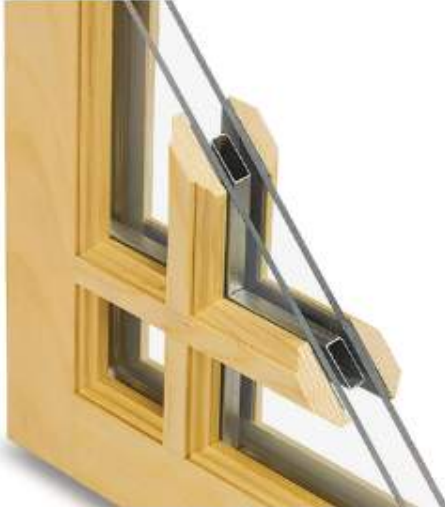
Simulated Divided Lite with Spacer Bar (SDLS)

Paired with SDL bars on the interior and exterior of the glass, a spacer bar is installed between the glass, creating an even closer resemblance to the ADL look.

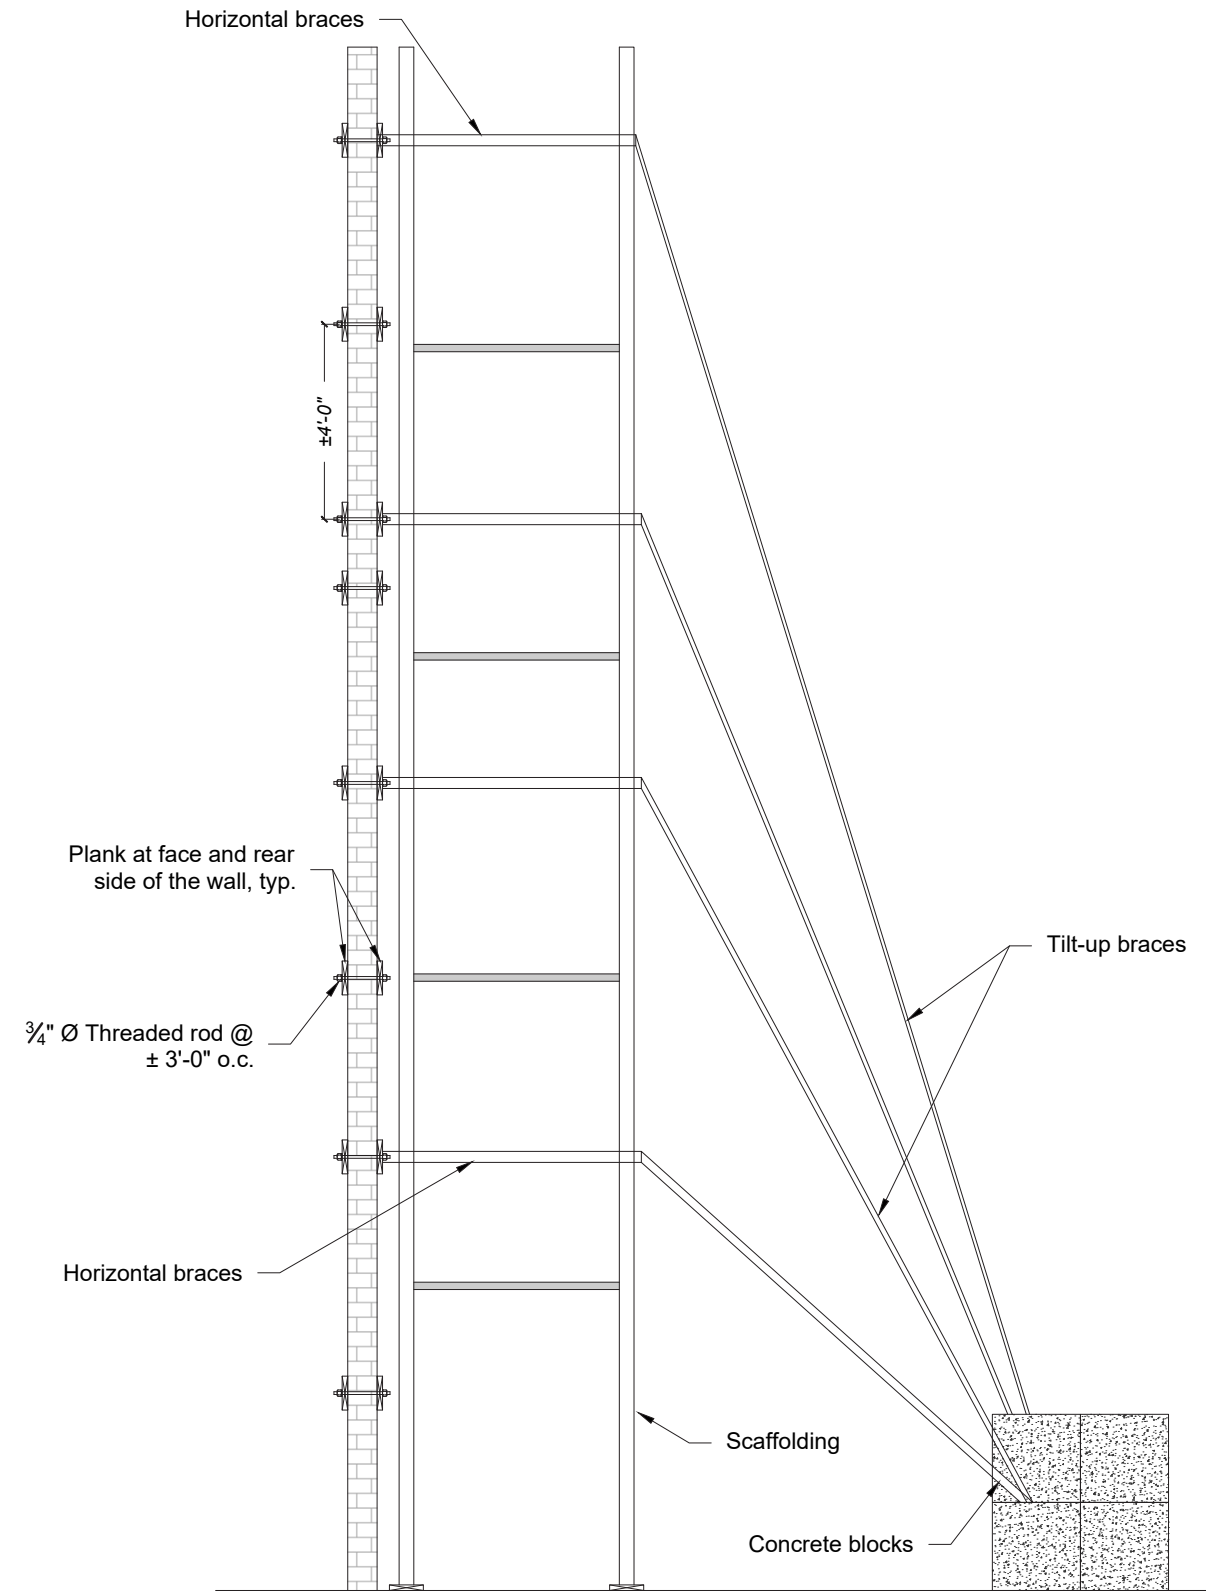
SECTION

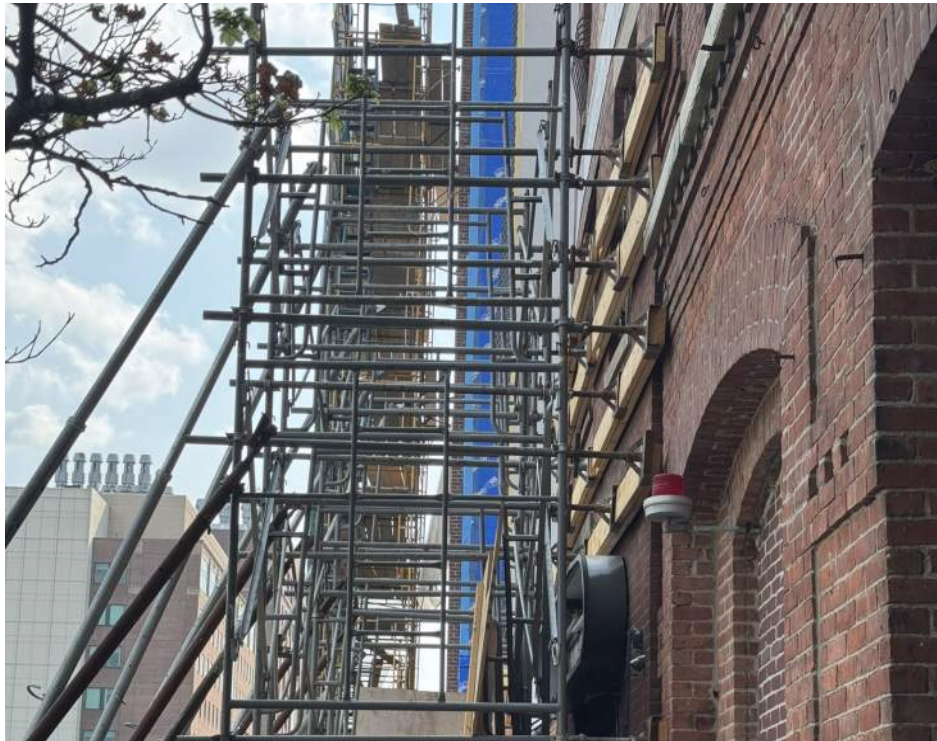
BRACING IN PLACE AGAINST BOWED MASONRY WALL

CURRENT CONDITIONS - EMERGENCY FACADE BRACING - 08/01/2024

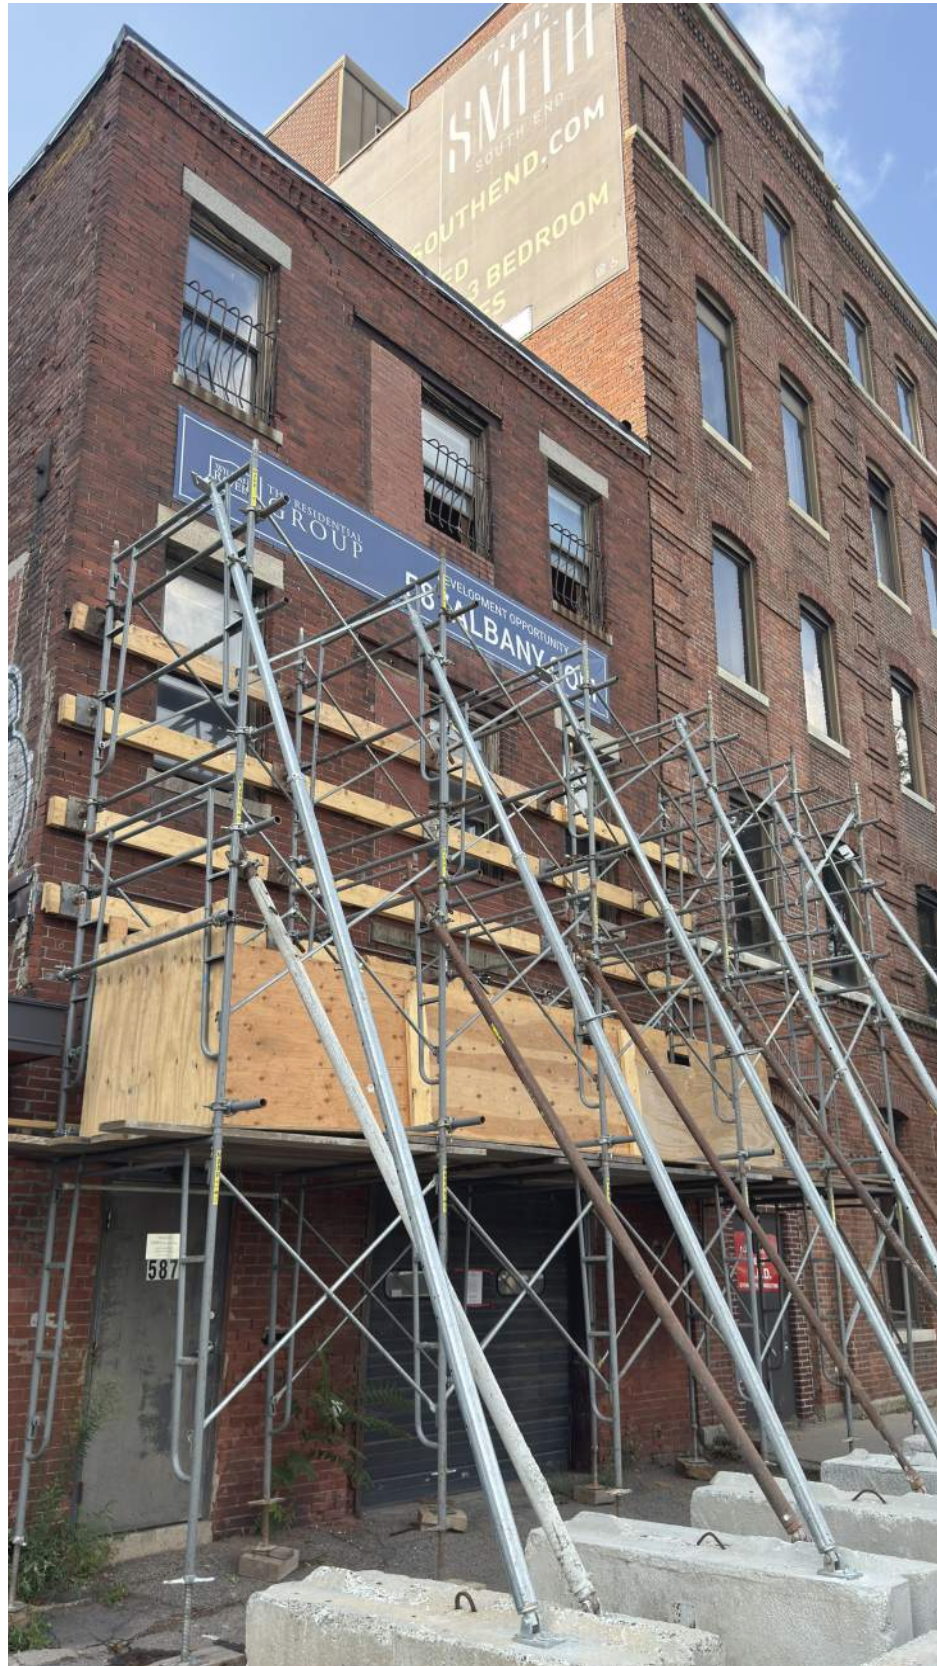
FACADE BRACING IN PLACE

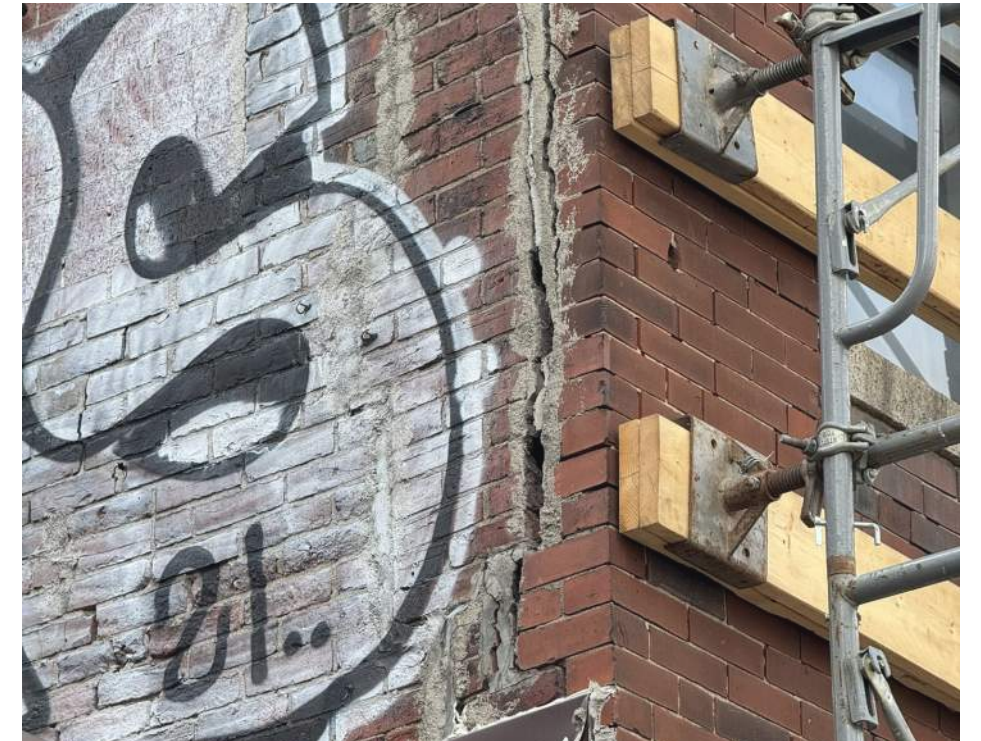
SEPARATION OF MASONRY WALLS

Of most concern, the back of the façade has pulled away from the framed second floor by about 3-5 inches. This is substantial movement, and we did not observe any floor ties, which suggests the façade currently has no bracing to prevent further movement.

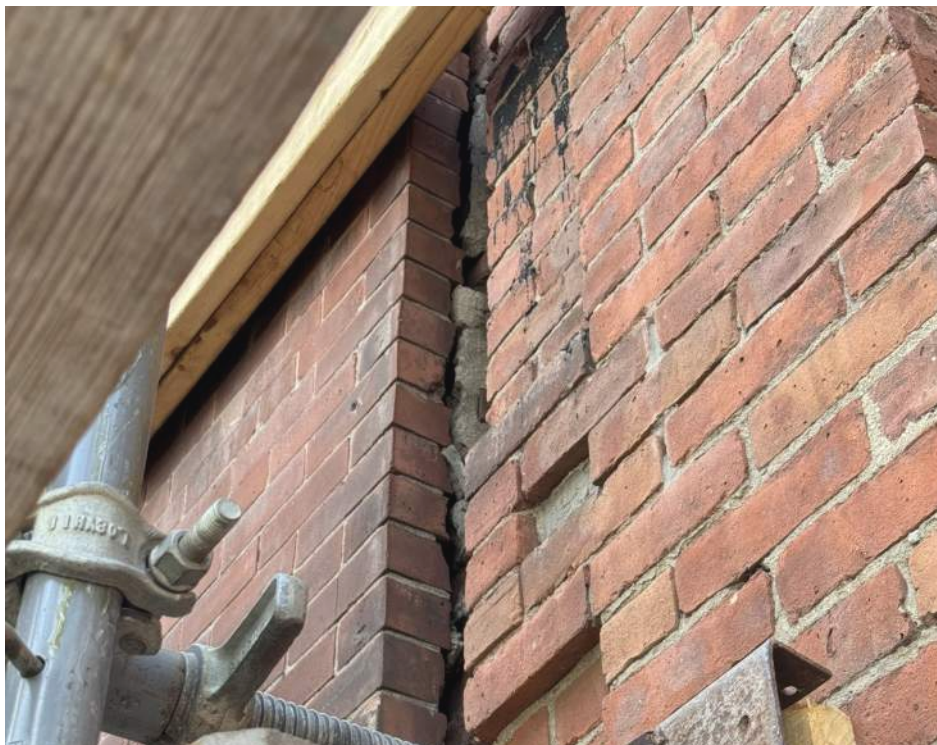
SEPARATION OF MASONRY WALLS

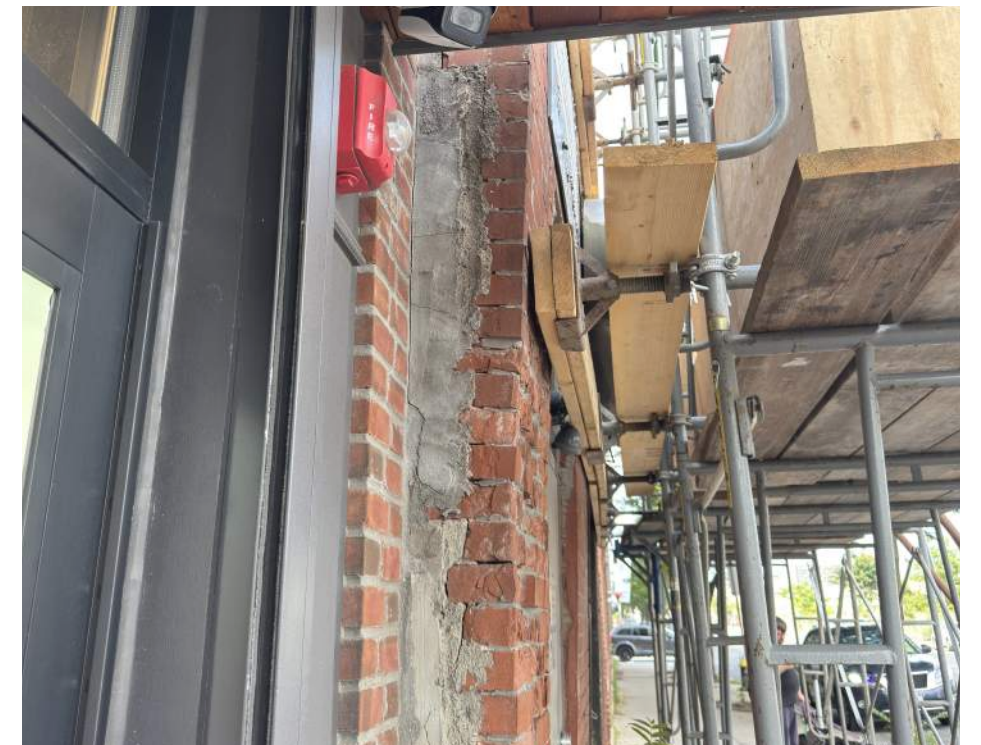
MASONRY WALL LEANING FORWARDS

There is planned redevelopment for this parcel that was intended to brace, restore, and reattach the façade to the new building. In our opinion, this façade cannot be safely braced and repaired in that manner given its out-of-plumbness and deteriorated condition. We suggest the full demolition of this wall and rebuilding or reincorporating it as a brick veneer in the new project.

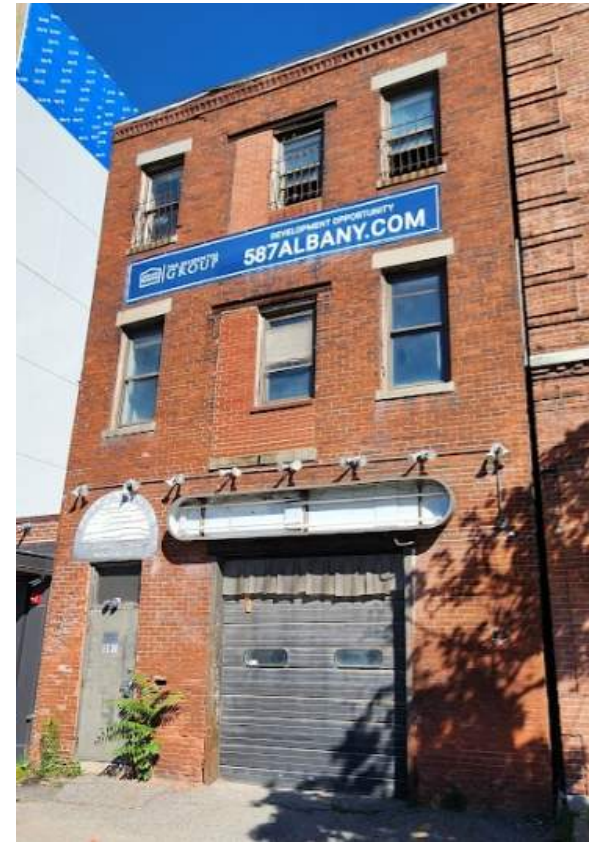
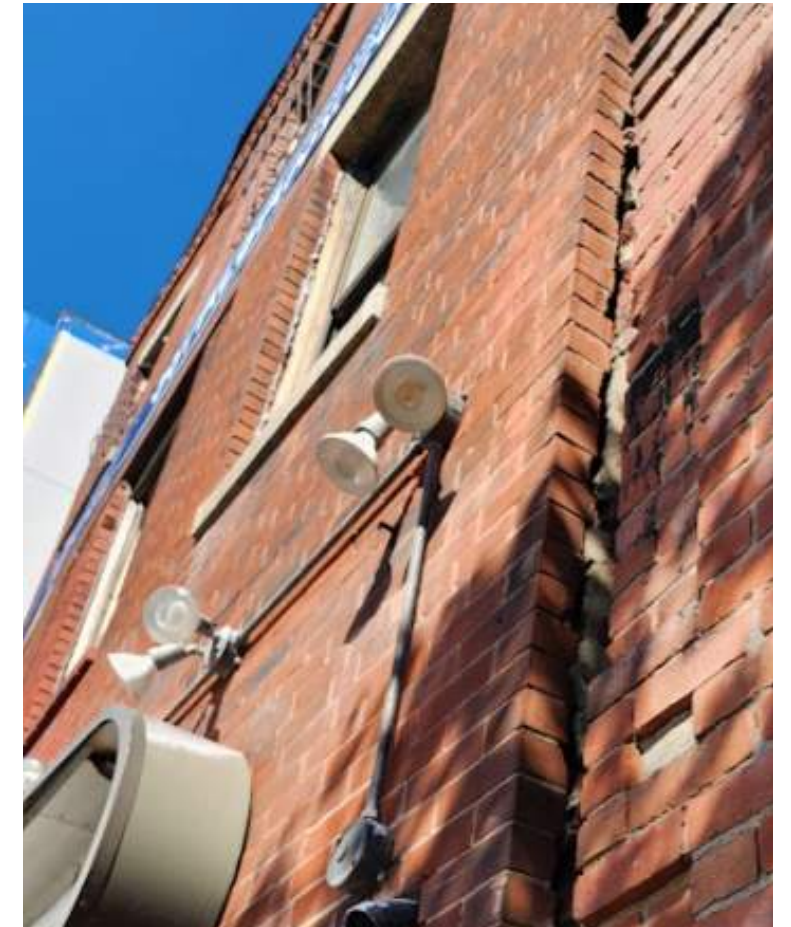
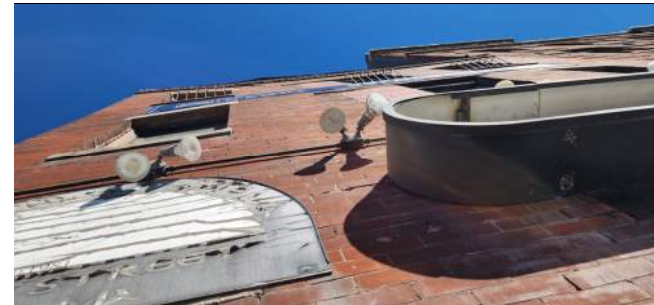
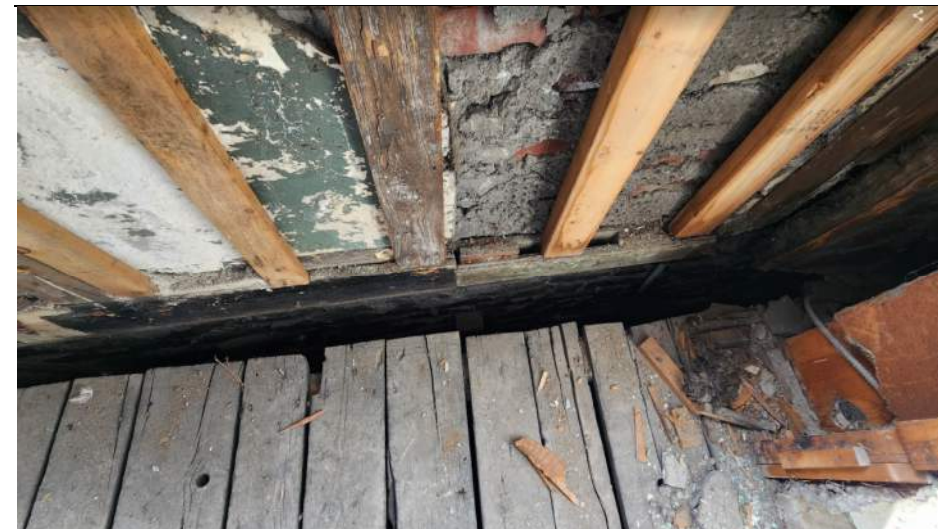
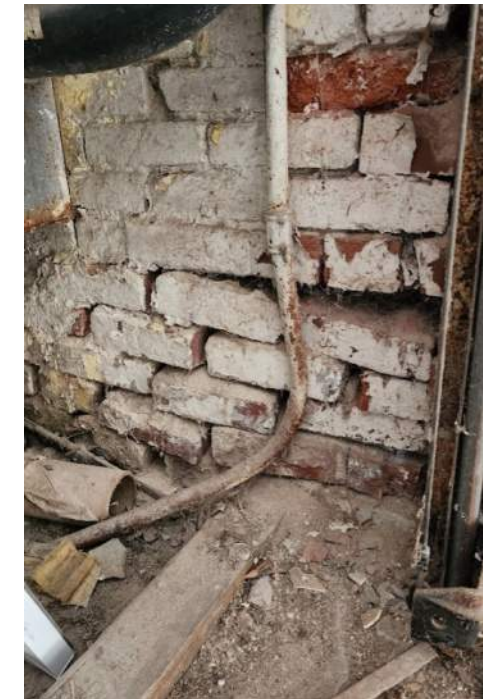
The existing structure is a 3-story unreinforced brick masonry building, a common construction type from this time period. The attached photos show several deficiencies observed during our visit. There was extensive loss of mortar, step cracking, and loose and missing bricks. At approximately the elevation of the second level, the outer wythe of masonry has pulled away and delaminated from the inner wythes. All of the above have created paths for water to enter the façade and further degrade it over time.
