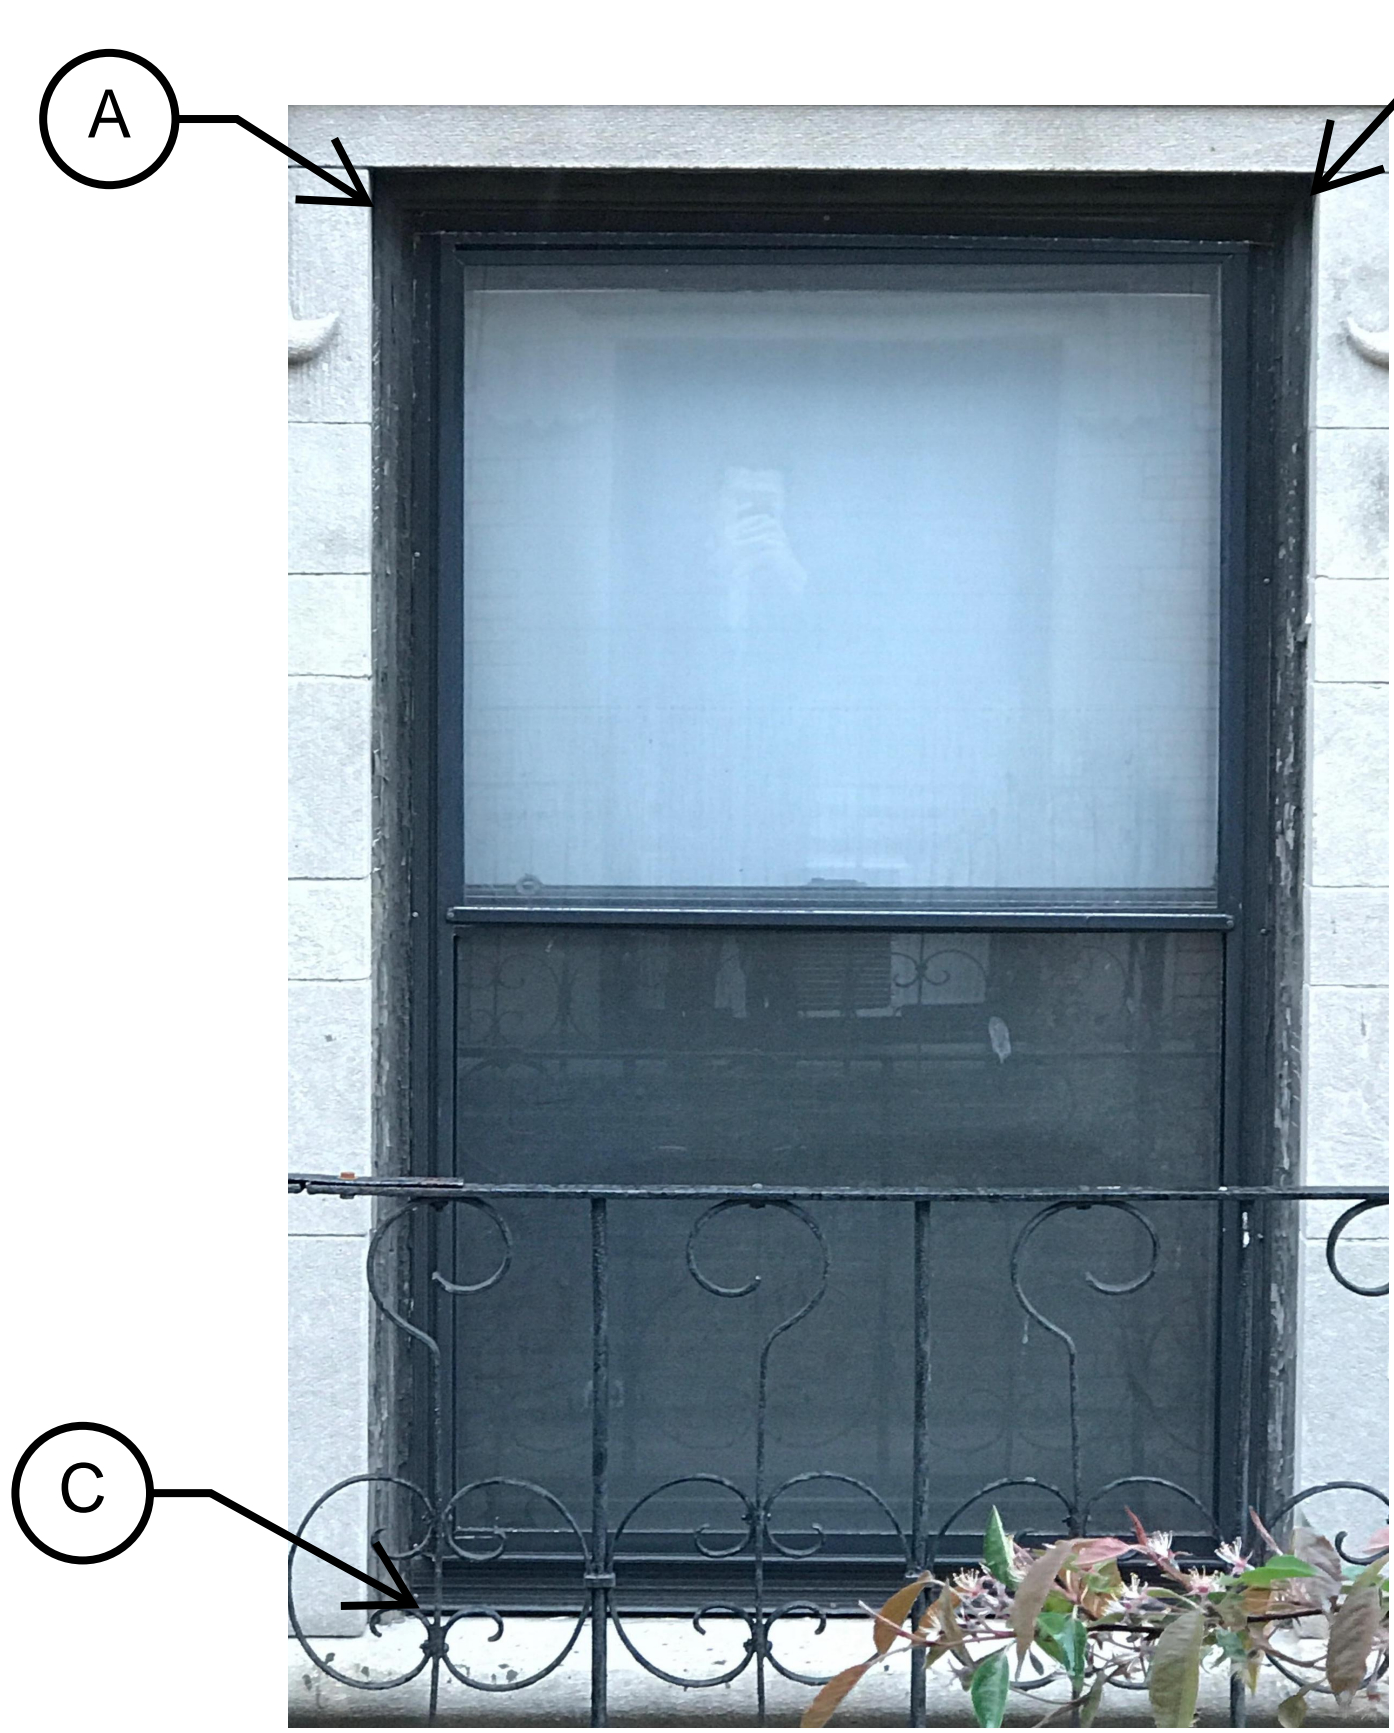
TYPICAL EXISTING WINDOW

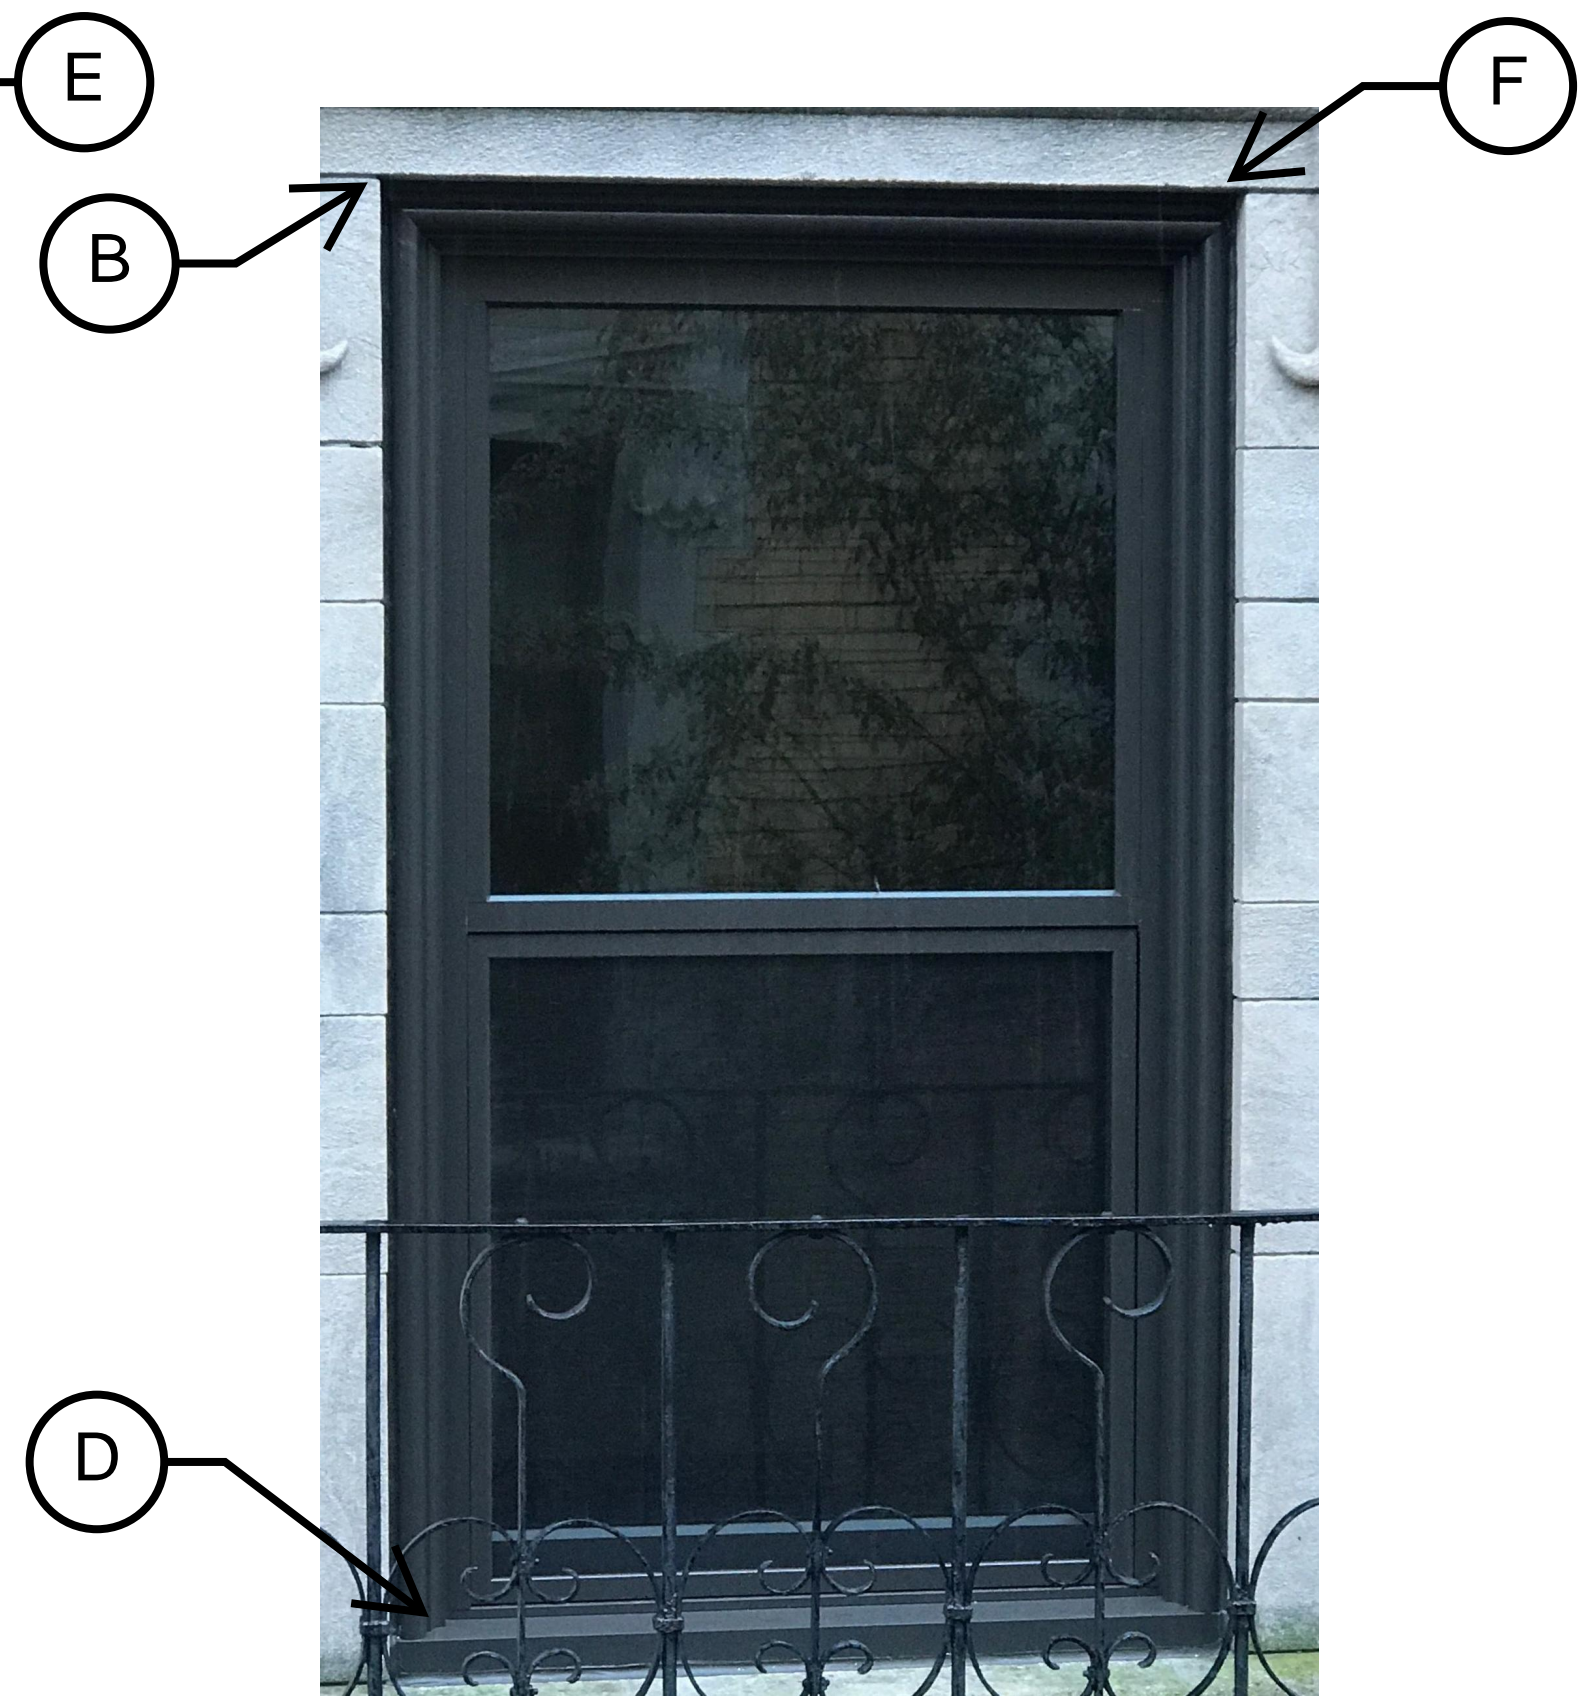
TYPICAL PROPOSED WINDOW

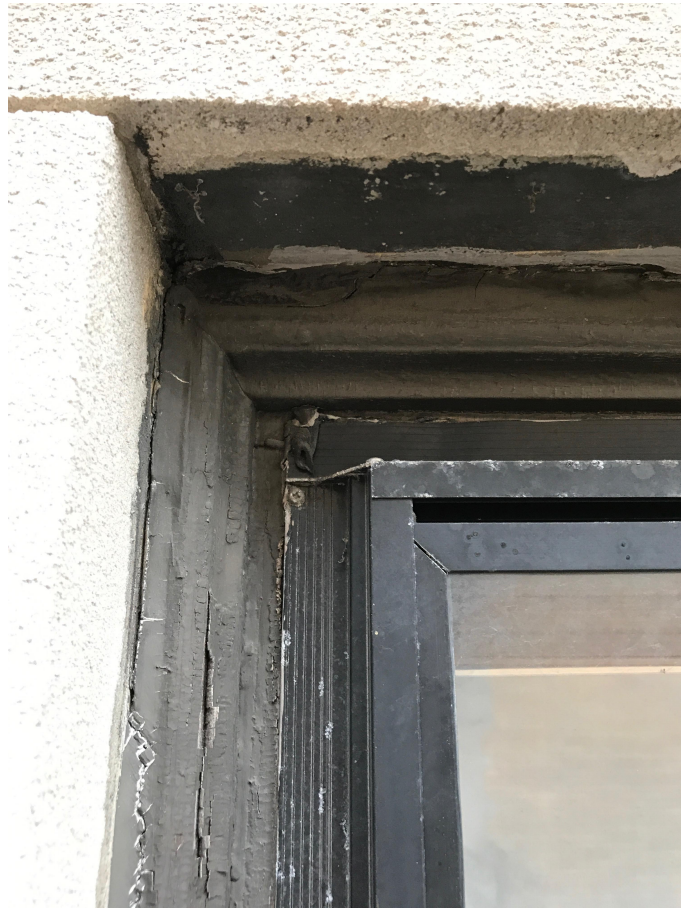
DETAIL A - EXISTING WINDOW BRICK MOLD AT JAMB / HEAD

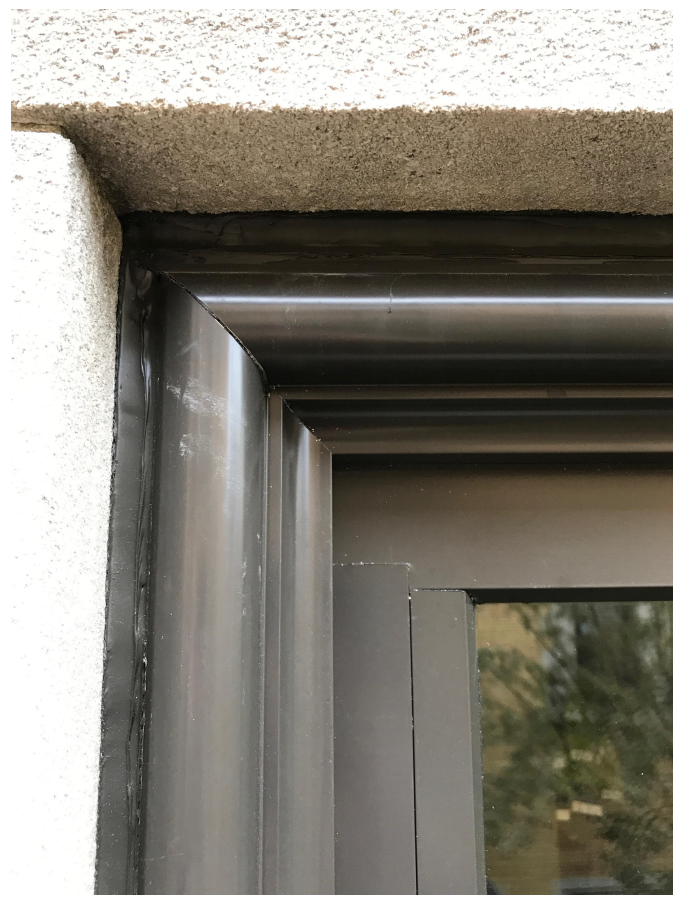
DETAIL B - PROPOSED WINDOW BRICK MOLD AT JAMB / HEAD

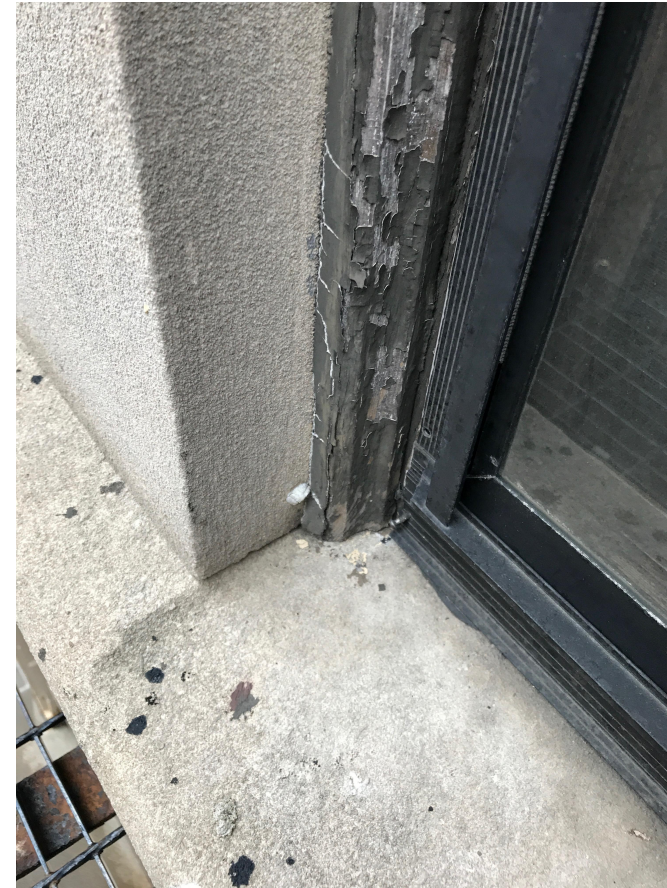
DETAIL C - EXISTING WINDOW BRICK MOLD AT JAMB / SILL

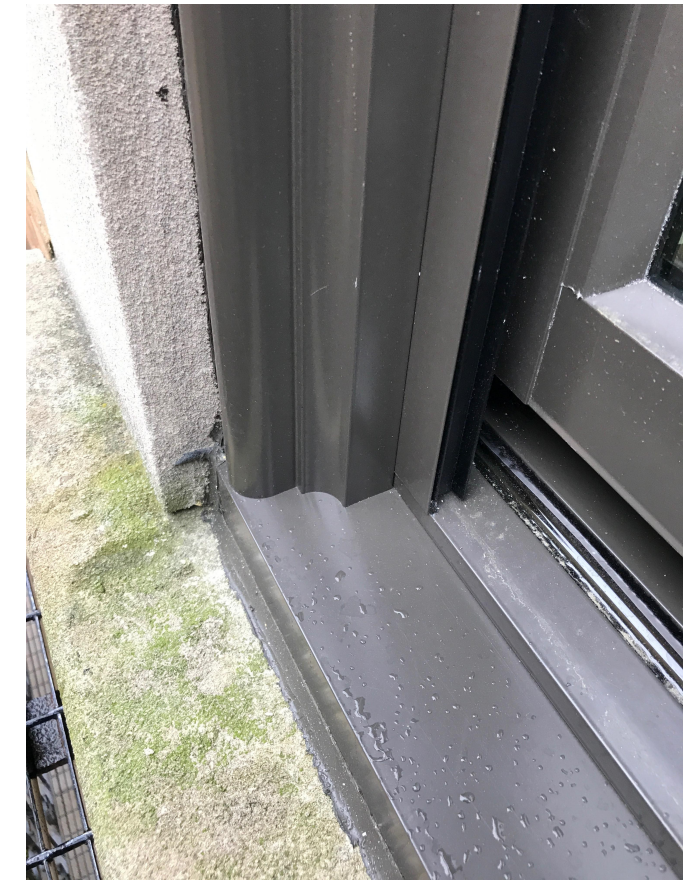
DETAIL D - PROPOSED WINDOW BRICK MOLD AT JAMB / SILL
NOTE: SILL PANNING DETAIL MATCHES HISTORIC PHOTOGRAPH

HISTORIC SILL PANNING. NEW ALUMINUM WINDOW TO MATCH. SEE DETAIL D

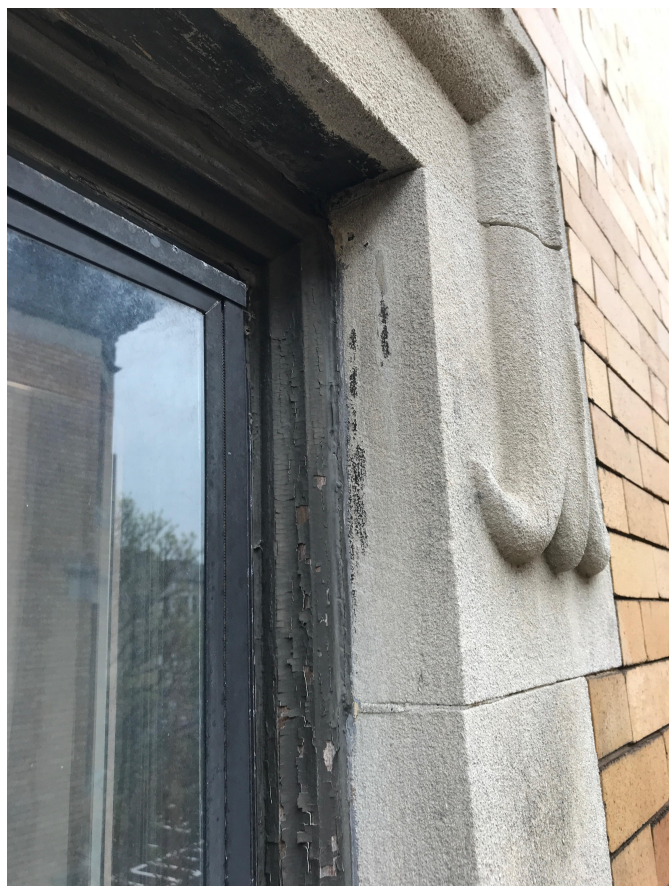
DETAIL E - EXISTING WINDOW BRICK MOLD AT JAMB / HEAD

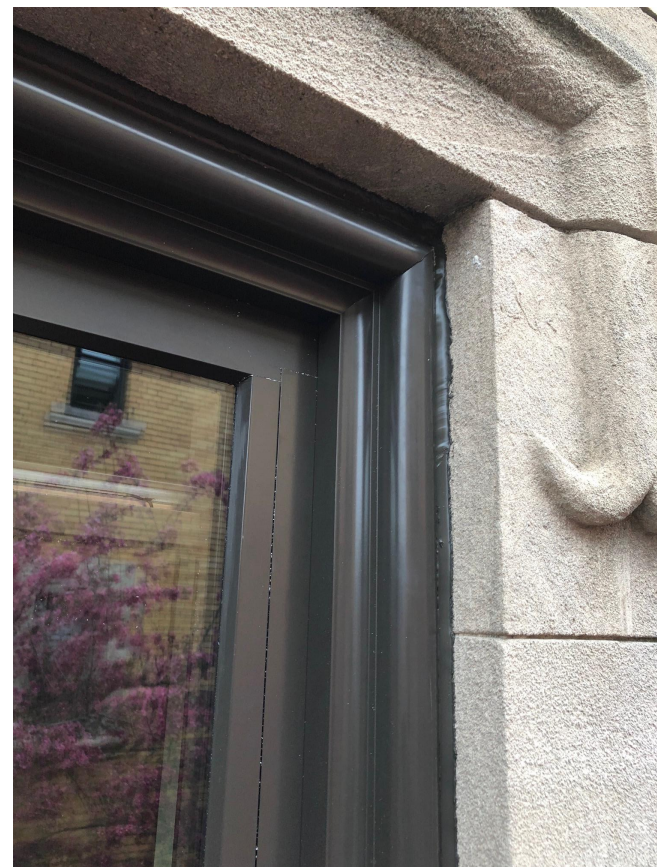
DETAIL F - PROPOSED WINDOW BRICK MOLD AT JAMB / HEAD
